Loss of separation involving GAF Nomad N22C, VH-ATO and two Boeing 737s, VH-VZA and VH-TJY

17 km NE of Melbourne Airport, Victoria | 16 February 2012

ATSB Transport Safety Report
Aviation Occurrence Investigation
AO-2012-029
Final – 29 August 2014

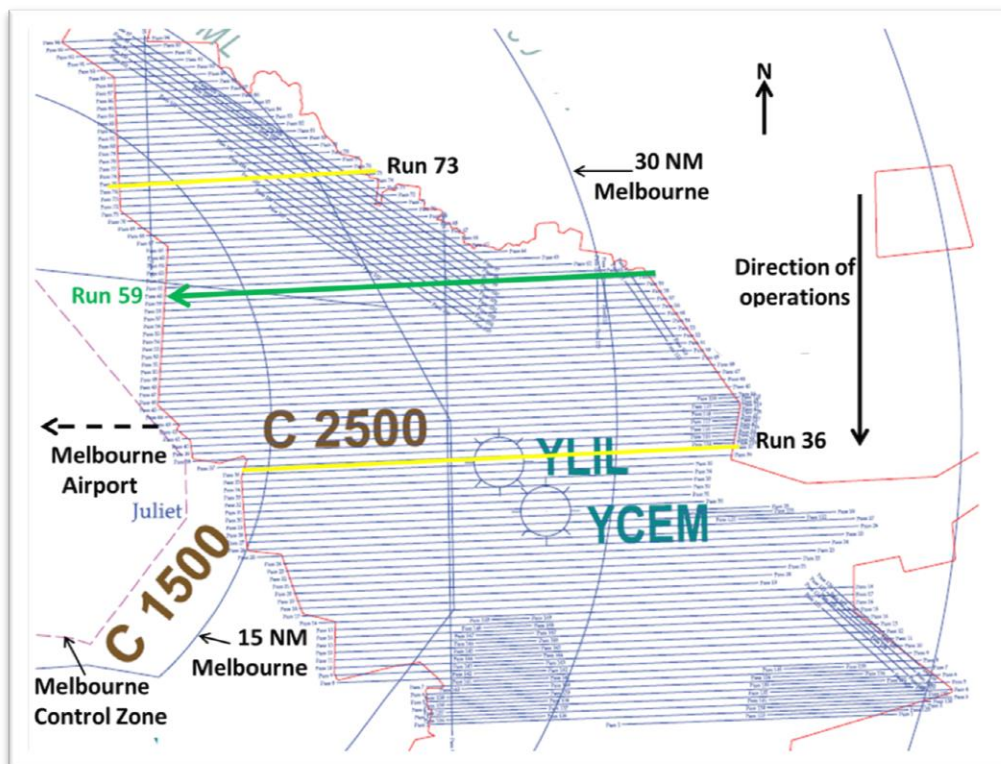
Figure 1: Survey area map with relevant detail added

Maps of the intended survey area were included in the pilot’s email (Figure 1), together with a request to conduct operations through east-west aligned runs from Run 73 south to Run 36. The scale of the survey map was different to that of the surveillance display used by ATC and did not contain details of the direction or size of the repositioning turns at the end of each of the survey runs. The western end of the intended survey area infringed airspace used by any aircraft arriving from the north of Melbourne Airport that were being positioned to land on runway 27.

At 1315, in response to Controller 1's request, the pilot of ATO advised that there were 8 NM (15 km) remaining on the westerly-oriented Run 59 prior to the need to turn (Figure 1). At 1316, the pilot of a Boeing 737 aircraft, registered VH-VZA (VZA), contacted MAE when 12 NM (22 km) north of Melbourne and was assigned 5,500 ft on an area navigation (RNAV)⁶ MIKE runway 27 approach via the ARBEY STAR. Shortly after, Controller 1 provided traffic information on VZA to the pilot of ATO. At that time VZA was 9 NM (17 km) north of Melbourne Airport and about 11 NM (20 km) west of ATO.

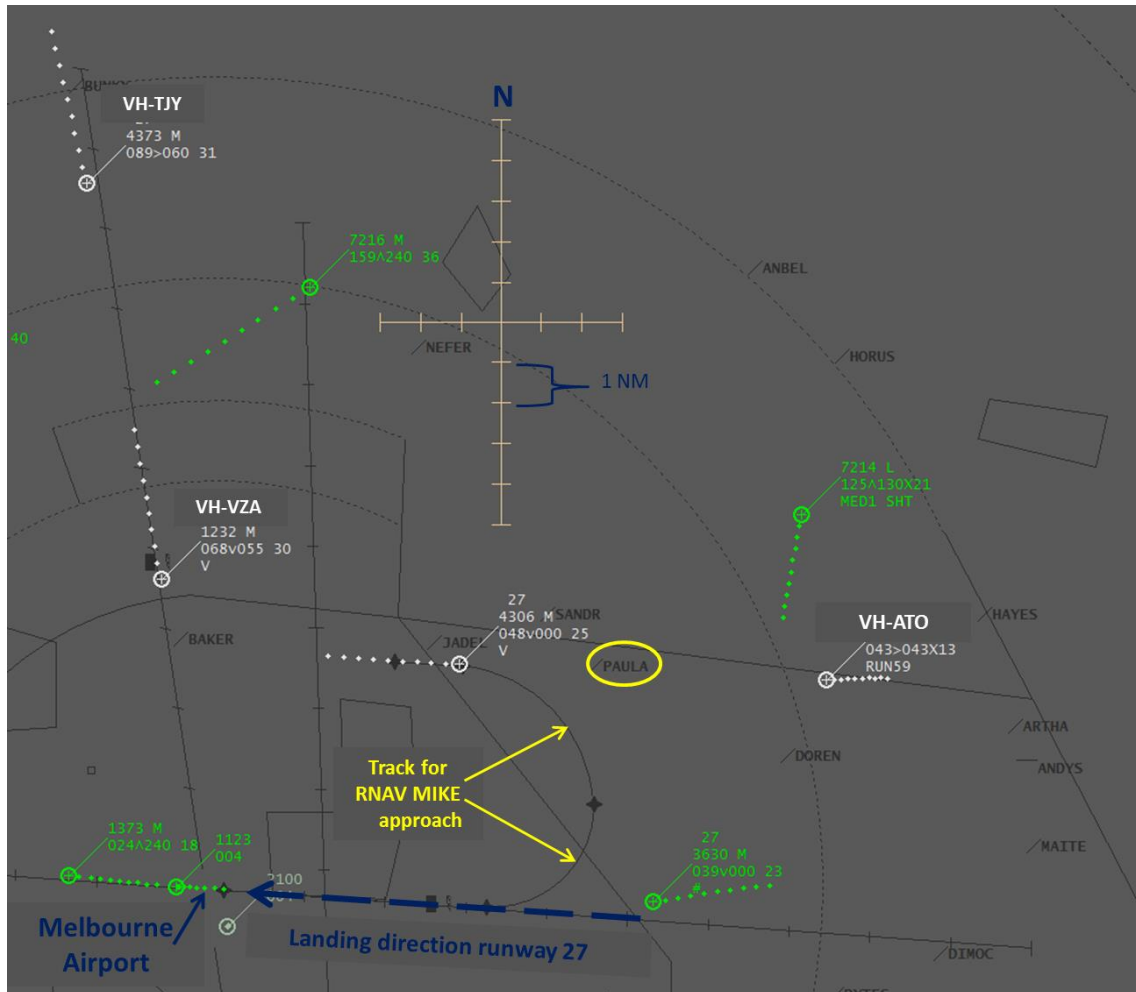
Figure 2: Surveillance display highlighting relevant detail, including the runway 27 landing direction (in blue)

When the TAC approved ATO's survey operations, runway 34⁴ was in use at Melbourne Airport. However, prior to the commencement of the survey operation, the runway in use at Melbourne changed to runway 27 (Figure 2). The TAC permitted the survey operation to continue following the change of runway. The pilot of ATO contacted the Melbourne Departures North controller (Controller 1) at 0957, prior to the first of the survey runs, and was advised that the changed runway configuration at Melbourne would impact on the survey operations, as the western sections of the survey area infringed the approach path of aircraft inbound to runway 27 from the north.

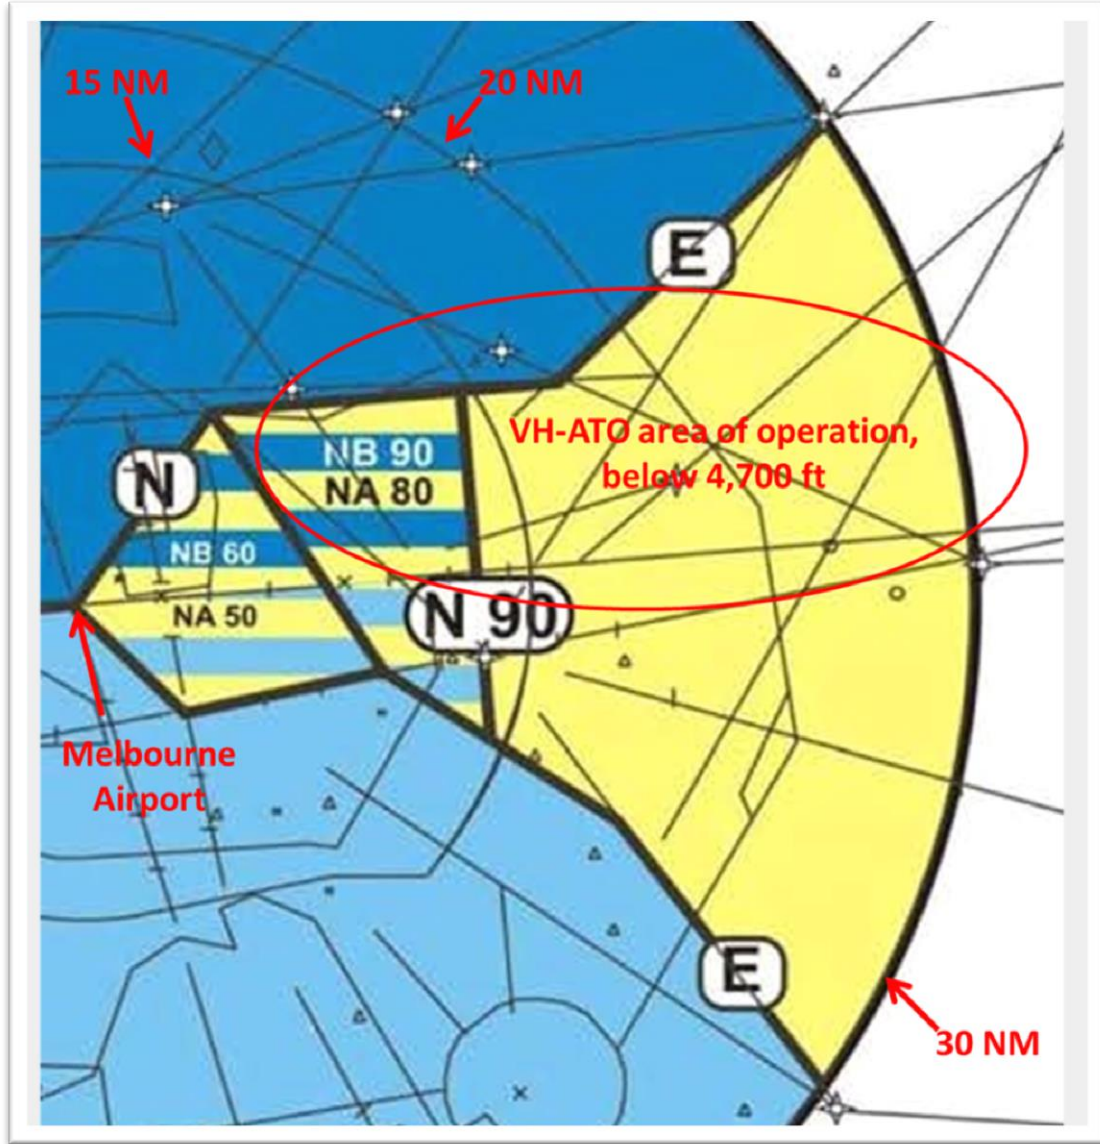
Figure 3: Melbourne Approach East airspace depicted in yellow, showing the approximate position of the survey area

At 1020, ATO entered the Melbourne Approach East (MAE) airspace (Figure 3), which was under the jurisdiction of another controller. From this time, ATO's planned operations kept it in MAE airspace. A handover (see the section titled *Controller handovers*) of the MAE control position was conducted at 1127, during which the relinquishing controller advised the incoming controller (Controller 2) that ATO was becoming difficult to separate with aircraft inbound to Melbourne from

The Melbourne Terminal Control Unit (TCU) had jurisdiction over aircraft in Class C airspace¹² within 30 NM (56 km) of Melbourne Airport up to flight level (FL)¹³ 245, except that airspace associated with the Melbourne and Essendon air traffic control (ATC) towers. The airspace, known as the Melbourne Terminal Airspace, was within radar coverage and was divided into three areas of responsibility that varied according to the runway configuration at Melbourne. At the time of the occurrences, ATO, VZA and TJY were operating in airspace under the jurisdiction of the Melbourne Approach East (MAE) controller (Figure 3).

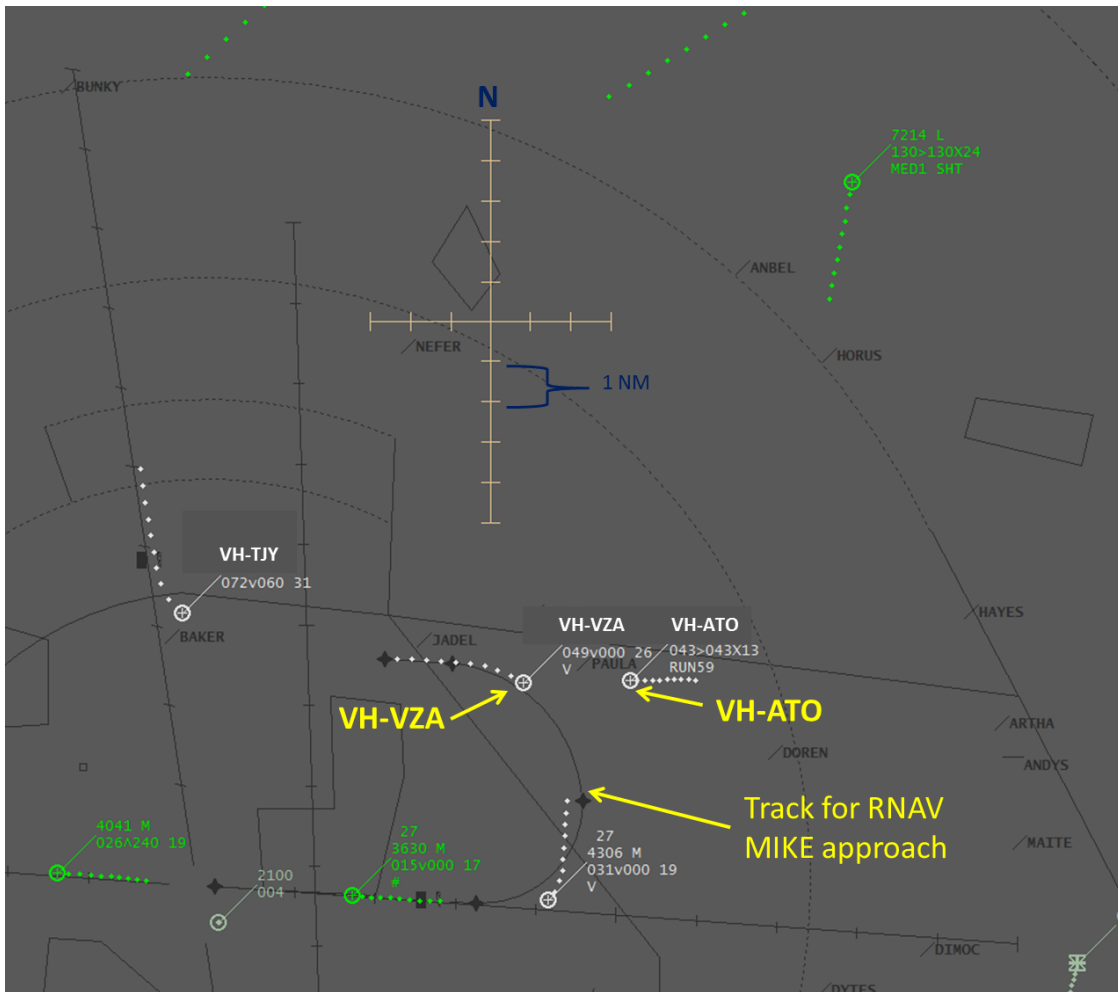
Figure 4: Surveillance display highlighting VH-ATO and VH-VZA, and the track for the RNAV MIKE approach

In preparation to establish visual (pilot) separation between ATO and VZA, Controller 1 identified the arrival path for runway 27 to the pilot of ATO by requiring that he sight an aircraft that was tracking via the STAR ahead of VZA. At 1317, after confirming that the pilot of ATO could remain visually clear of the runway 27 arrival path, Controller 1 cleared the flight crew of VZA to descend through ATO's operating altitude. At that point, a loss of separation assurance (LOSA)⁷ occurred between ATO and VZA as visual (pilot) separation had not been applied in accordance with the requirements of that standard – the pilot of ATO had not reported having VZA in sight, and the phrase 'maintain separation with' had not been used. Thirty-six seconds later, when VZA was 7 NM (13 km) directly ahead of, and 1,900 ft above ATO, the pilot of ATO reported VZA in sight.

At 1318, an ATC system Short Term Conflict Alert (STCA) (see the section titled *Compromised separation recovery*) activated in respect of ATO and VZA with 7 NM (13 km) lateral and 800 ft vertical separation between the aircraft. Believing that the responsibility for separation had been transferred to the pilot, Controller 1 took no action. Soon after, the flight crew of VZA turned right on the STAR.

One minute later, a loss of separation (LOS)⁸ (see the section titled *Separation*) occurred between ATO and VZA when the existing separation standard of 3 NM (5.6 km) or 1,000 ft was infringed just before ATO completed Run 59 (Figure 4). The separation standard was infringed for 45 seconds and, at their closest point, the separation of the aircraft reduced to 1.5 NM (2.8 km) and 300 ft with the aircraft flying in opposite directions.

As ATO completed Run 59 the aircraft entered a right turn and advised the controller that he was ‘...turning right, keeping away from the traffic as much as possible.’ Controller 1 advised the pilot of ATO that there was another inbound 737 aircraft, registered VH-TJY (TJY), about 8 NM (15 km) in their 12 o’clock position,¹¹ also on the ARBEY STAR, and asked if ATO would remain visually clear of that aircraft’s track. The pilot responded in the affirmative and stopped the right turn on a northerly heading. At that time, the crew of TJY were not monitoring Controller 1’s frequency as the aircraft had not yet entered MAE airspace (Figure 3).

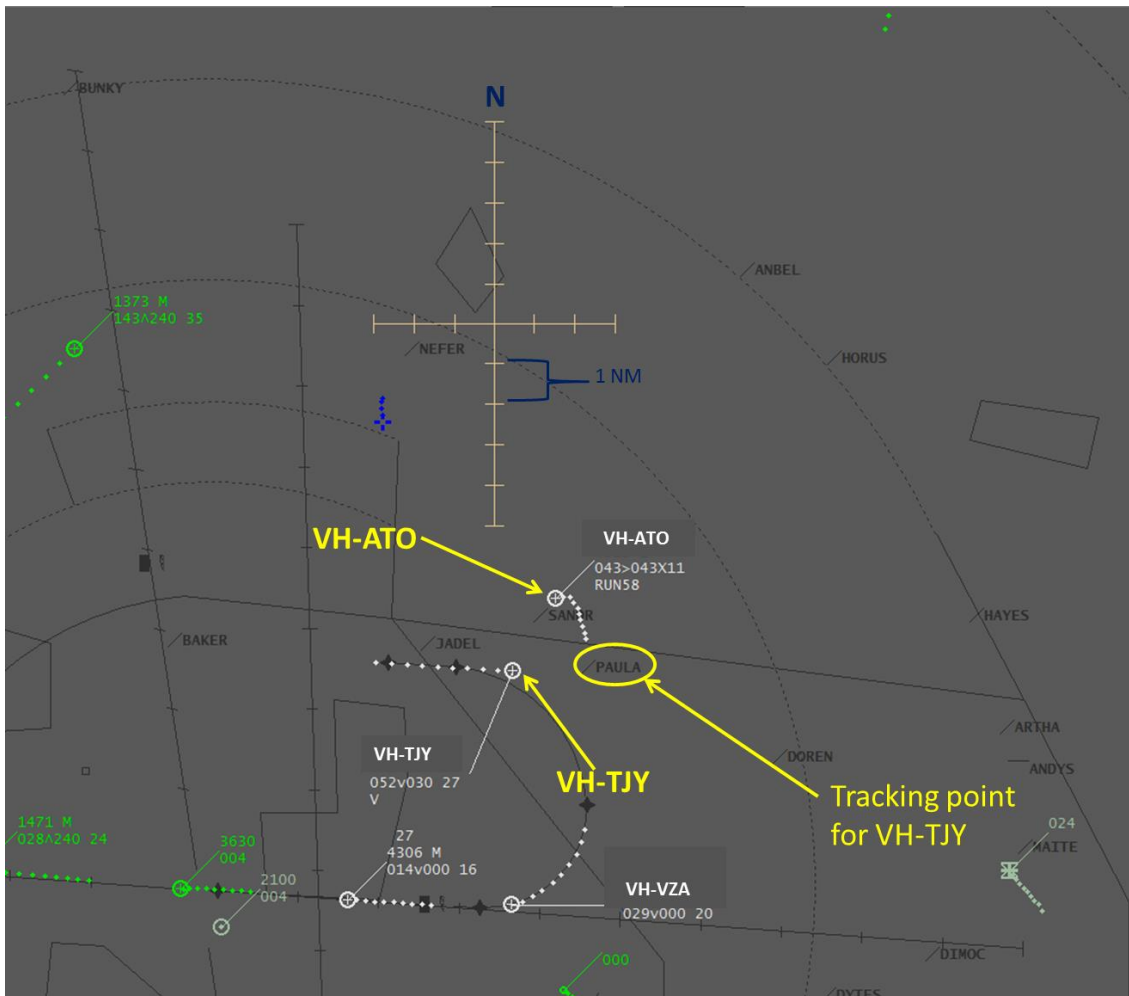
Figure 5: Surveillance display highlighting VH-ATO and VH-TJY and the tracking points for the ARBEY STAR

At 1320, when TJY was 3 NM (5.6 km) south-west of ATO, ATO commenced turning left towards TJY (Figure 5). In response, Controller 1 asked the pilot of ATO if he had the 737 in sight. When the pilot of ATO reported in the negative, the controller initiated compromised separation recovery actions and immediately instructed the pilot of ATO to fly a heading of 210°. Shortly after, the STCA activated and there was a LOS, as the altitude between the two aircraft reduced to less than 1,000 ft while the aircraft were less than 3 NM (5.6 km) apart. The pilot did not read back the heading instruction, instead advising the controller that TJY was sighted and well clear. Controller 1 did not restate or cancel the heading instruction and the pilot of ATO continued the left turn with TJY in sight.

Controller 1 reported that, as the pilot of ATO had sighted the 737, he believed that visual (pilot) separation was in place and therefore no further compromised separation recovery action was required. However, the LOS remained as the correct visual (pilot) separation phraseology had not been used, and the flight crew of TJY had not been issued traffic information on ATO or advised that the pilot of ATO had been assigned responsibility for separation. The LOS existed for 51 seconds, with separation reducing to 1.7 NM (3.2 km) and 700 ft before being re-established through the divergent tracking of the aircraft.
