Aircraft proximity event between two Piper PA-28 aircraft, VH-LXH and VH-TAU

Moorabbin Airport, Victoria, 26 November 2012

ATSB Transport Safety Report
Aviation Occurrence Investigation
AO-2012-159
Final – 21 March 2013

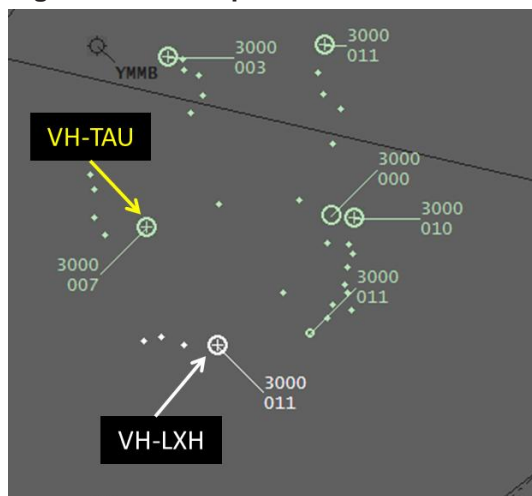
Figure 1: Aircraft position at 1528

At 1528, TAU was observed commencing the turn onto crosswind, at 700 feet above mean sea level (AMSL)². At that time, LXH was on mid-crosswind, maintaining 1,100 feet (Figure 1). The instructor of TAU noted that the turn was commenced at an earlier than normal position and advised the student to conduct the turn later on the next circuit. At that time, the instructor of LXH also observed TAU turn onto crosswind early and continued to monitor the aircraft. A review of the radar data indicated that the turn occurred earlier than other aircraft in the circuit.

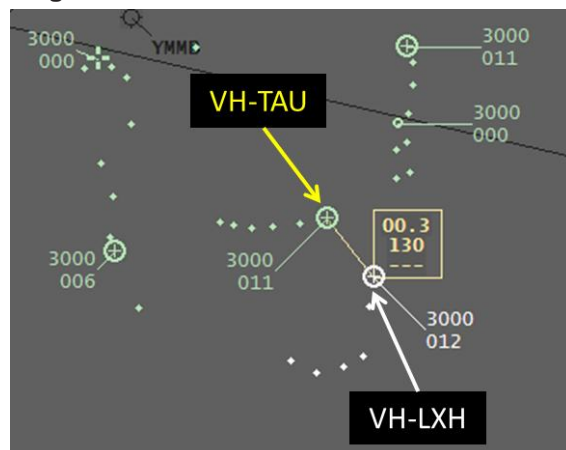
Figure 2: LXH on downwind

LXH made a broadcast advising that they had turned onto downwind. Separation between LXH and TAU reduced to 0.3 NM laterally and 100 feet vertically (Figure 2).

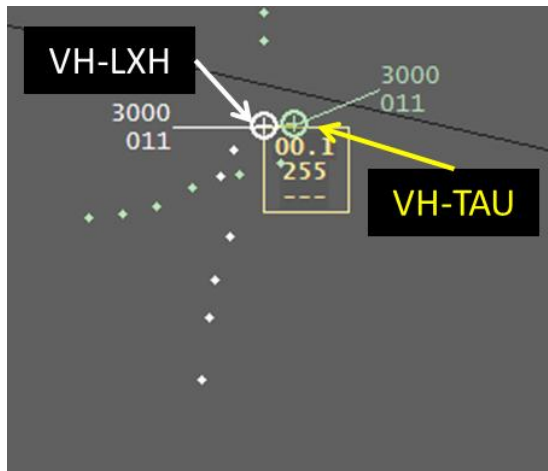
Figure 3: TAU passes underneath LXH

Soon after, TAU commenced the turn onto downwind. The instructor of LXH continued to monitor the location of TAU and at 1529, observed TAU pass 100 feet below (Figure 3). TAU then advised ATC that they had turned onto downwind, however, the end of the broadcast was partially over-transmitted. At that time, separation had reduced 0.1 NM laterally, with both aircraft at 1,100 feet. Air traffic control then advised another aircraft, VH-TAX (TAX)³ to follow the ‘Cherokee’ on mid-downwind. The pilot of TAX acknowledged the call.

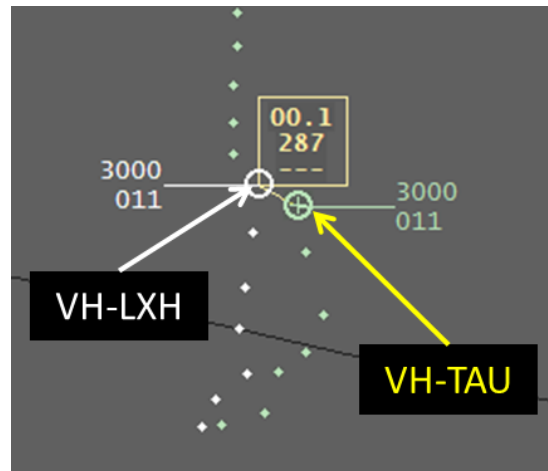
Figure 4: TAU sighted LXH

About 30 seconds later, the instructor of TAU observed LXH to the left and incorrectly advised ATC that they had traffic in their ‘3 o’clock’⁴ position and asked if they were to be following that aircraft (Figure 4). LXH then advised ATC that TAU had cut them off. ATC confirmed that TAU was to follow LXH and that they should widen their circuit to ensure separation.
