Incorrect configuration involving an Airbus A320, VH-VFU,

Sydney Airport, New South Wales, 28 July 2014

ATSB Transport Safety Report
Aviation Occurrence Investigation
AO-2014-129
Final– 26 February 2015

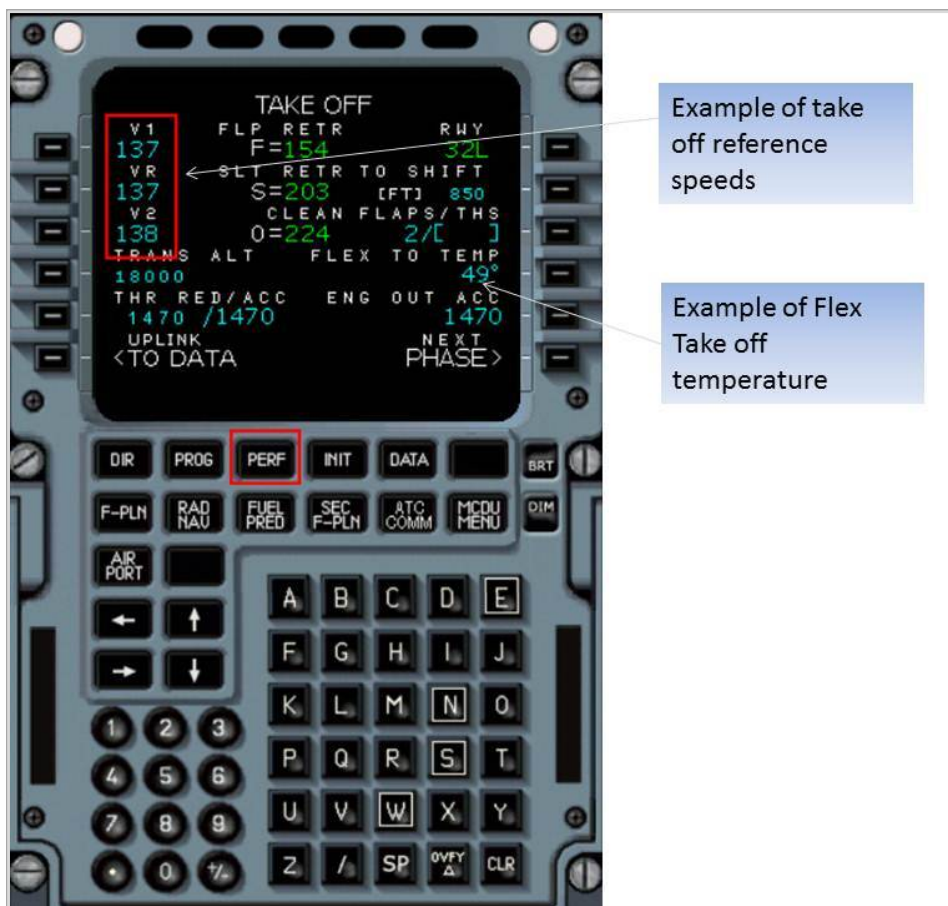
Figure 2: MCDU Performance page: Examples of take-off speeds and flex temperature

established that a Configuration 1 + F³ would now be required for take-off. The PF completed new take-off and landing data (TOLD) cards, and updated the FMGC with the new performance data; including new take-off reference speeds⁴ and flex take-off temperature⁵ (Figure 2).

- Both crew members reported being tired at sign on; however, had judged themselves fit to fly.
- There had been a change in procedure after the change in PDC from ATC. The PF revised the performance data which changed the take-off configuration to a Flap 1 + F and then entered this new information into the MCDU before the FO had checked the data in the performance manual. The PF also updated the TOLD cards at this time.

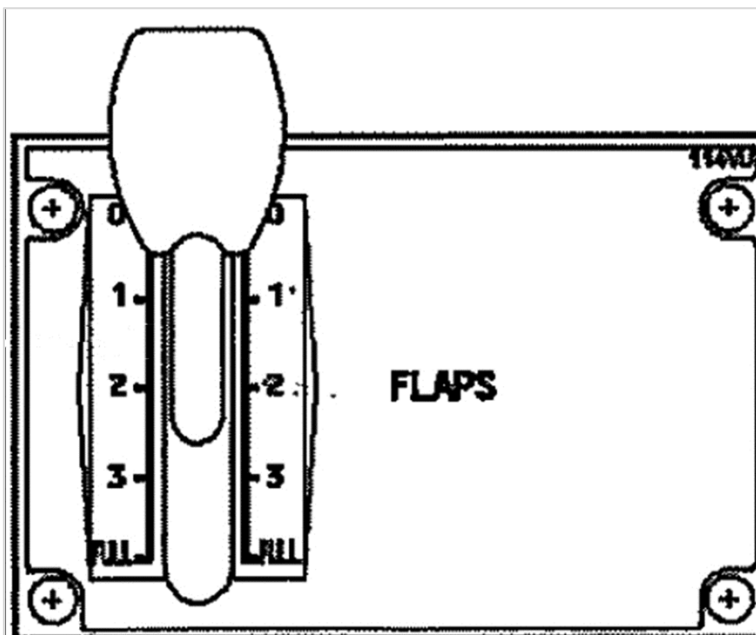
Figure 4: Flap (and configuration) selection lever

As part of the after start procedures (Figure 3, shown as PNF list), the PM inadvertently selected the originally calculated Flap 2 take-off setting. He then checked the flap position on the upper ECAM, which was showing this selection. As he believed he needed to set flap 2, the flap 2 setting displayed on the ECAM confirmed what he believed to be correct.

At this time the flight crew realised that they had positioned the flap lever in the flap 2 position which meant that additional slats and flaps were deployed for the take-off (Figure 1). As the airspeed was above F speed, the flap lever was moved to the flap 1 position where the aircraft continued to accelerate toward the S speed indication. After reaching the required S speed the PNF selected Flaps 0, thereby stowing the remaining slat and flap. The remainder of the flight to Adelaide was uneventful.

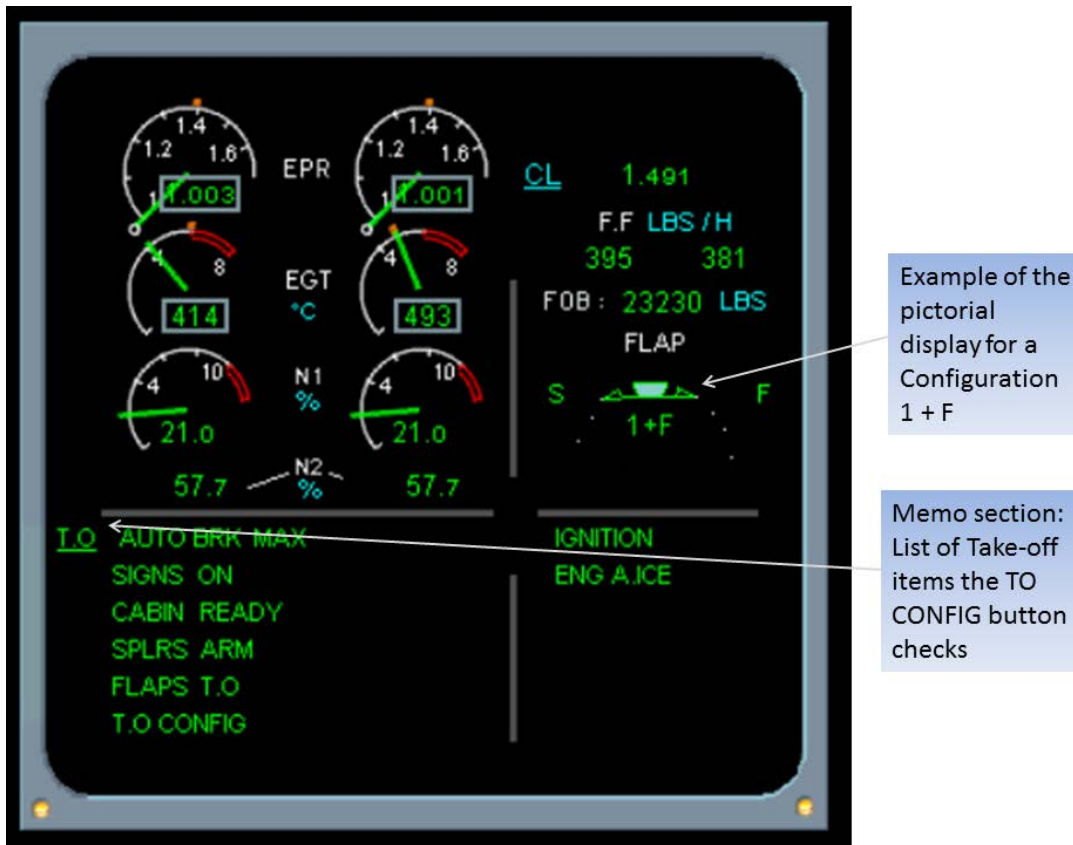
Figure 5: A 320 Upper ECAM Engine / Warning Display

As part of the pre-take-off checks conducted prior to line up, the PM pressed the take-off configuration pushbutton. This button simulates take-off power being applied, and is a final check for the crew on the take-off settings they have selected. The check is designed to trigger a warning if the aircraft is not properly configured for take-off. Any warnings appear in the memo section on the upper electronic centralised aircraft monitor (ECAM) or Engine/Warning Display (E/WD) (Figure 5).

Note: This check does not crosscheck the manually selected take-off flap (configuration) (Figures 1 and 4) with the information programmed by the crew into the FMGC. The system is designed to check that any of the take-off flap positions (1, 2 or 3) has been manually selected, not which particular setting. Therefore, despite the crew incorrectly selecting a Flap 2 (configuration) for take-off, no messages appeared on the ECAM.
