# Wirestrike involving a Piper PA-25, VH-CPU

near Michelago, New South Wales on 20 September 2014

**ATSB Transport Safety Report**  
Aviation Occurrence Investigation  
AO-2014-153  
Final – 27 January 2015

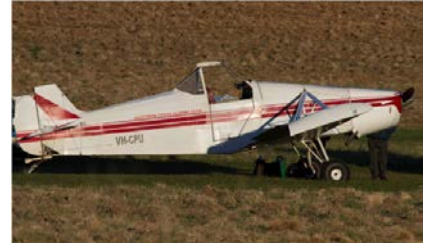
Damage to VH-CPU

The aircraft was heading south and as the airstrip was oriented approximately north-south, the pilot elected to overfly the runway. The pilot observed the windsock indicating a southerly wind of about 8-10 kt. When about 300 m beyond the runway threshold, the aircraft struck powerlines that crossed the runway about 15 m above ground level, dislodging the windscreen and canopy (Figure 1). The top of the fin was severed by the powerlines.

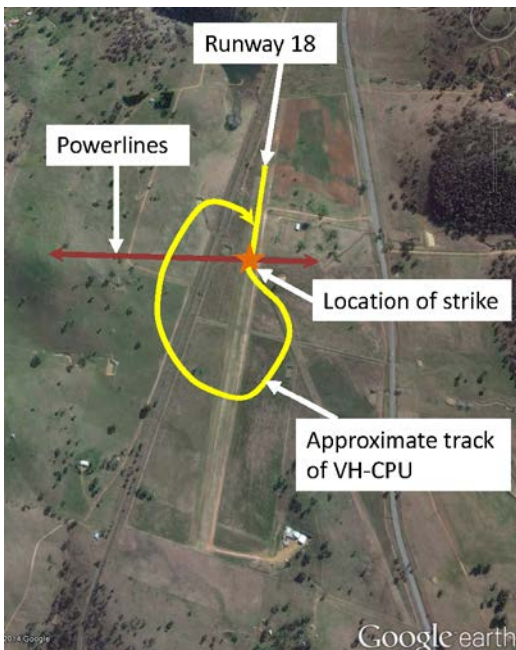
**Figure 2: Approximate flight path of VH-CPU**

The pilot attempted to broadcast a Mayday<sup>1</sup> call, but his headset was no longer in place. Immediately after the strike, the aircraft banked to the left before returning to level flight. The pilot assessed that the aircraft was too high to land ahead on the remaining runway and sighted a hill straight ahead. He then made a right turn, initially planning to land towards the north on the adjacent paddock. However, due to the rough surface of the paddock and tailwind, he conducted a short downwind leg before turning to the right, and the aircraft landed into wind on the runway (Figure 2).

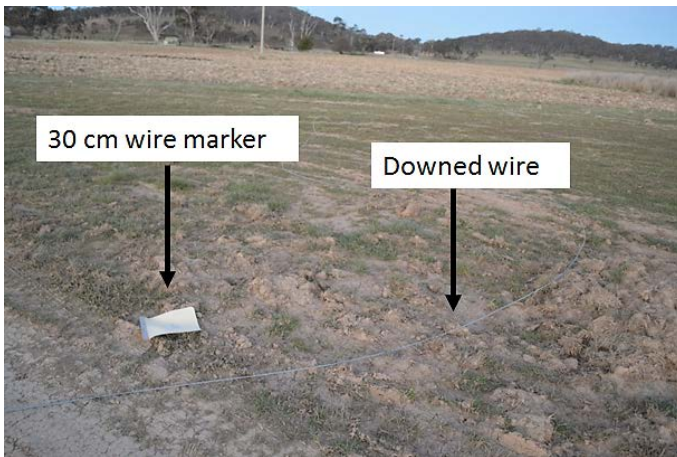
**Figure 4: Wire marker**

The wires were marked with square off-white markers, about 30 cm wide, located adjacent to but not overhead the runway (Figure 4).
