Near collision involving a Cessna 152, VH-NKL and a Starduster SA300, VH-XRS

Tyabb Airport, Victoria, 2 January 2015

ATSB Transport Safety Report
Aviation Occurrence Investigation
AO-2015-002
Final – 22 April 2015

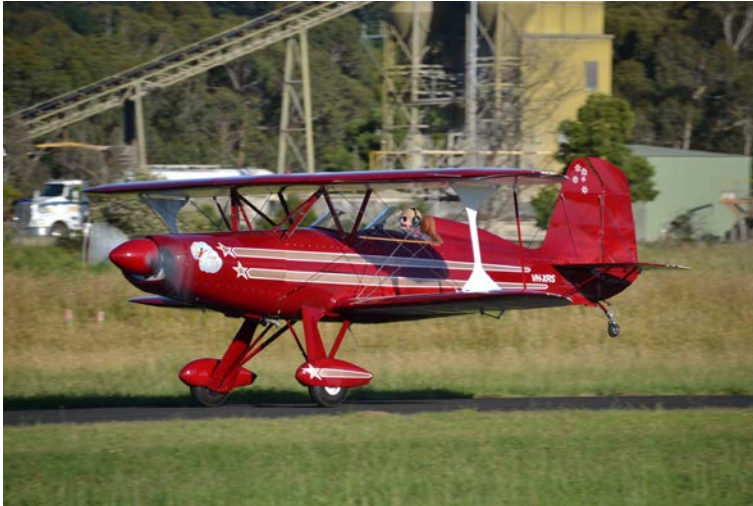
Figure 1: VH-XRS

On 2 January 2015, at about 1400 Eastern Daylight-saving Time, the pilot of a Starduster SA300 aircraft, registered VH-XRS (XRS), commenced pre-flight preparations for a local private flight at Tyabb Airport, Victoria (Figure 1). The pilot of XRS observed the windsock indicating calm conditions. The pilot elected to follow the airport operator's procedures for nil wind, and use the preferred runway, runway 17. During the next 30 minutes, no aircraft operated in the circuit. The pilot did not hear any broadcasts on the common traffic advisory frequency (CTAF) during that time.

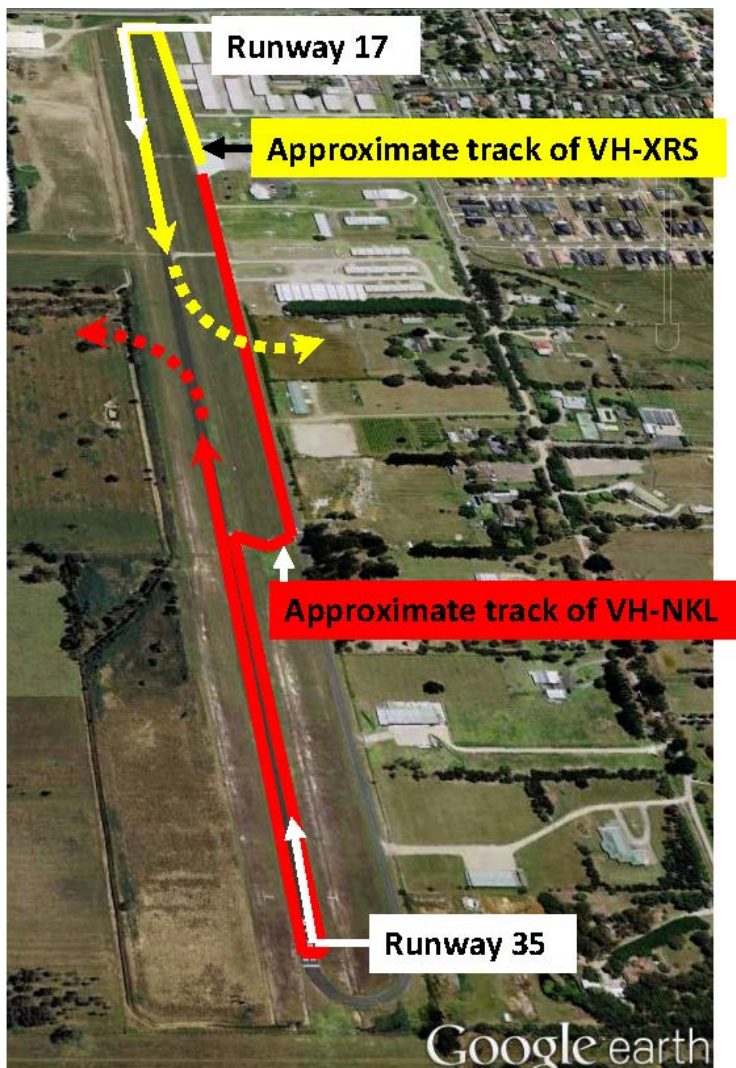
Figure 2: Tyabb Airport and aircraft tracks

When about 500 m along the runway and at rotate speed, the instructor of NKL pointed out the airspeed to the student and the aircraft lifted off. The instructor then sighted XRS in the take-off run on the opposite runway. The instructor immediately took control of the aircraft from the student and commenced a left climbing turn, while keeping XRS in sight (Figure 2).

When about 300 m along the runway, XRS lifted off. When at about 10 ft above ground level, the pilot of XRS sighted NKL, about 300 m ahead and banking to the left. He also commenced a left turn to increase separation between the two aircraft, which then passed about 50 m from each other, with NKL slightly higher than XRS. The pilot of XRS then joined the circuit for runway 35 on the crosswind leg, and broadcast that he was joining the circuit to return to land at Tyabb.

The incident will be discussed at a monthly meeting, emphasising the use of the preferred runway in nil wind conditions. Pilots and instructors will be reminded that operating outside of the normal and expected procedures, requires higher levels of alertness.

The ERSA entry for Tyabb will be amended as the layout may have been misleading.

They will review the installation of an AFRU and possible means of recording the CTAF.
