Near collision between a Beechcraft 76 aircraft, VH-ZUA and a Eurocopter AS350 helicopter, VH-SWX

Near the Gold Coast Airport, Queensland, 4 January, 2015

ATSB Transport Safety Report
Aviation Occurrence Investigation
AO-2015-004
Final – 27 August 2015

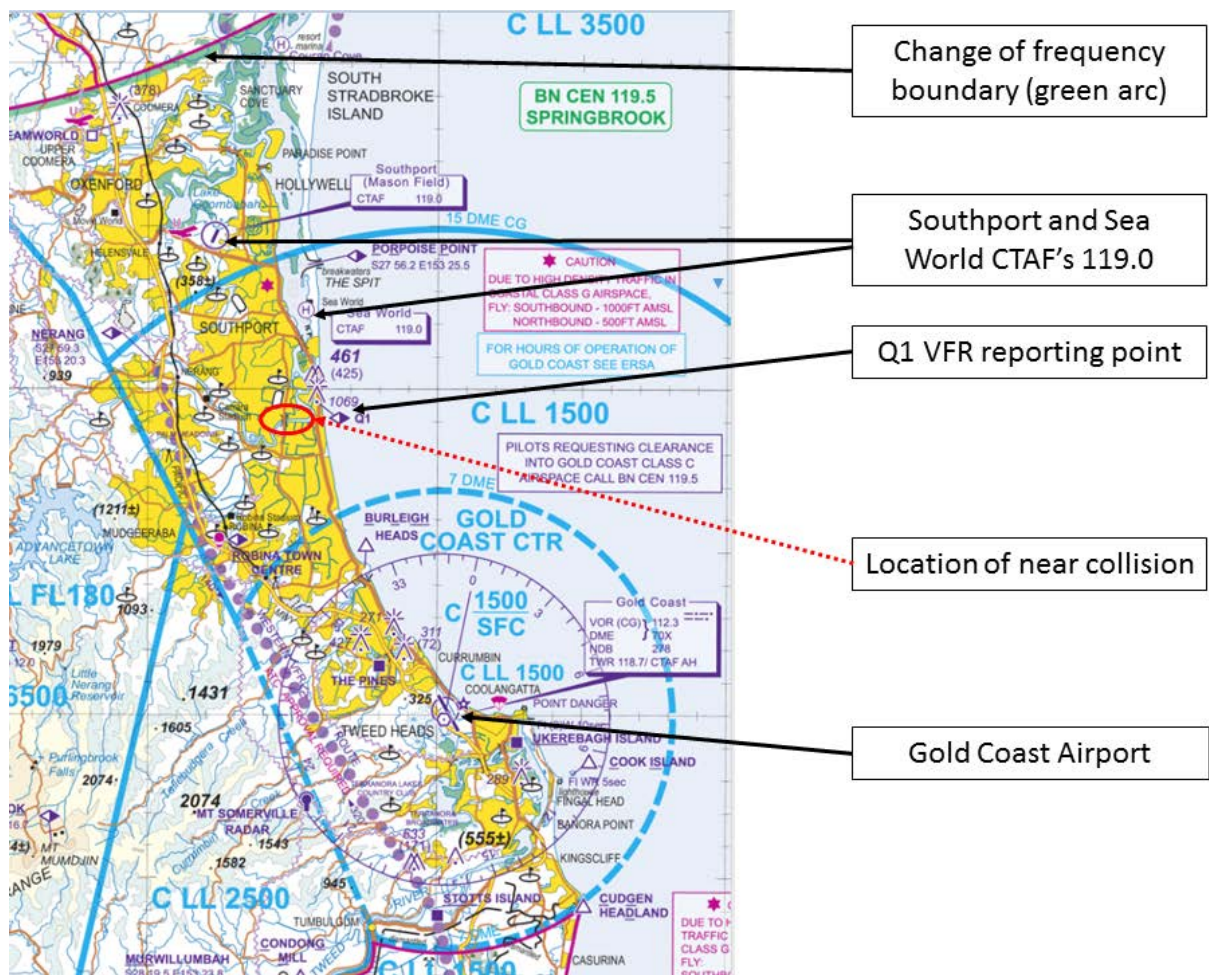
Figure 1: Gold Coast VTC

At about 1210, as ZUA approached the change of frequency boundary (Figure 1) just north of Dreamworld, the pilot changed to the area frequency (119.5 MHz) on COMM 1¹ with the

Southport CTAF frequency (119.0 MHz) in the standby section of the Garmin 530. As he approached Southport airport, the pilot moved the standby frequency (119.0 MHz) into the active box and as required, broadcast the aircraft's position and intentions. The CTAF frequency is common to both Southport Airport and the nearby Sea World helipad (Figure 1).

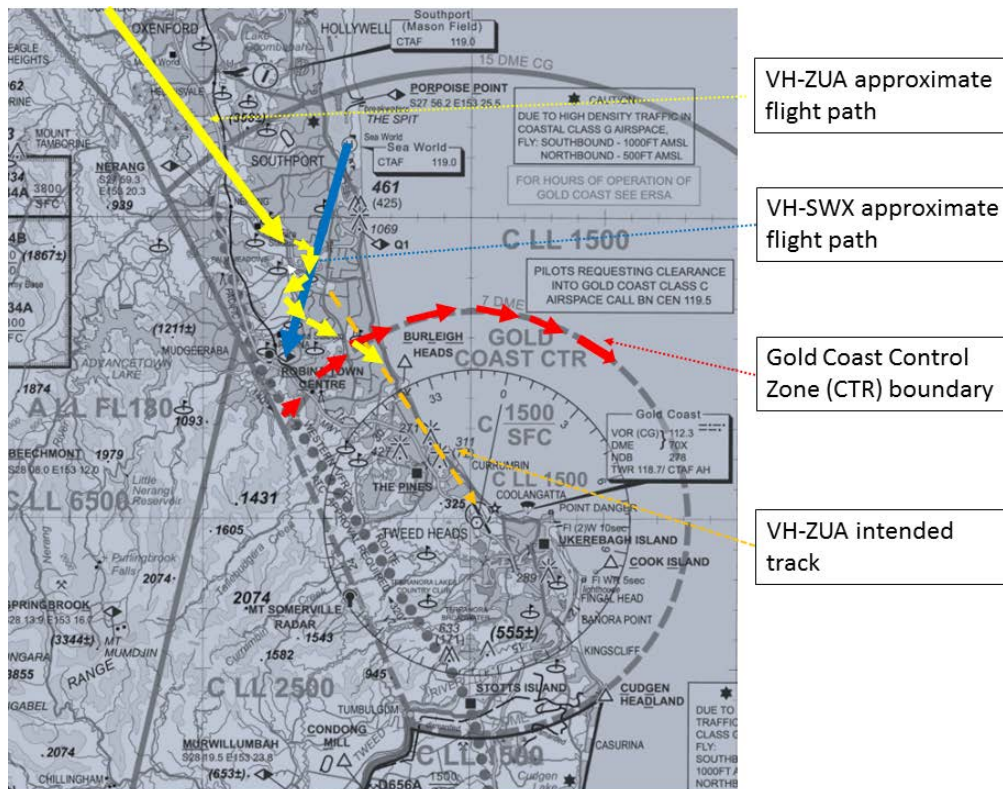
Figure 2: Approximate flight path of ZUA and SWX

At about 1212, the pilot of an AS350 helicopter, registered VH-SWX (SWX) prepared to depart from Sea World, Queensland, for a 15 minute local commercial scenic flight. The first sector was from Sea World to overhead the Robina shopping centre (Figure 2). On board were the pilot and 5 passengers.

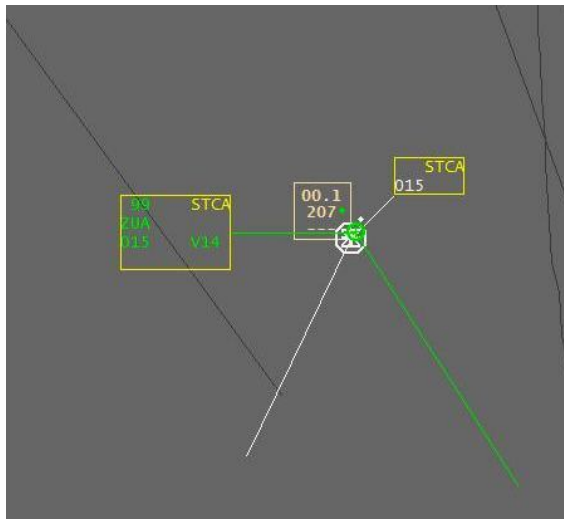
Figure 3

Also noticing the short term conflict alert (STCA) (Figures 3 and 4) on the air situation display, the Brisbane Centre controller twice attempted to make contact with ZUA which was still in uncontrolled airspace; but there was no response. The controller then contacted the Gold Coast tower controller via the internal coordination line, to confirm that a safety alert had been issued. The tower controller advised the Brisbane Centre controller that a safety alert had already been issued and the situation was under control.

Time: 2.21.37 ZUA at 1,500 ft; SWX 1,500 ft ; about 100 m horizontally

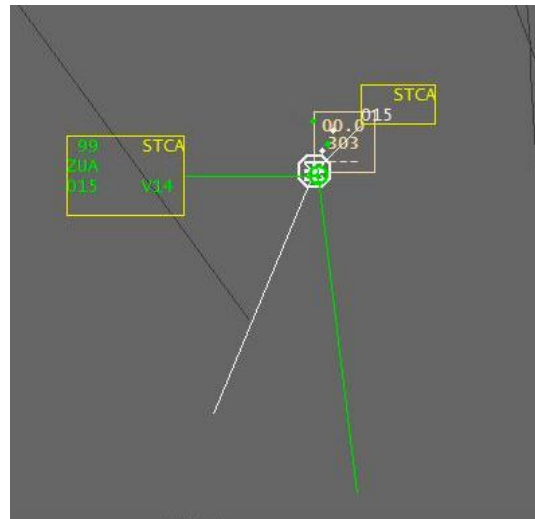
Figure 4

Time: 2.21.42 Near collision

ZUA at 1,500 ft; SWX 1,500 ft; Nil horizontal distance showing on radar

The traffic collision avoidance system (TCAS) on board the helicopter did not alert the pilot to the potential conflict, possibly because ZUA overflew the helicopter from behind, which may have shielded the TCAS aerial.
