Collision with terrain involving a Robinson R44, VH-YMD

near Alice Springs, Northern Territory, 09 January 2015

ATSB Transport Safety Report
Aviation Occurrence Investigation
AO-2015-006
Final – 10 June 2015

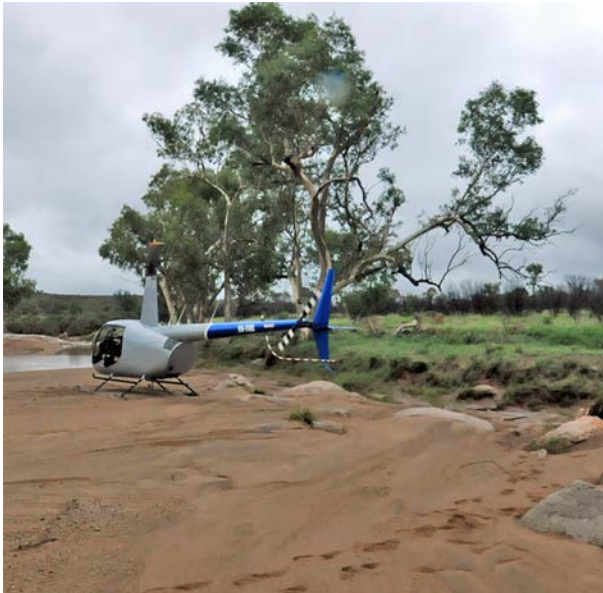
Figure 1: VH-YMD landing site on the river bed

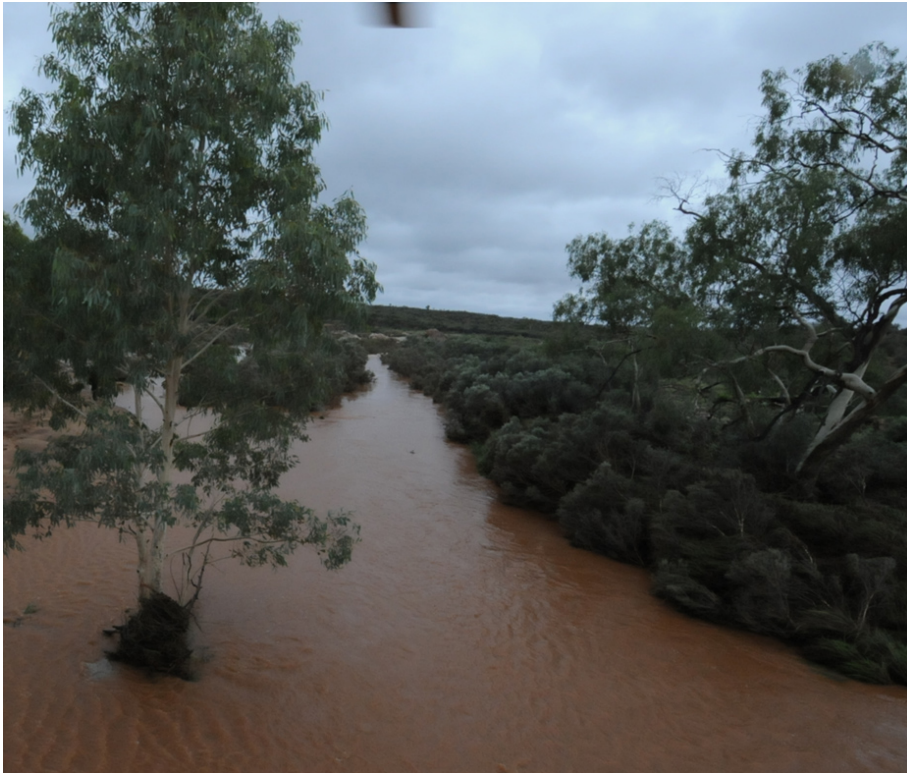
Figure 2: Photograph taken from left side of VH-YMD as it crossed the river

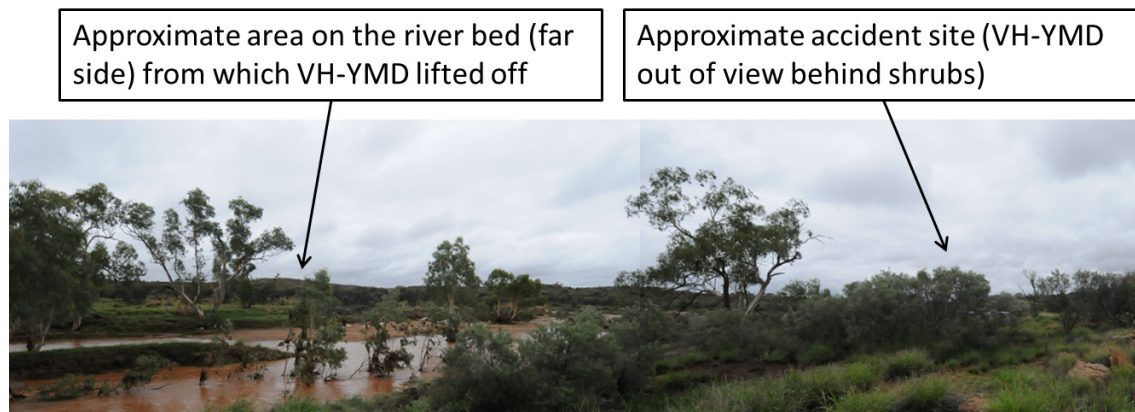
The pilot needed to maintain height to clear the rocks and shrubs on the southern side of the river, but was acutely aware that rotor RPM would be further compromised by the application of more collective.¹ The pilot carefully managed the collective and the helicopter cleared the rocks and shrubs, but with decaying rotor RPM, he realised that continued climb was not possible. The pilot steered the helicopter toward a flat area, just above the river bed on the southern side of the river, and conducted a run-on landing² (Figure 3).

Figure 3: Take-off and landing area

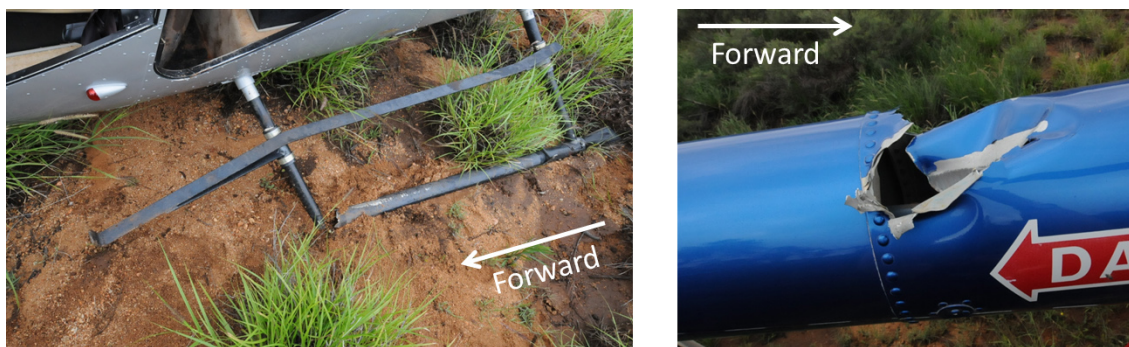
During the run-on landing, the left skid sank into mud and struck a rock. The left skid was substantially damaged by the impact (Figure 4) and the helicopter tipped precariously. As the helicopter came to a stop, it was on a substantial lean. The pilot reported that he considered the situation to be unsafe, so he immediately lifted off again and repositioned the helicopter on the ground with a level attitude. During the second lift off, a passenger recalled that the main rotor of the helicopter struck the limb of a tree, and that this was when damage to the tail boom occurred³ (Figure 4). The pilot then shut down the engine and the passengers evacuated the helicopter.

³ Damage to the tail boom is consistent with damage that could be expected if the main rotor struck the tail boom.

Figure 4: Damage to VH-YMD skid (left) and tail boom (right)
