VFR into IMC involving a Beech A36, VH-ANX

1 NM E of York (ALA), Western Australia, on 19 May 2015

ATSB Transport Safety Report
Aviation Occurrence Investigation
AO-2015-053
Final – 27 August 2015

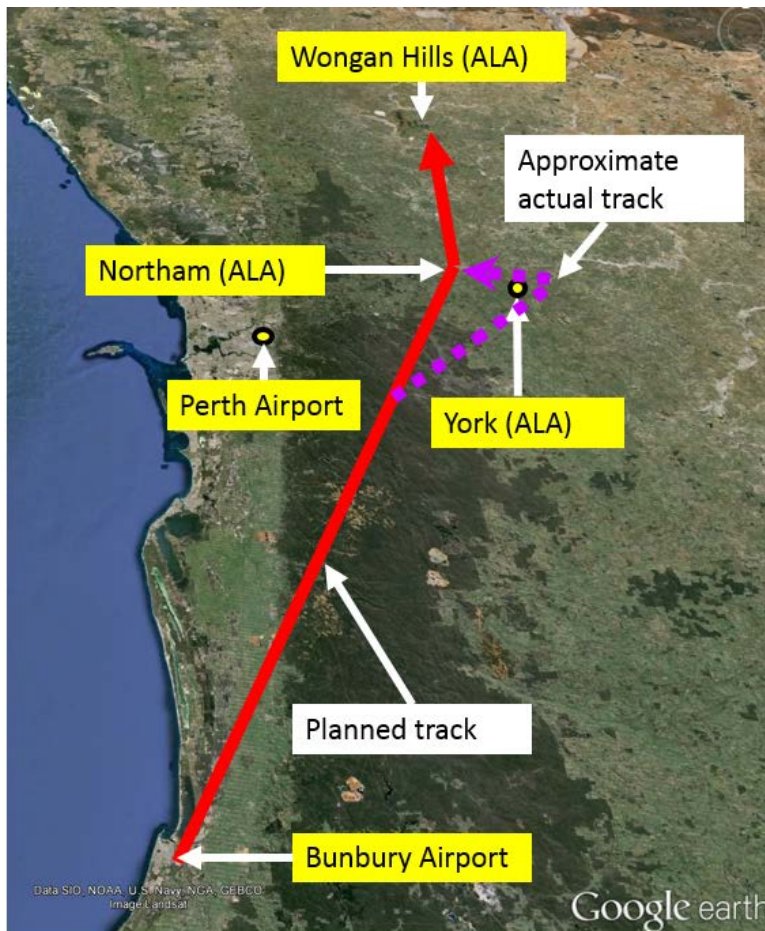
Figure 1: The pilot’s planned route from Bunbury to Wongan Hills via Northam (red) and the approximate actual track, via York (purple)
