# Collision with terrain involving a Cirrus SR22, VH-OPX

near Moree, New South Wales, on 17 September 2015

**ATSB Transport Safety Report**  
Aviation Occurrence Investigation  
AO-2015-110  
Final – 22 December 2015

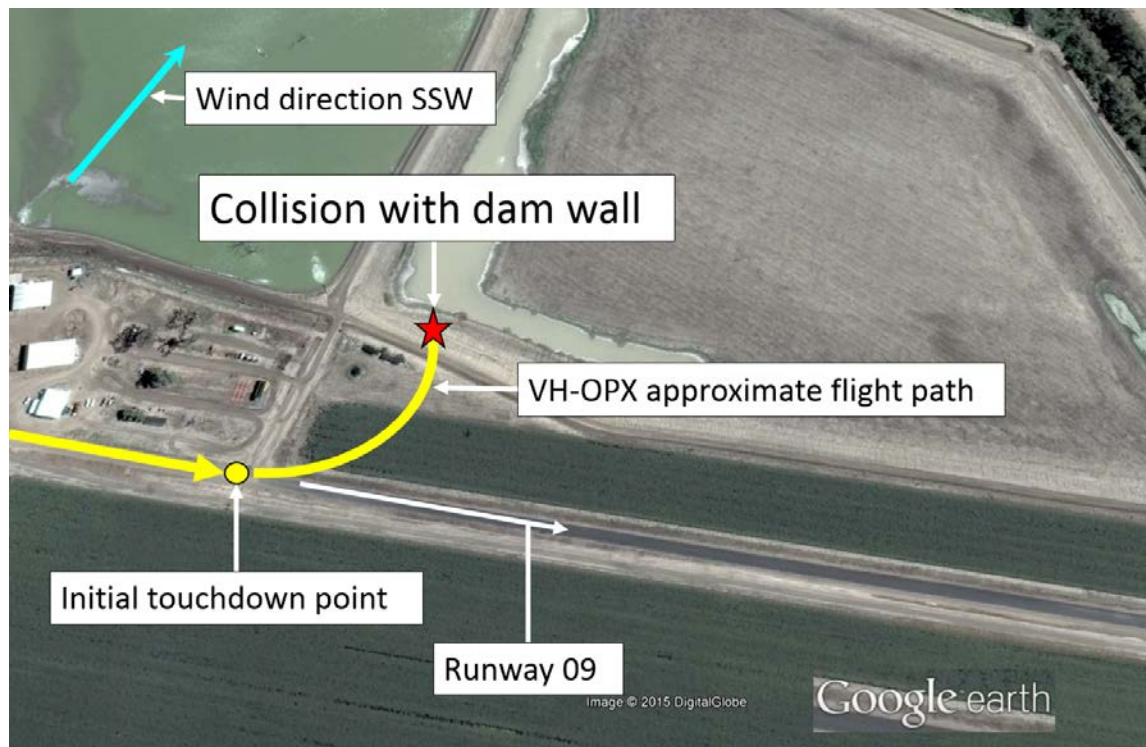
**Figure 1: Accident site**

The right main landing gear touched down first, and the aircraft bounced back into the air. The pilot immediately applied full power to initiate a go-around. However, the left wing dropped and the aircraft yawed to the left. The aircraft's left wing and propeller then collided with a dam wall (Figure 1). The aircraft stopped abruptly and spun around. The engine separated from the aircraft and came to rest about 20 m away, the tail broke off and the nose landing gear collapsed. The pilot suffered minor injuries, and the aircraft sustained substantial damage (Figure 2).
