ATSB TRANSPORT SAFETY INVESTIGATION REPORT

Aviation Occurrence Investigation – AO-2007-048

**Breakdown of separation
7 km SW of Sydney Airport, NSW
21 September 2007**

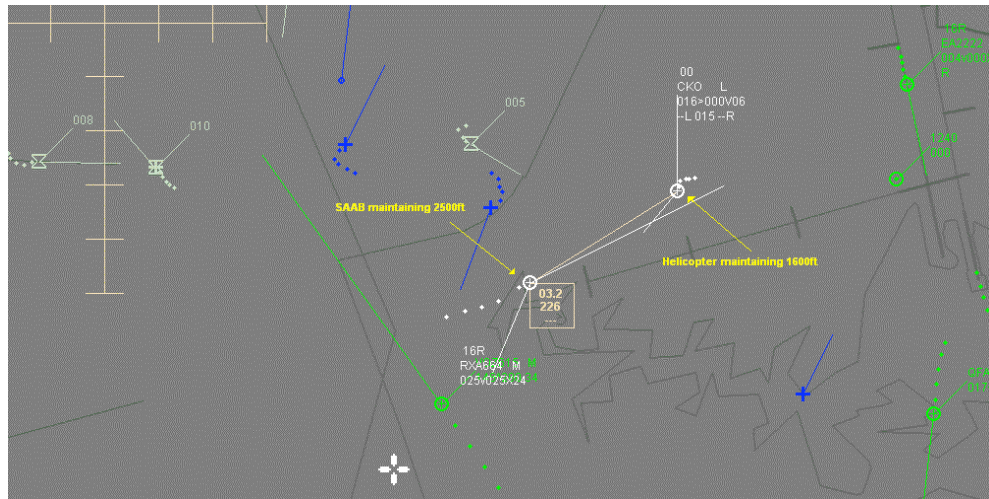
Figure 1: Air situation display depicting aircraft positions at the time the SAAB crew reported seeing the helicopter

approach to runway 07 would allow the SAAB to fly directly to Sydney with very little manoeuvring required for a straight in approach, because the aircraft was already positioned on the extended centreline for that particular runway. The controller advised that runway 07 was not available due to the presence of the helicopter, which was in the vicinity and about to be overflown by the SAAB. At 1057:28, the copilot acknowledged the controller's advice and reported seeing the helicopter (Figure 1).
