Aviation Occurrence Investigation AO-2007-060

Collision with terrain

Uaroo Station, Pilbara, WA

Cessna Aircraft Company 172M

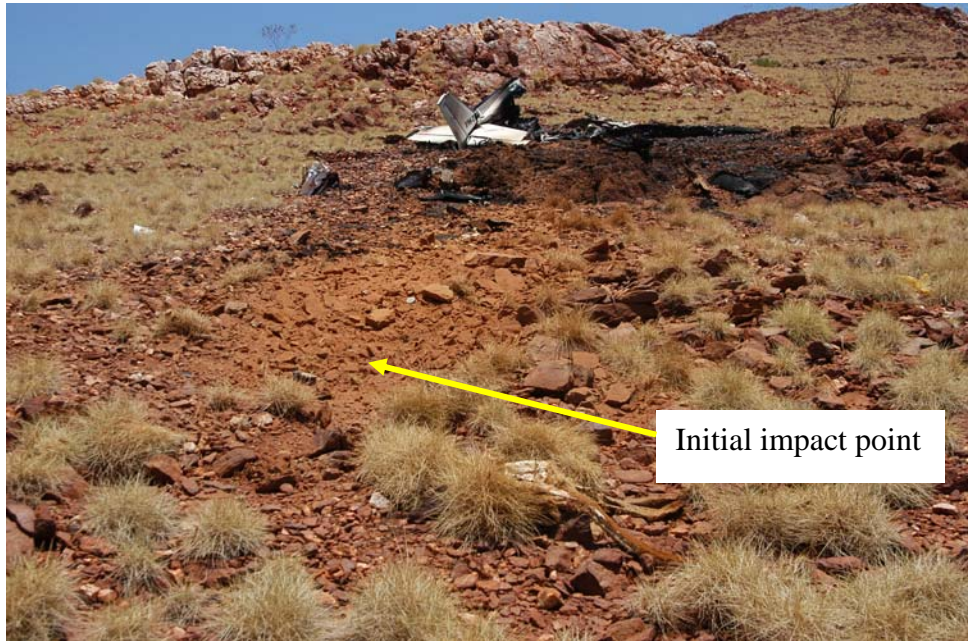
Figure 4: Accident site – westerly view in direction of impact

The aircraft impacted the hillside heading in a westerly direction, in a slightly nose-down, left wing-low attitude, with a slight left yaw. The aircraft came to rest 29 m from the initial point of impact (Figure 4). The initial impact point was at a height of about 12 m (40 ft) above the level of the airstrip. The hillside slope was at an angle of about 22 degrees.

An on-site examination of the aircraft engine and propeller indicated that the engine was operating at high power at the time of impact.

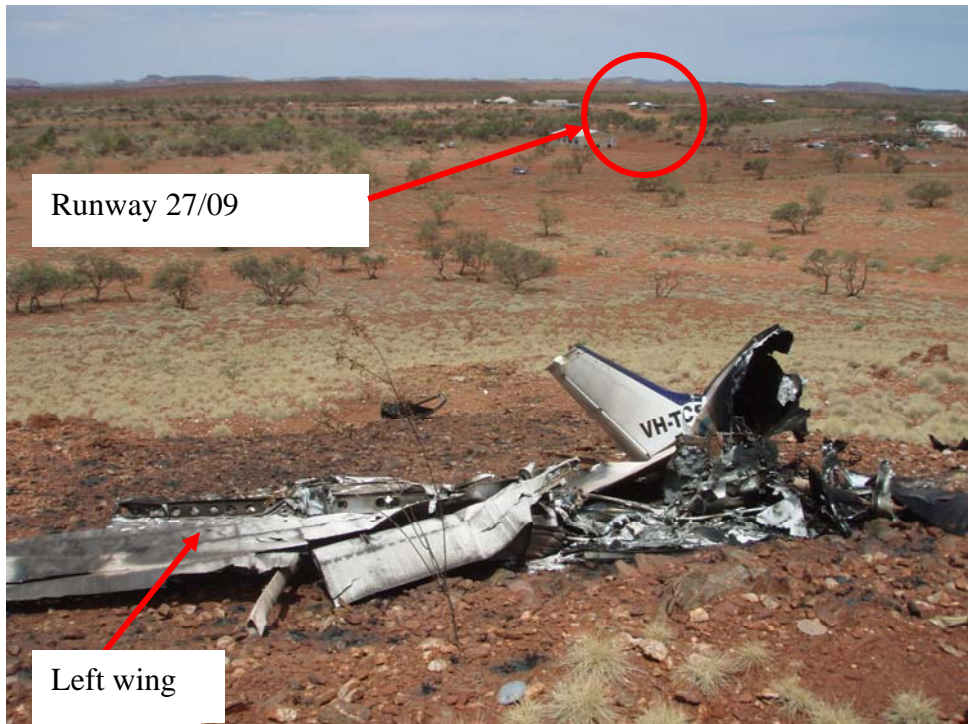
Figure 5: Accident site – easterly view towards property buildings

Impact forces and the subsequent fire resulted in disintegration of the right wing, cabin and cockpit of the aircraft. The left wing, which came to rest on the right side of the accident site, retained some integrity (Figure 5). The empennage was also damaged by impact forces.

The elevator trim tab, wing flap, and aileron positions at impact could not be determined due to the extent of damage.

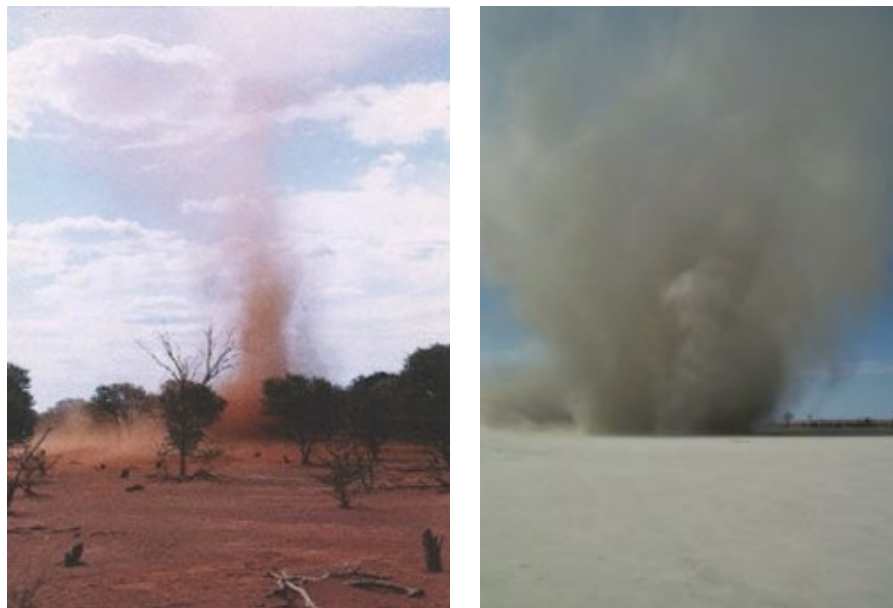
Figure 6: Images of willy-willies

Willy-willies occur as a result of hot air at ground level expanding, becoming less dense, and rising rapidly. Sideways movement (such as a light wind) in the initial upward surge of the air, establishes a vortex and a twisting, rising column is formed. Willy-willies are only seen by the naked eye when dust or debris is picked up within the vortex (Figure 6). As a result, not all willy-willies are visible.
