Aviation Occurrence Investigation – AO-2007-060

Preliminary

**Collision with terrain  
Uaroo Station, Pilbara, WA  
15 November 2007  
Cessna Aircraft Company 172M, VH-TCS**

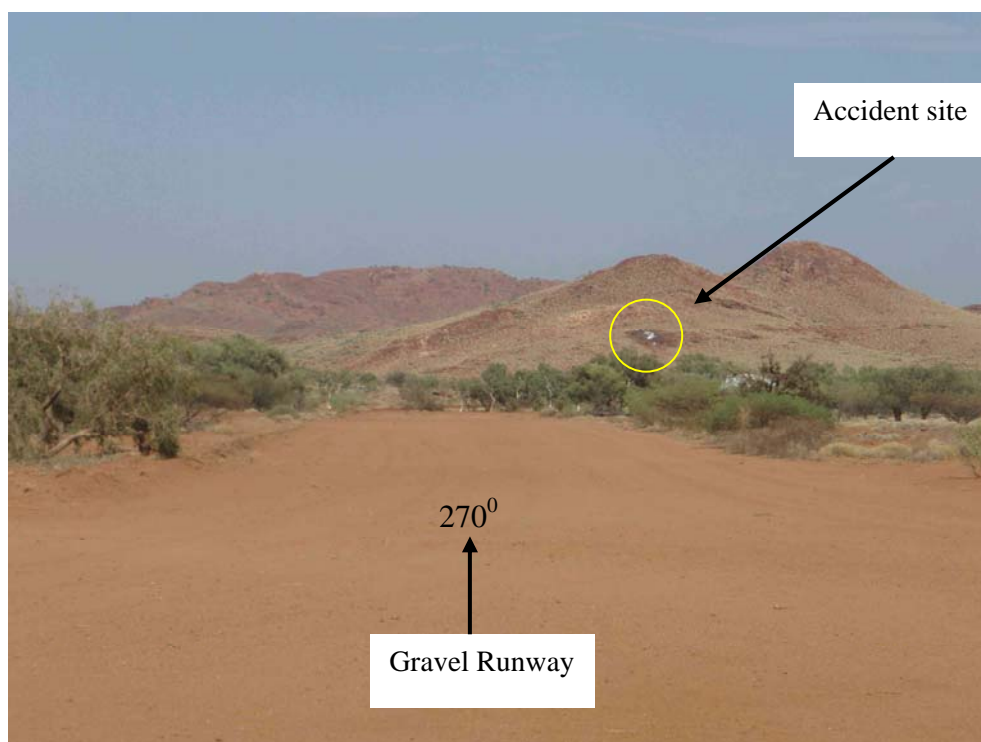
**Figure 2: Accident location – view to the west**

On the morning of 17 November 2007, the aircraft wreckage was discovered on the side of a hill, located about 500 m from the property landing strip (Figure 2). The aircraft had been destroyed by impact forces and a post-impact fire. The pilot, who was the sole occupant, was fatally injured.

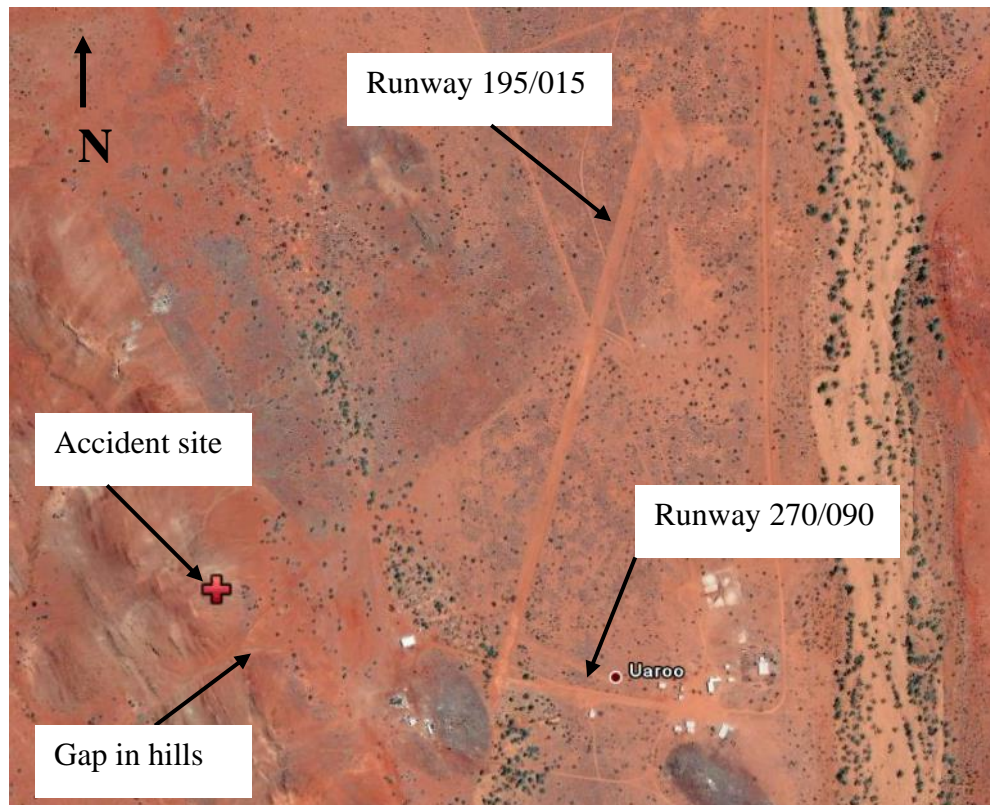
**Figure 3: Accident location**

A line of hills, which ran in a north-south direction, was located to the west of the property airstrip (Figure 3). The tops of those hills ranged in height from about 400 to 500 ft (120 to 150 m) above the level of the airstrip. A gap in the line of hills was located about 50 m to the south of the accident site.

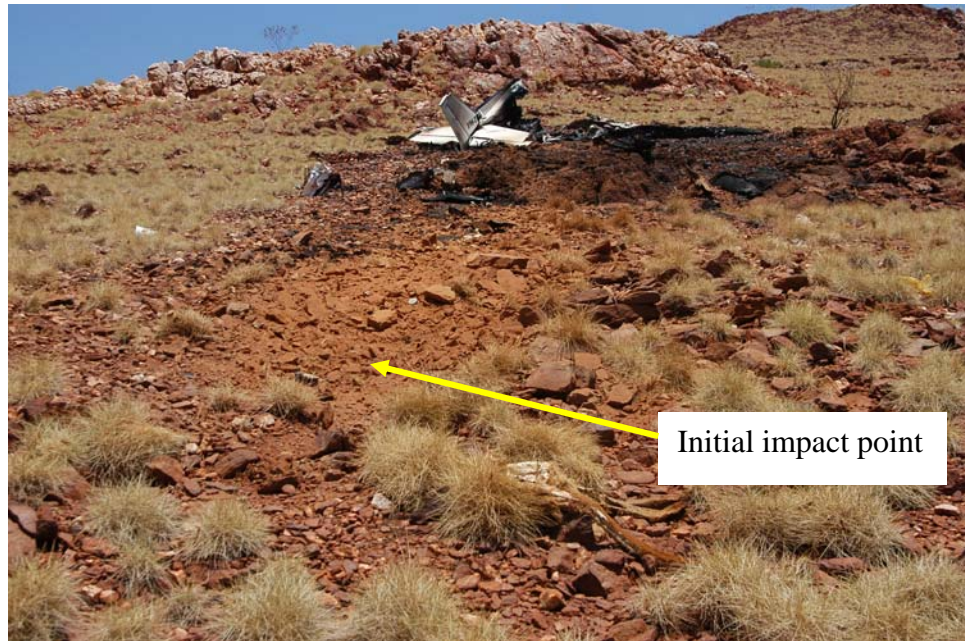
**Figure 4: Accident site – westerly view in direction of impact**

The aircraft impacted the hillside, heading in a westerly direction, at an attitude of about 3 degrees nose-down, 10 degrees left wing-low and with a slight left yaw, coming to rest 29 m from the initial point of impact (Figures 4 and 5). The aircraft impacted the hillside at a height of 150 to 200 ft (45 to 60 m) above the level of the airstrip. The hillside slope was at an angle of about 30 degrees.

Impact forces and the subsequent fire resulted in disintegration of the right wing, cabin and cockpit of the aircraft. The left wing, which had come to rest on the right side of the accident site, retained some integrity. The empennage, although damaged by impact forces, was largely unaffected by the post-impact fire. Impact forces had compressed the remains of the rear fuselage and lower forward fin and

tailplane and caused binding and restriction of movement of the rudder and elevator control surfaces.
