**ATSB TRANSPORT SAFETY INVESTIGATION REPORT**

Aviation Occurrence Investigation – AO-2007-069

**Collision with terrain**

**Pier 35, Melbourne, Vic.**

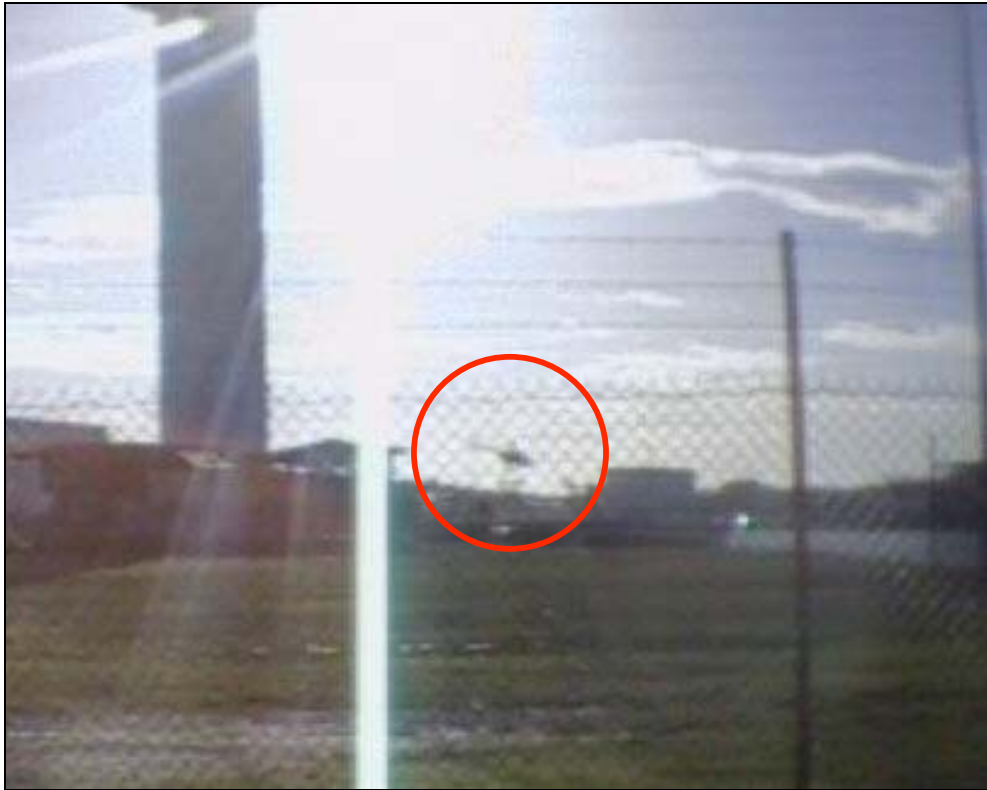
**Figure 1: CCTV footage of the helicopter taking off<sup>3</sup>**

A Port of Melbourne Corporation closed circuit television (CCTV) security camera recorded the helicopter's flight and impact with the water. The video confirmed the witness reports and also revealed that, following the takeoff, the helicopter momentarily lost altitude and the main rotor RPM<sup>2</sup> appeared to slow prior to impact (Figure 1).

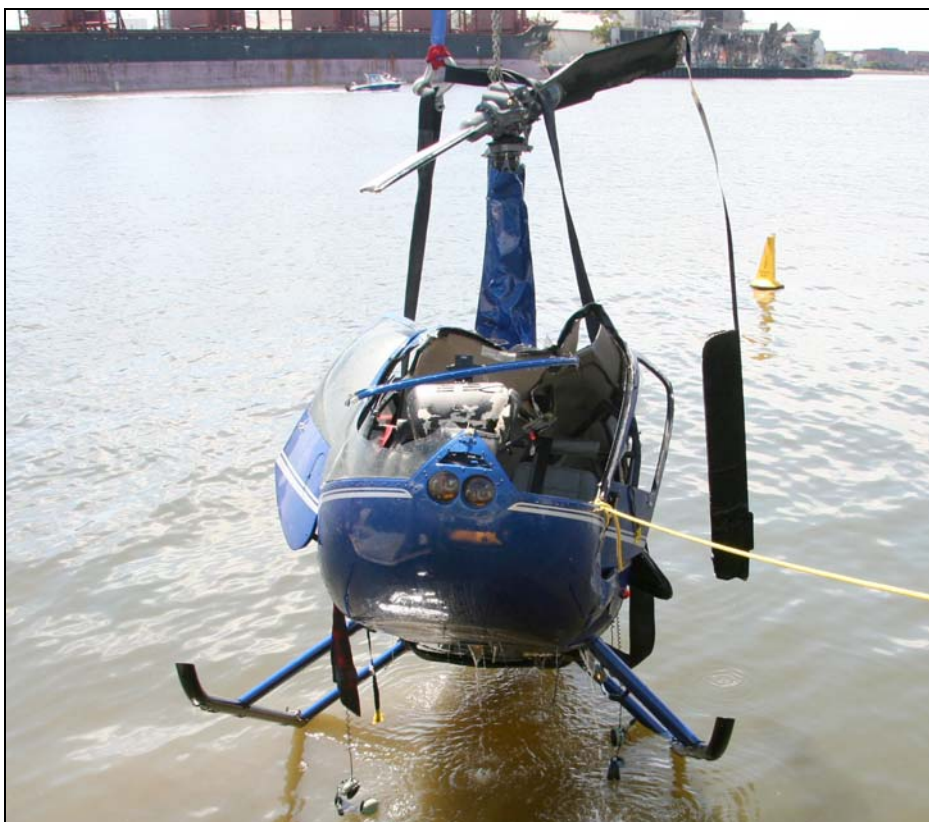
**Figure 2: Recovered helicopter wreckage**

Late in the evening of 29 December 2007, the divers located the helicopter wreckage and secured it to the marina. On 30 December 2007 at about 1440, the wreckage was recovered from the river and secured for technical examination by the Australian Transport Safety Bureau (ATSB) (Figure 2).

- a left side down, slightly forward impact
- impact damage to the cockpit upper and forward structure
- a missing section of the tail boom, including the tail rotor and tail rotor gearbox
- impact damage to both main rotor blades
- impact related damage to the main transmission and supporting frame work
- impact related damage to the tail rotor drive system
- the helicopter was configured with dual-controls<sup>4</sup>.

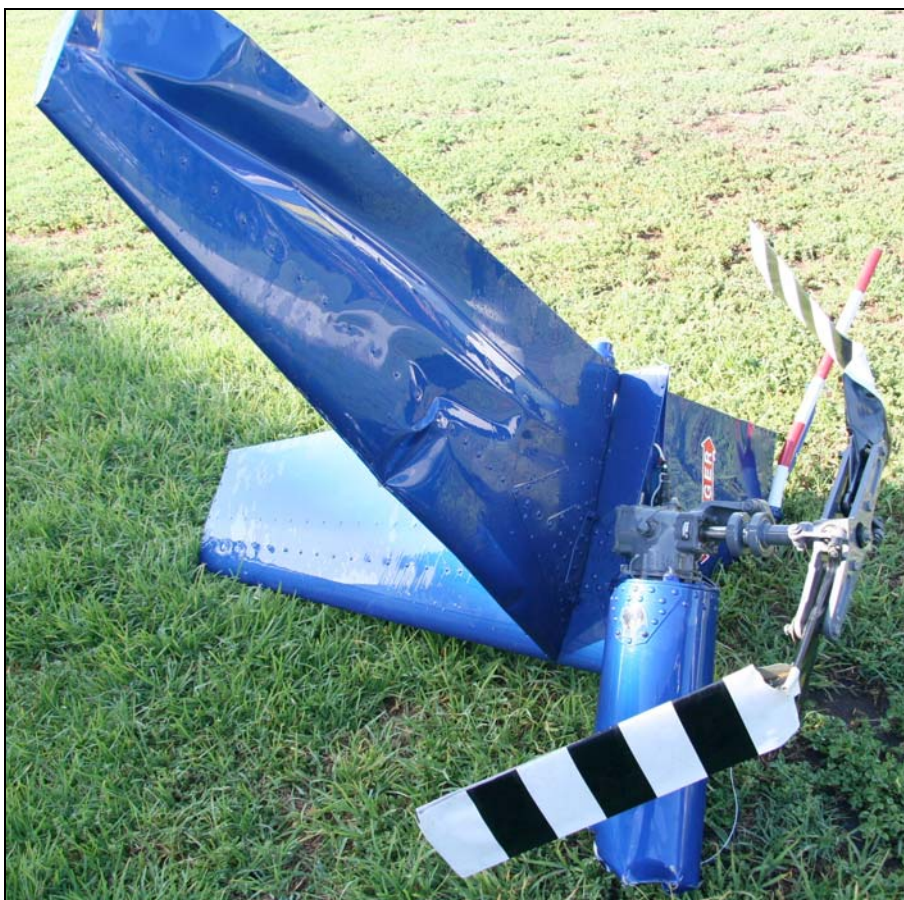
**Figure 3: Tail rotor gearbox and tail rotor**

On 1 January 2008, the police divers recovered a large section of main rotor blade, the tail rotor control tube and a missing section of tail boom, with the tail rotor gearbox and tail rotor attached (Figure 3). The tail rotor blades were intact, but bent towards the tail boom. Analysis of photographs taken by witnesses indicated that the separated section of the tail boom and tail rotor was attached when the helicopter was floating inverted in the water.

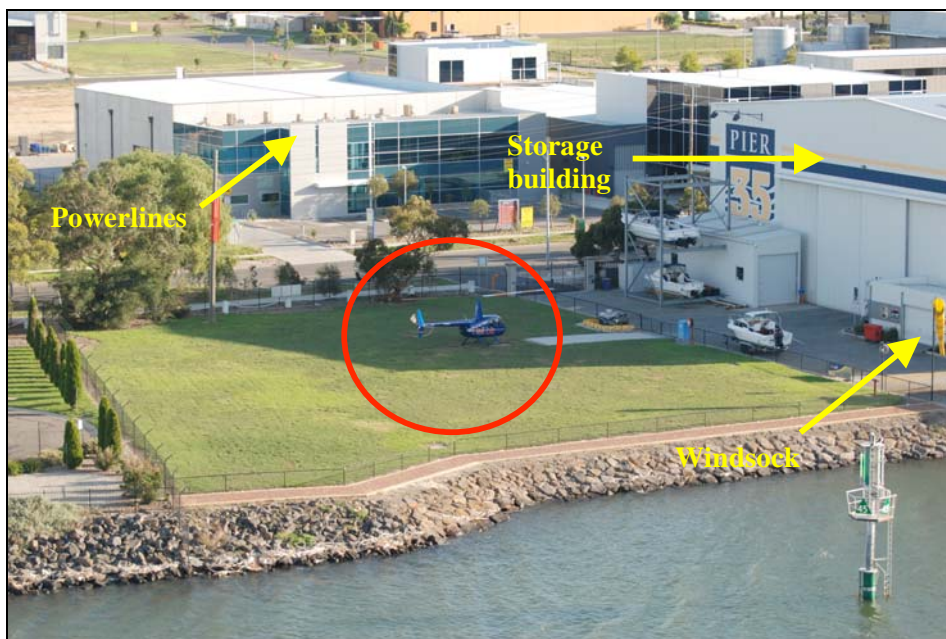
**Figure 4: VH-MEB on Pier 35 helipad and marina building**

The helipad was adjacent to a 15.5 m high boat storage building (to the west of the helipad). A wind sock, fitted to a 5 m tall pole, was located in the north-west corner of the helipad. The helipad was elevated approximately 2 to 2.5 m above the level of the river. To the east side was a 50 m Port of Melbourne Corporation control/surveillance tower and powerlines were located to the south.

The photograph below was taken just prior to the helicopter's takeoff by a crewmember on board a container ship, Josephine Maersk, that was entering the port. The control/surveillance tower is located to the left and out of view of the photograph. Note that the windsock is indicating little or nil wind (Figure 4).

There was no readily available information, for pilots planning to use the helipad, on the pad's unique characteristics including constraints on operations and, in particular, the fact that the windsock may provide erroneous wind indications in some weather conditions. [*safety issue*]

Despite the helipad operator's actions, there are no measures that will prevent the unauthorised use of the helipad as has happened in the past. Consequently, unauthorised pilots using the pad will be most likely unaware of the pad's unique characteristics including, constraints on operations. Also, the windsock may provide false or incorrect indications of the local wind in some conditions, due to the location of the windsock on the helipad.

The Australian Transport Safety Bureau recommends that Heli Air Pty Ltd takes action to address this safety issue.
