**ATSB TRANSPORT SAFETY INVESTIGATION REPORT**

Aviation Occurrence Investigation – AO-2008-003

**Electrical system event - Bangkok, Thailand**

**Boeing Company 747-438**

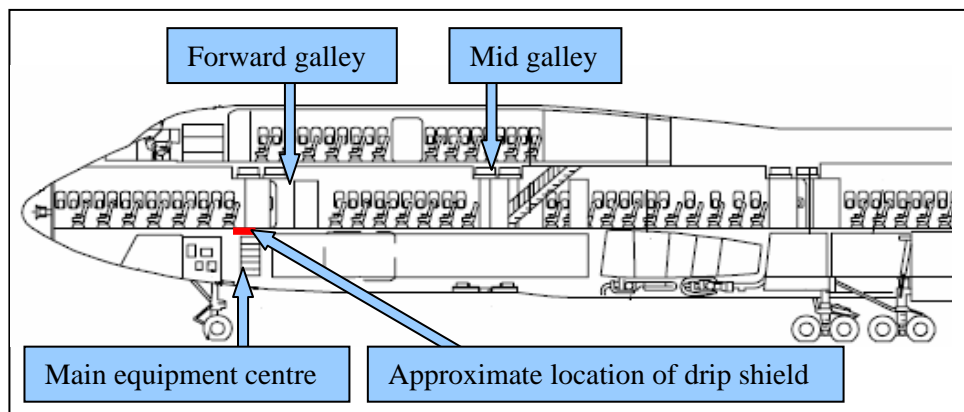
**Figure 1: Location of galley and main equipment centre**

At about 0837 Coordinated Universal Time (UTC)<sup>1</sup>, while the aircraft was at about 21,000 feet on descent to Bangkok International Suvarnabhumi Airport, the customer service manager (CSM) notified the flight crew that a substantial water leak had occurred in the forward galley (Figure 1). The CSM later reported that the water was ‘smelly’ and that the water covered the entire galley floor. The CSM also reported that cabin crew had attempted to soak up the water using blankets, and that about four or five blankets were saturated.

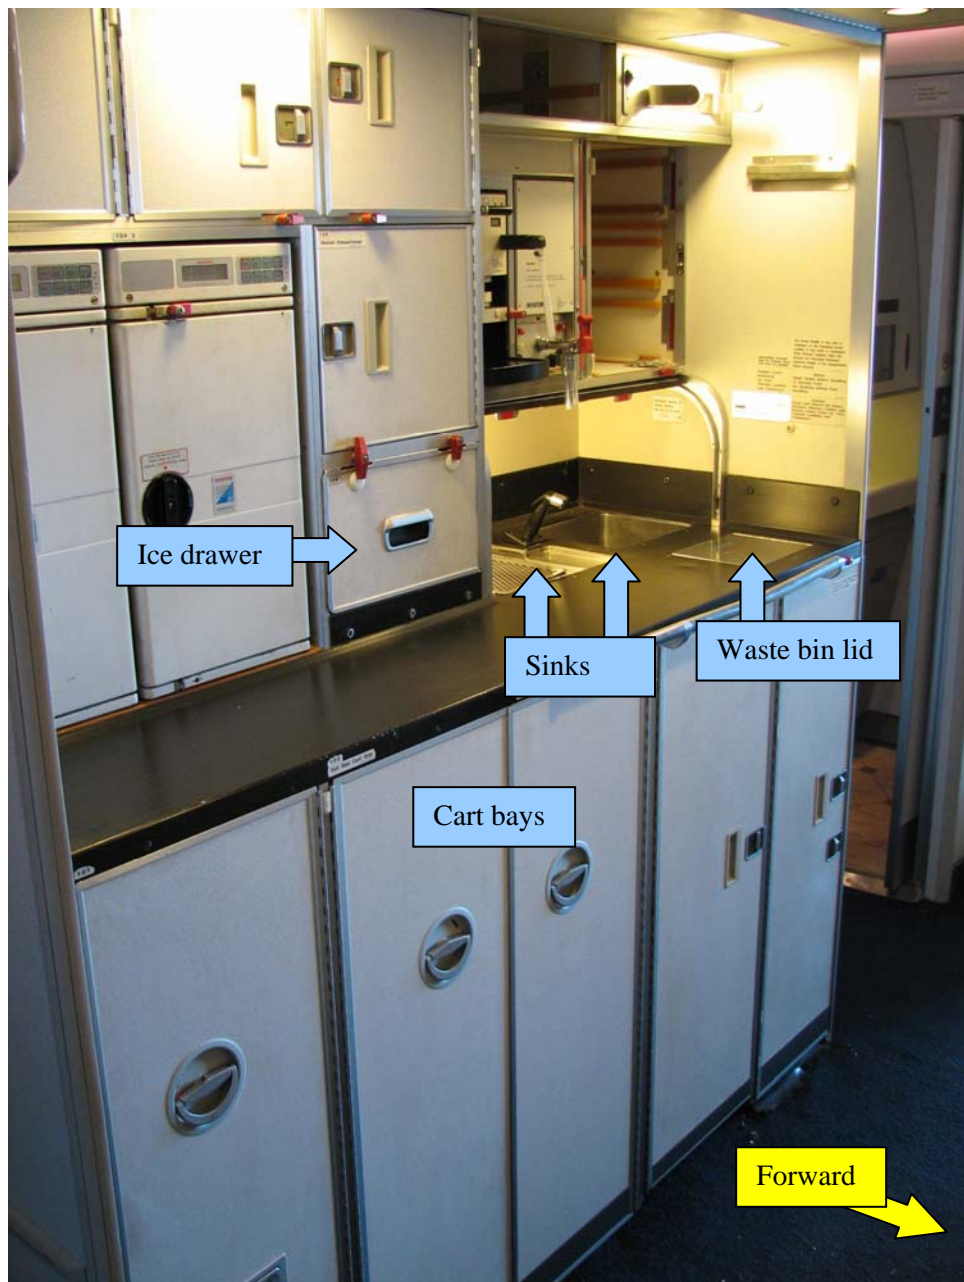
Figure 2: Forward galley (example from VH-OJK)

Post-flight inspections identified a minor water leak in the forward galley sink drain, and that the first class galley ice drawer drain was blocked. Maintenance personnel reported the presence of water on the floor in the galley area after landing.

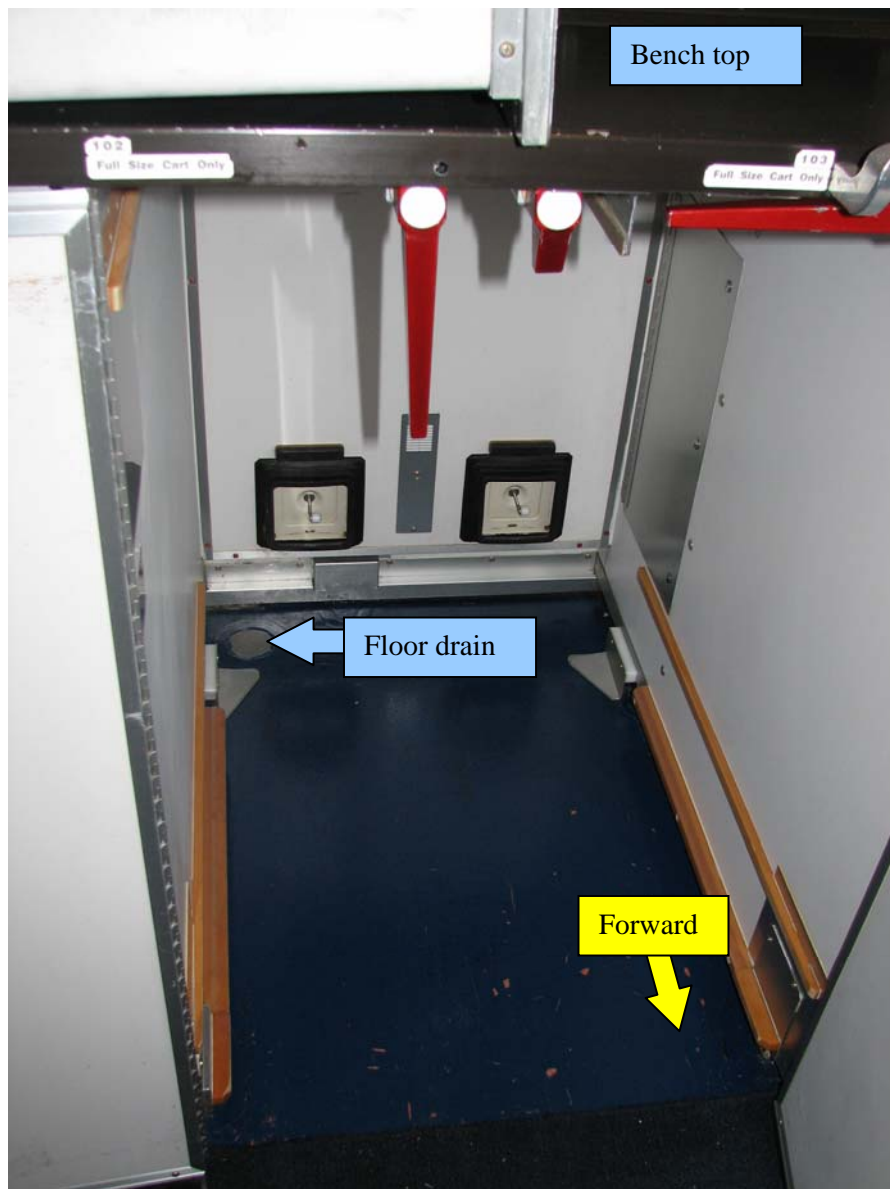
Figure 3: Floor drain in forward galley cart bay (example from VH-OJK)

The forward galley (Figure 2) drainage system consisted of sink drains and floor drains (Figure 3), each covered by a perforated grate. Waste water from galleys, galley drains, lavatory washbasins, and drinking fountains was directed overboard through drain masts (Figure 4). The drain masts were fitted with electrical ribbon heaters to prevent icing.

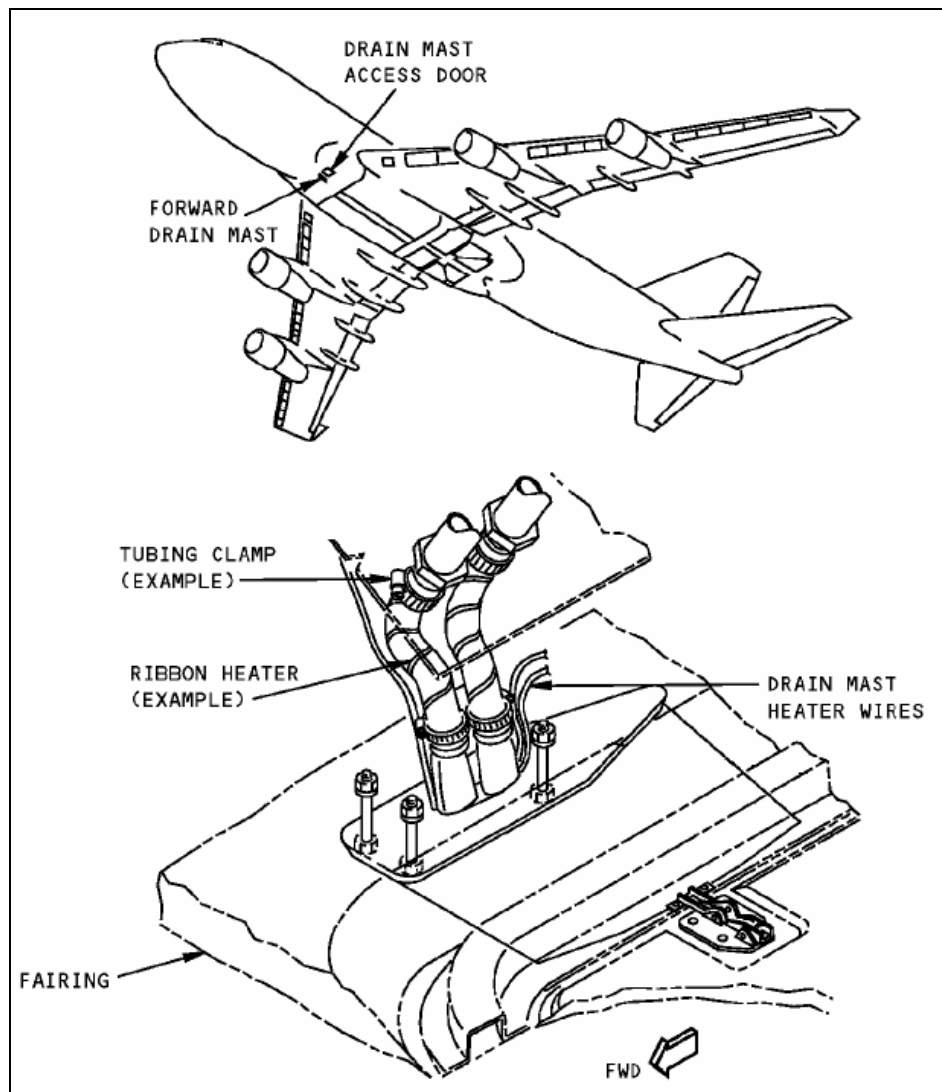
**Figure 4: Forward drain mast and ribbon heater**

Subsequent inspections found that a ribbon heater on a drain line leading to the forward grey water drain mast was inoperative, and that a length of drain line at that location was split. The heater and hose were removed for examination and testing.

- Carried out a fleet inspection of 747-400 drip shields and made temporary repairs of any cracks found during those inspections. The operator identified cracks in the drip shields of 14 out of 30 aircraft inspected.
- Conducted a fleet inspection of 747-400 galleys to identify potential water leaks and drain blockages.
- Conducted a fleet inspection of 747-400 drain mast heaters, drain line heaters and drain mast hoses, and identified six failed drain ribbon heaters, two of which had associated split drain hoses.

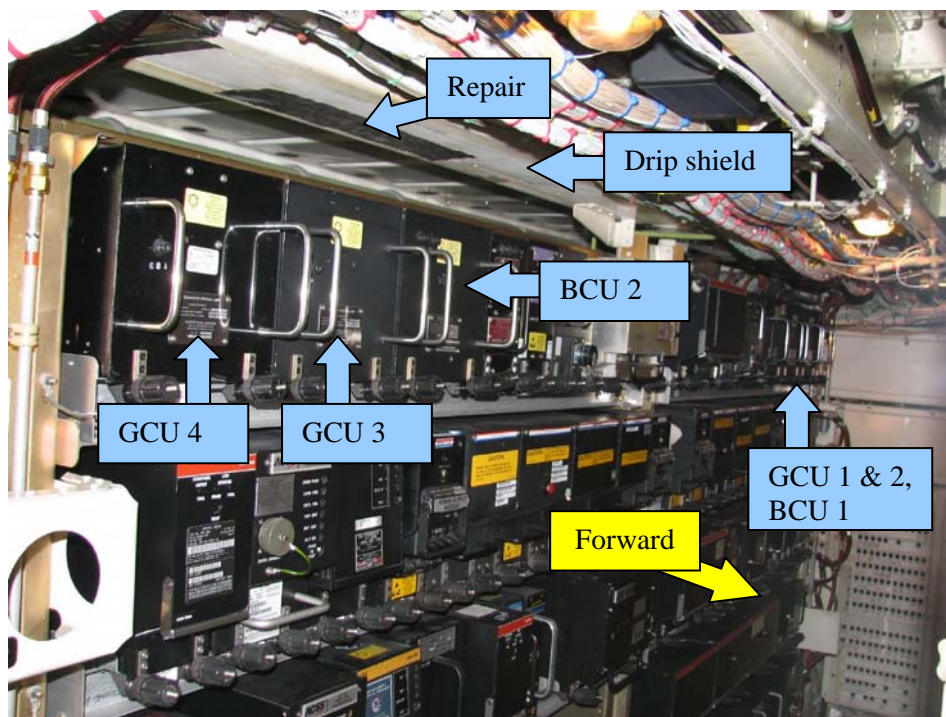
**Figure 6: Main equipment centre (example from VH-OJK)**

Maintenance personnel also identified cracks in a fibreglass drip shield<sup>2</sup> located above an electrical component rack in the aircraft's main equipment centre (MEC), as well as evidence of dark liquid stains on the shield.

The MEC (Figure 6) consisted of equipment racks which contained some of the electrical and avionic equipment on the aircraft, including the GCUs and BCUs. The MEC was located forward of and below, the forward galley (Figure 1). The drip shield was mounted above the MEC, and was designed to collect fluids such as condensation that would otherwise drip into the equipment racks from above, and to divert these fluids to drains on each side of the shield.

On 11 January 2008, the aircraft manufacturer issued a Multi Operator Message to operators of 747-400 series aircraft that contained advice and instructions for the inspection and repair of main equipment centre drip shields.
