ATSB TRANSPORT SAFETY REPORT

Aviation Occurrence Investigation – AO-2008-010

Interim Factual

Mid-air collision

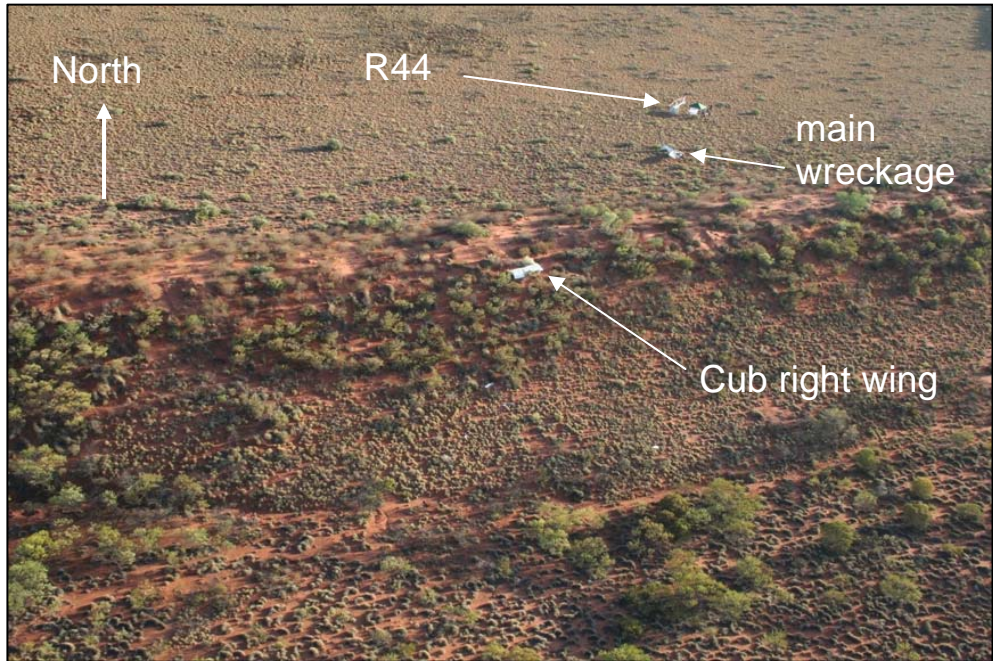
Figure 4: Accident site

The accident occurred over relatively flat terrain, characterised by regular sand ridges 20 m high and orientated approximately east to west (Figure 4). The elevation of the accident site was about 1,150 ft.

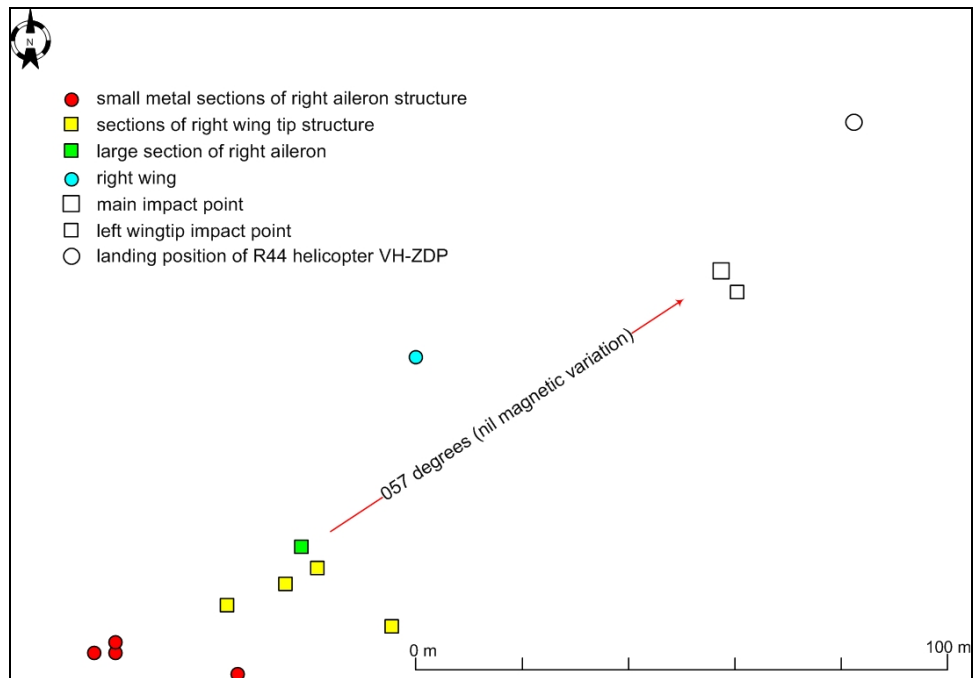
Figure 5: Cub wreckage trail

The wreckage trail of the Cub was orientated about 057 degrees and extended about 130 m across a sand ridge. The wreckage trail comprised the right wing and associated aileron and wing tip structure, and the main wreckage (Figure 5).

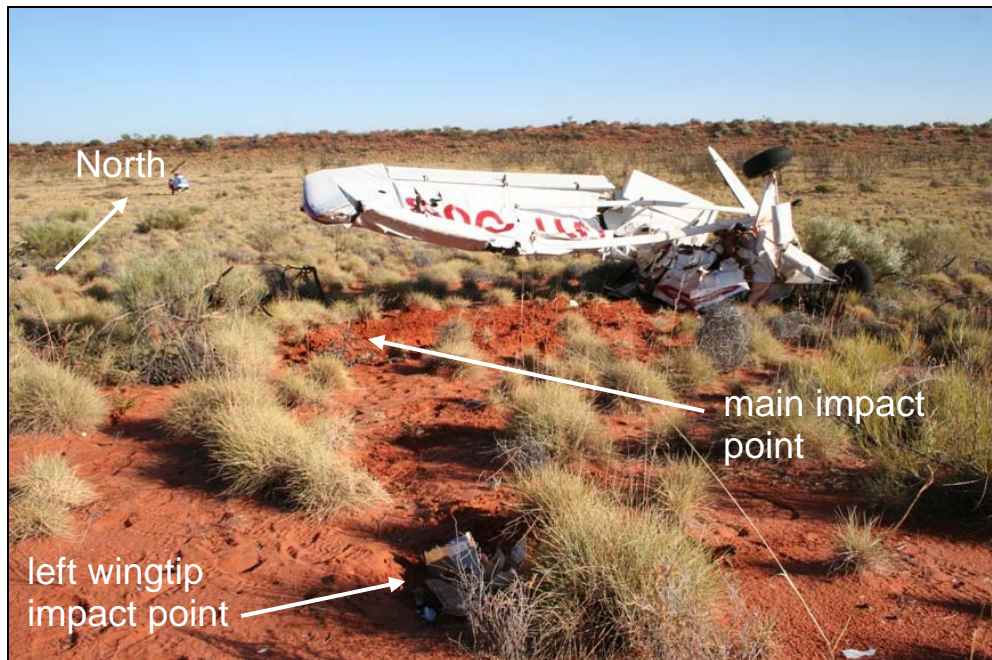
Figure 6: Piper Super Cub wreckage

The aircraft impacted the ground inverted in a steep, nose-down attitude. Following the initial impact, it rotated to the right before coming to rest inverted, a short distance from the initial impact point (Figure 6).

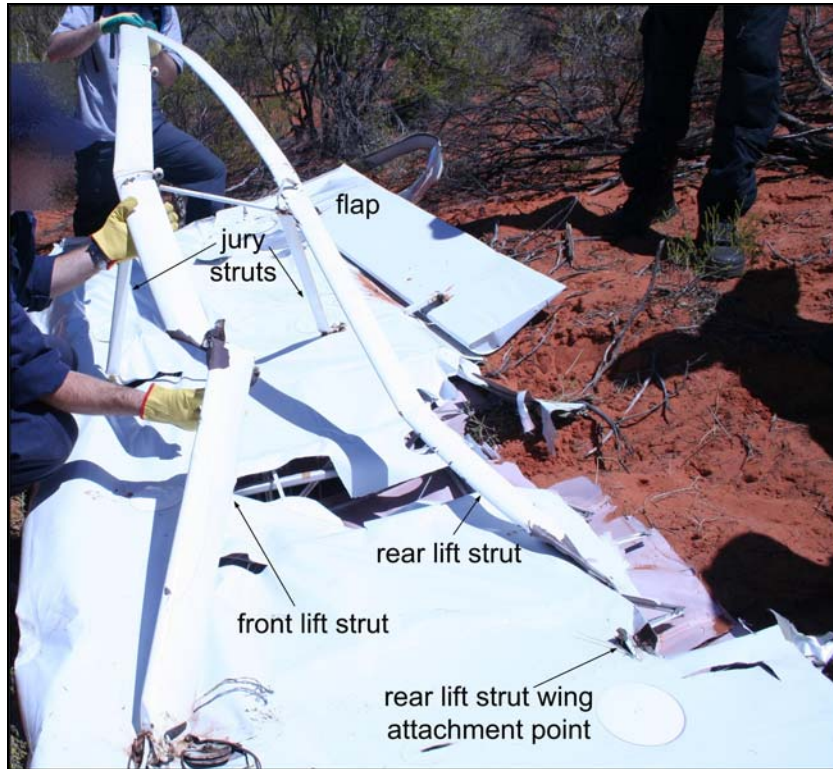
Figure 7: Wing and lift strut damage

The contact damage to the Cub was limited to the right wing and associated support struts, with the R44 main rotor blades severing both wing lift struts and impacting the wing rear spar, aileron and wing tip (Figures 7 and 8). The wing was fractured at the inboard attachment fittings and had detached from the fuselage.

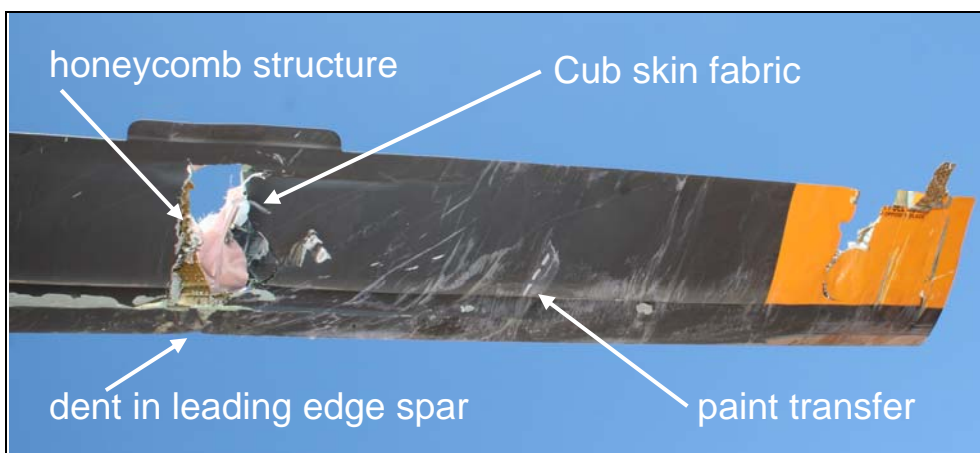
Figure 9: Main rotor blade damage

There was substantial damage to one of the main rotor blades, consistent with the mid-air collision (Figure 9). A section of the blade's skin and honeycomb structure was forced upwards between the leading edge spar and the trim tab, with part of the Cub's wing fabric retained within the blade. In addition, the blade tip had a section of the skin and honeycomb missing at the trailing edge. Both main rotor blades showed paint transfer along the majority of their length, and there were creases on the lower surface of the blades' skin.

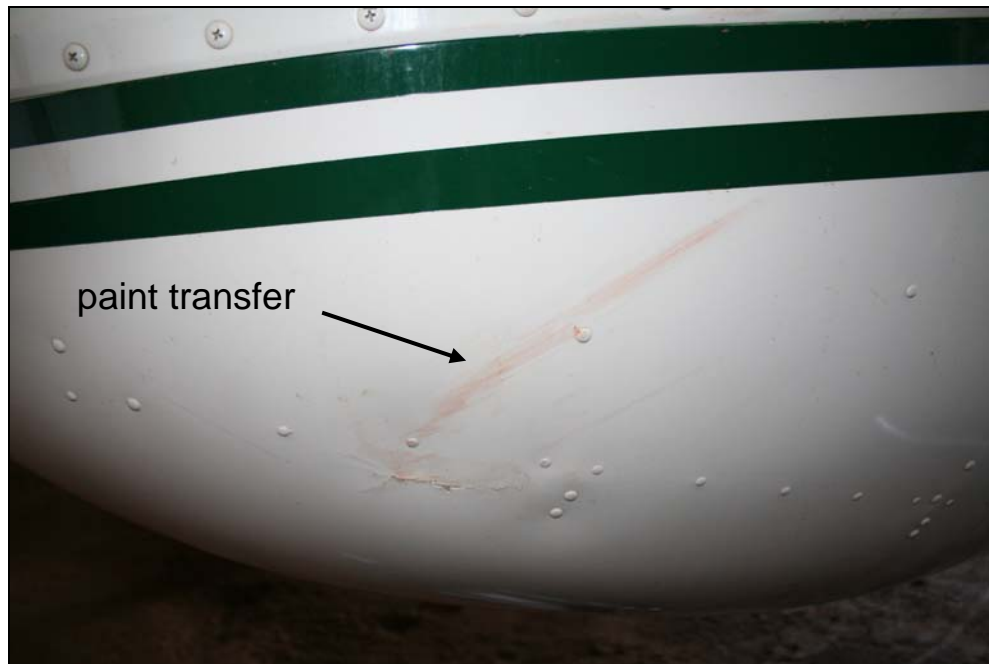
Figure 10: Chin bubble paint transfer

There was also evidence of contact with the Cub (paint transfer) on the lower left area of the chin bubble (Figure 10).
