Aviation Occurrence Investigation – AO-2008-014

Preliminary

Mid-air collision – 10 km NE of Wee Waa, NSW

26 February 2008

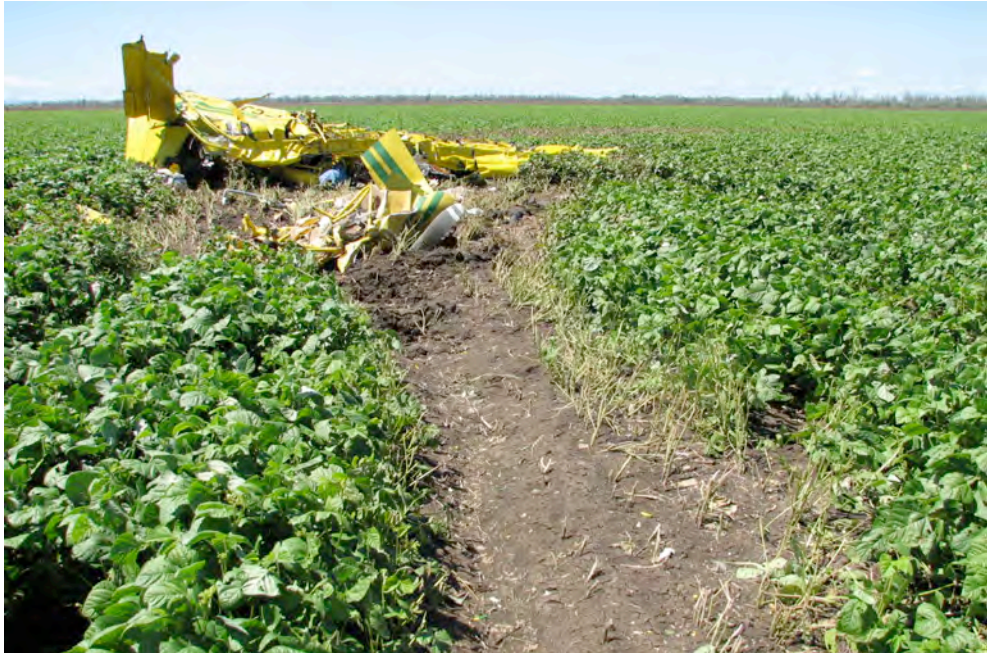
Figure 3: Wreckage of VH-CJK

The wreckage of CJK was lying in a knee-high crop of mung beans (Figure 3). The site was contaminated by a chemical spill from the ruptured hopper, and by aviation turbine fuel. The chemical (Alpha-Cypermethrin) was classified as a Group 3A insecticide and access to the site required full protective covering for a period of 48 hours after spillage.

The wreckage of CJK came to rest inverted with both wings detached from the fuselage. The right wing was intact and had sustained high velocity, vertical impact damage along its entire leading edge. The left wing was pushed rearward and was missing the outboard section. The separated section of the left wing was found approximately 80 m from the aircraft toward the wreckage of ATB. The left side of the fuselage, adjacent to the cockpit, sustained considerable damage from ground impact forces. The left horizontal stabilizer displayed high-energy damage to its tip and the left elevator had been torn from its torque tube. The left landing gear had separated from the aircraft and was found approximately 60 m from the main wreckage, beside a deep furrow that marked initial impact with the ground. Fragments of unpainted fibre-glass were found imbedded in the wheel and tyre. The right landing gear leg was with the main wreckage, but the wheel had detached on impact with the ground and was lying behind the wreckage. The engine and propeller had detached from the fuselage in the collision with the ground and came to rest approximately 10 m from the main wreckage. Examination of the engine indicated that it was producing power at the time of impact with the ground.

Due to the attitude of CJK when it impacted the ground, the left side of the fuselage was deformed, breaching the integrity of the protective structure in the area of the cockpit. The attachments for the pilot's four-point harness were intact and the webbing of both the upper and lower restraint straps had been cut by rescuers attempting to free the pilot. The buckle was still fastened correctly. The seat was correctly attached to the airframe, but the tubular steel frame of the fuselage had buckled under overload. The pilot's helmet was nearby and intact, but the chin straps were found in their stowed position.

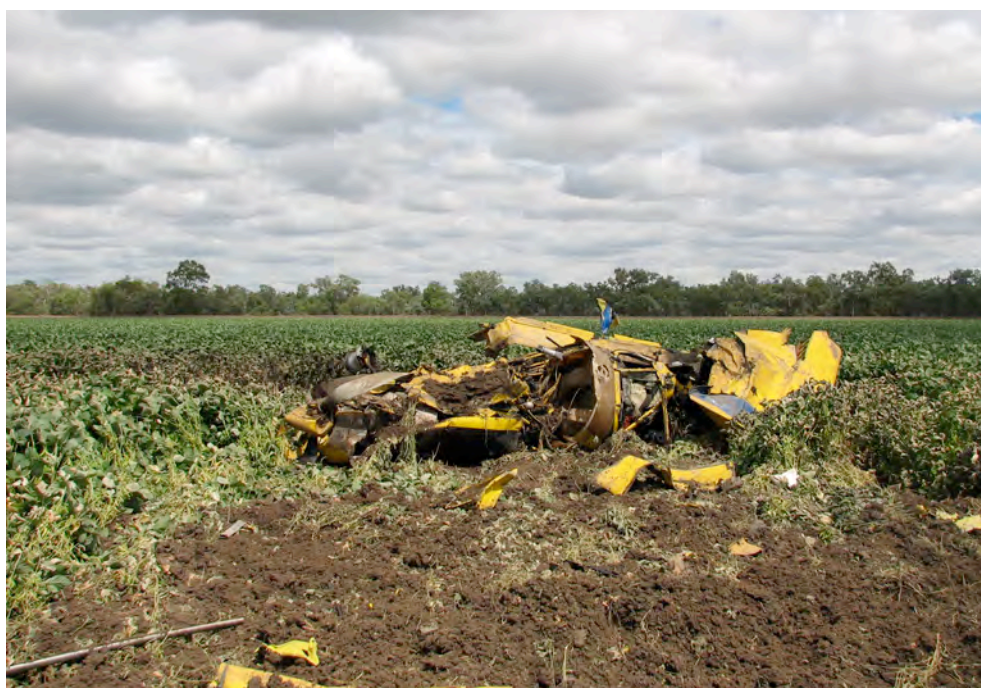
Figure 4: Wreckage of VH-ATB

The wreckage of ATB was lying in a soy bean crop that stood nearly chest high (Figure 4). A localised, intense post-impact fire destroyed part of the aircraft's structure and the immediate environment. A chemical spill of herbicide (Glyphosate) from the ruptured hopper had contaminated some of the surrounding crop. The chemical was not classified as a hazardous material.

The wreckage of ATB was inverted and fire had consumed the inboard half of the left wing, the centre fuselage section and the cockpit area. The right wing had been torn into two pieces, with the top cap of the front spar holding the outboard section of the wing to the fuselage. The inboard sections of the right wing and wing flap were found along the wreckage trail in the direction of the wreckage of CJK. The fin of ATB was destroyed and the rudder remained attached to the aircraft by its control cables. The horizontal stabilisers and elevators remained integral with the fuselage and exhibited ground impact damage. The left main landing gear was attached to the airframe but the right gear leg and wheel had separated and were found behind the wreckage. The top panel of the fibreglass hopper and lid actuating mechanism were found 100 m back along the wreckage trail. The engine and propeller were attached to the fuselage and displayed evidence of power being produced at the time of impact with the ground.

ATB impacted the ground on its right main wheel before tumbling and coming to rest inverted. The integrity of the cockpit cage remained intact, allowing a survivable space. Fire had consumed the inboard section of the left main wing and damaged the centre section of the fuselage, including much of the cockpit area. The pilot's seat mounts had failed. The lower straps of the pilot's four-point harness were burnt, leaving only their attachment points. The buckle and buckle-end fittings were destroyed in the fire. The upper restraint straps were found near the wreckage. Their buckle-end fittings were undamaged, but the webbing had been torn from their attachments. There was no fire damage to these straps. The pilot's helmet was found in the cockpit and had been burnt. Its straps were not in the stowed position.
