ATSB TRANSPORT SAFETY INVESTIGATION REPORT
Aviation Occurrence Investigation No. AO-2008-035
Preliminary

Collision with terrain, VH-IDM, Cessna 210L 83km NE Georgetown, Qld 15 May 2008

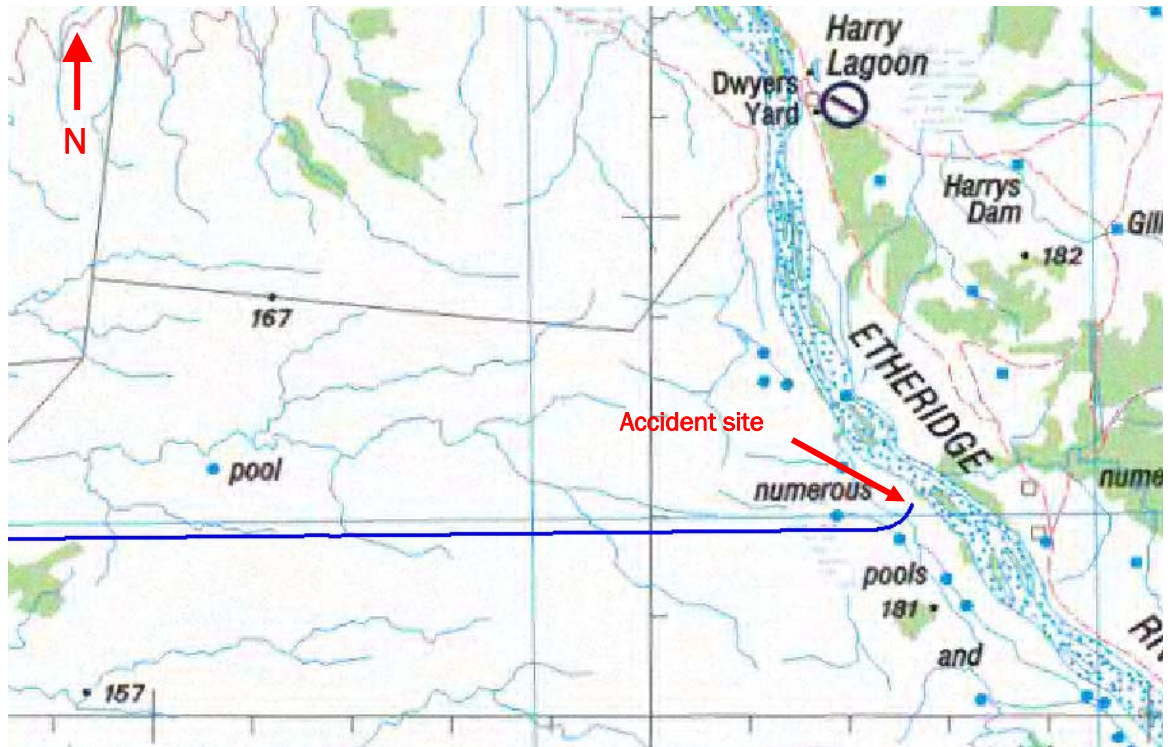
Figure 1: Aircraft track recorded by the survey equipment

The onboard survey equipment recorded IDM's location and altitude at half-second intervals. The data was downloaded for the Australian Transport Safety Bureau (ATSB) and showed that the pilot had accurately completed the survey line and turned to the north (Figure 1). During the left turn, IDM began to lose altitude. The last recorded data was approximately 2 seconds prior to the accident.

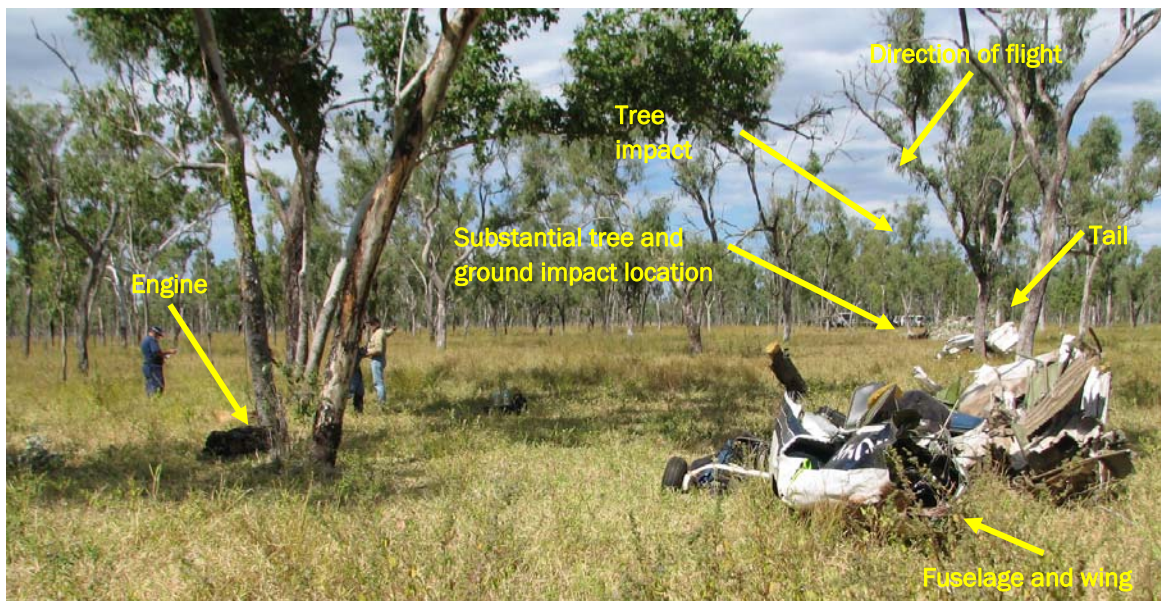
Figure 2: Accident site and aircraft wreckage

The fuselage and most of the wing structure came to rest approximately 66 metres from the ground impact point (Figures 2 and 3) with the engine

found nearby. The fuselage was upright and facing back in the direction of approach. Damage to the forward fuselage was severe and the wing structure had detached from the upper fuselage.
