# Collision with terrain – 5 km NE Purnululu ALA, WA

**14 September 2008**

INFRA-08302

## Abstract

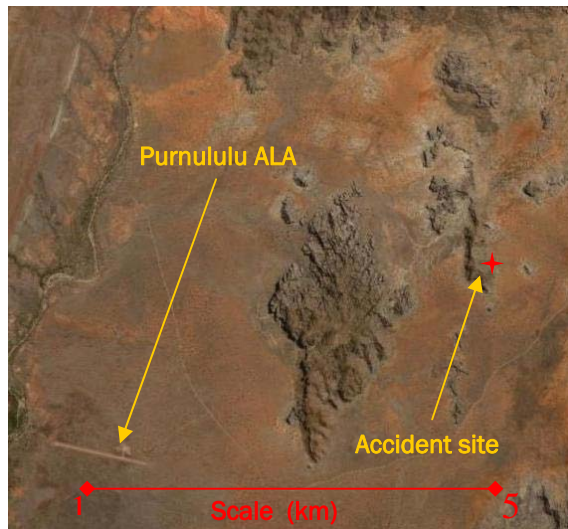
**Figure 2: Accident site relative to the Purnululu ALA**<sup>4</sup>

high frequency (UHF) radio, but without success. A second company pilot then commenced a search using another company helicopter. Shortly after becoming airborne, that pilot noticed smoke to the north-east of the ALA (Figure 2), and flew to that location. On arrival in the area of the smoke, the pilot determined that the missing helicopter had collided with the ground and was on fire. The pilot assessed that there were no survivors.

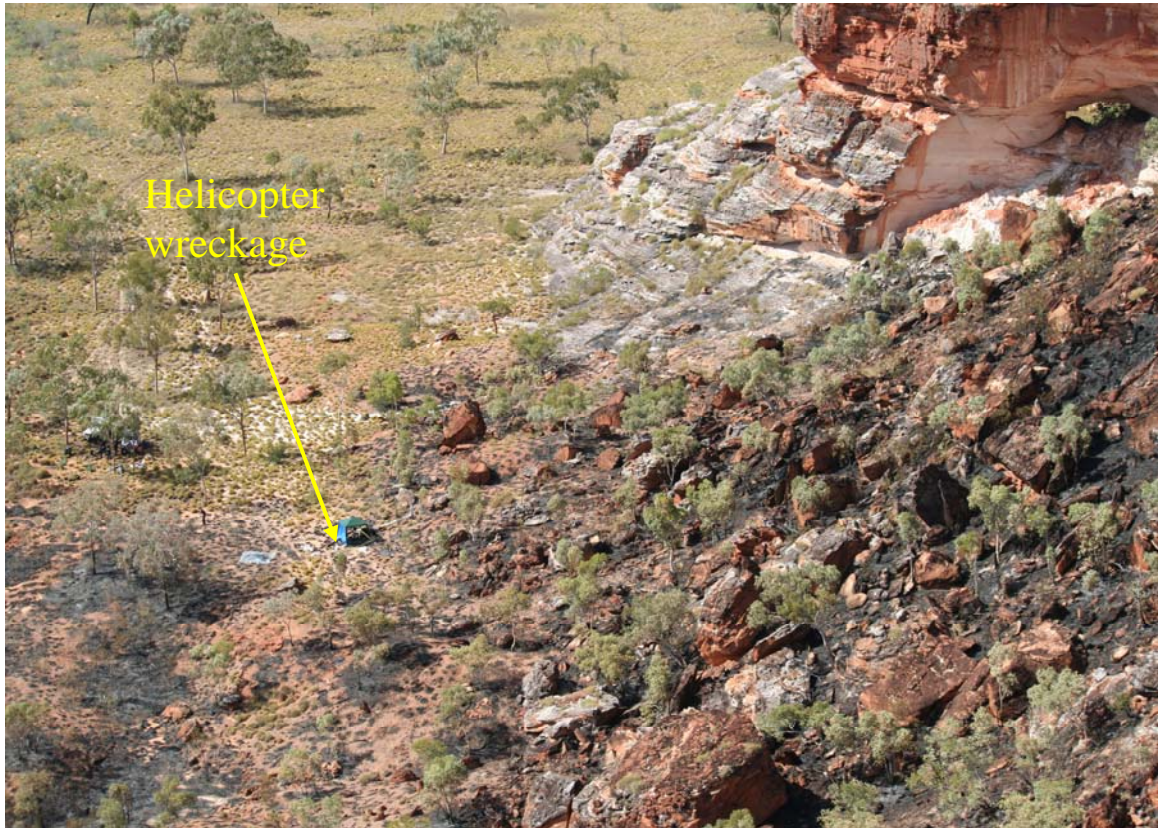
Figure 3: Overhead view of the accident site

The accident site, although relatively flat, was situated close to a rocky outcrop that extended several hundred feet above the underlying terrain (Figure 3).

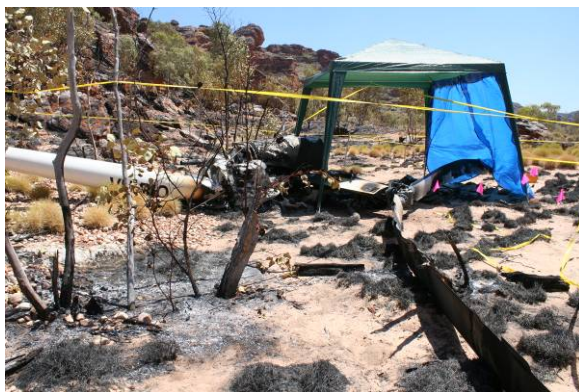
Figure 4: Accident site facing north

Damage to the lower right corner of the engine firewall indicated that the helicopter impacted the ground heavily and with little or no forward speed before coming to rest on its right side. The helicopter's cabin and engine compartment were substantially damaged by the fire (Figure 4).

Due to the severity of the post-impact fire, it was not possible to verify the integrity of the flight control system. However, all steel components associated with the collective and cyclic flight controls were found intact and secure. Evidence of the rubber drive belts that transmit engine power to an overrunning clutch and then to the main and tail rotors was found within the drive pulley system. However their pre-impact serviceability could not be established.
