# Collision with terrain

## 3 km N Bathurst Airport, NSW - 7 November 2008

INFRA-08376

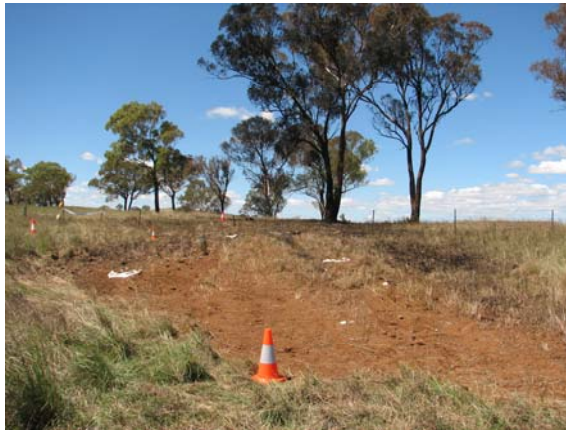
The initial impact point was 1.9 km north-east of the departure end of runway 35 with a descent angle over trees calculated as greater than 20 degrees. The aircraft was upright and right wing low at impact.

**Figure 2: Initial impact marks (looking in direction of travel)**

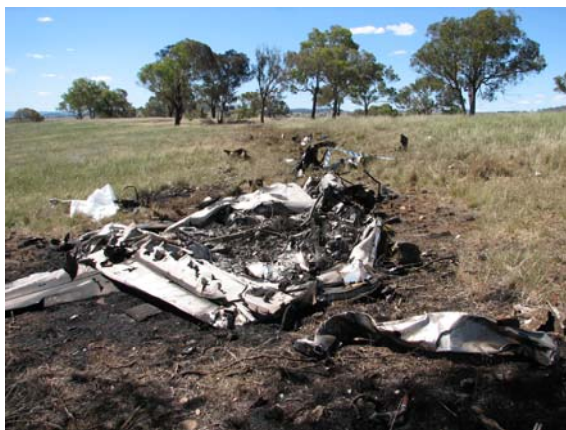
The wreckage trail was orientated on 165 degrees magnetic (generally towards the airport) and extended for about 300 m, with some small heavy items further on. There was evidence of fire along the wreckage trail and most of the wreckage was fire affected.

**Figure 3: Main wreckage (looking back towards initial impact point)**

The bending of the propellers indicated that at the time of impact, both propellers had rotational energy and the left engine was producing less power/torque than the right engine.

There was no evidence of pre-impact structural or flight control defects.
