Midair Collision

Cessna 152 - VH-FMG/Liberty XL2 - VH-XLY

Casula, NSW

18 December 2008

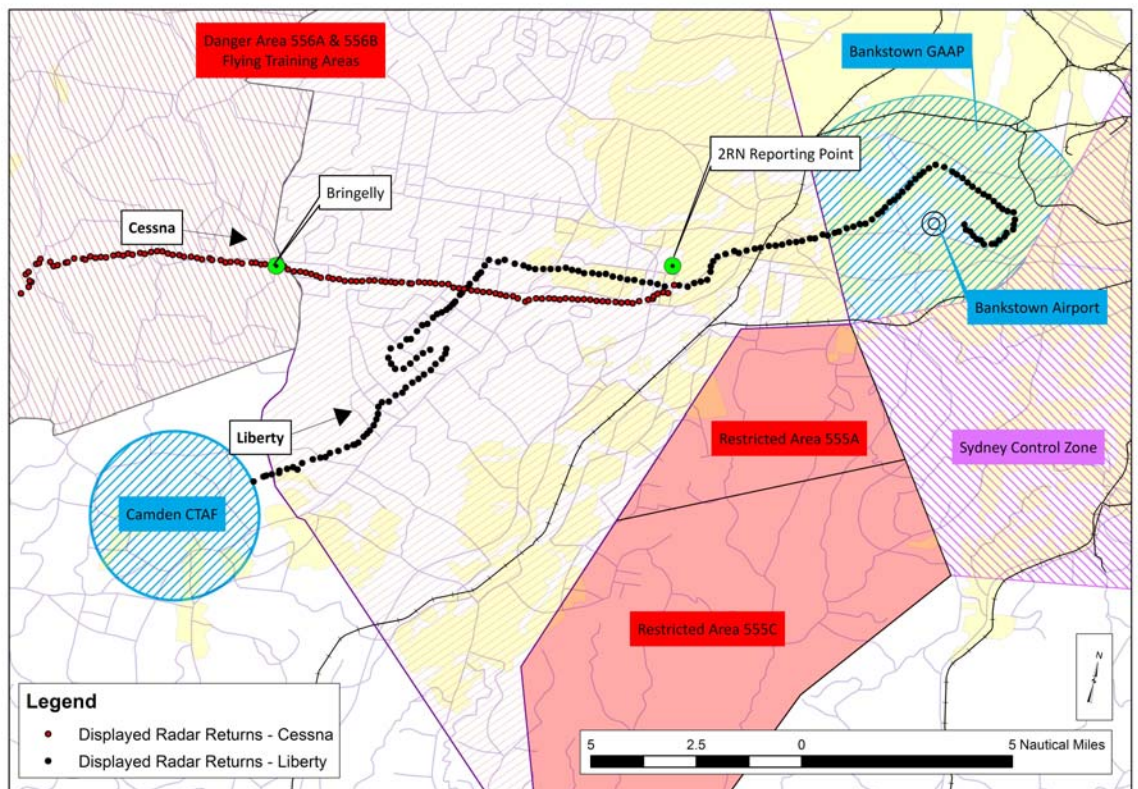
Figure 1: Displayed radar returns of both aircraft

degrees into the training area and tracked to the north-east towards 2RN. Shortly after, the Liberty was observed to conduct a turn to the left through 180°, followed by a turn to the right through 180°. The Liberty then flew in a northerly direction and overflowed the Cessna which was approximately 600 ft below. The Liberty continued to track north for a short time, then turned to the right and descended and tracked towards 2RN (Figure 1).

Radar data showed that both aircraft were tracking on converging courses towards 2RN and the radar returns merged approximately 900 m to the south of 2RN. In the minute before the returns merged, the Liberty averaged a groundspeed of 110 kts and the Cessna 87 kts. One radar return disappeared and the other return continued on and indicated that this aircraft landed at Bankstown. The radar return that disappeared represented the Cessna, which descended almost vertically and impacted the rear of a house in an adjacent suburb. Both occupants of the Cessna were fatally injured. The ATO on board the Liberty sustained minor injuries.

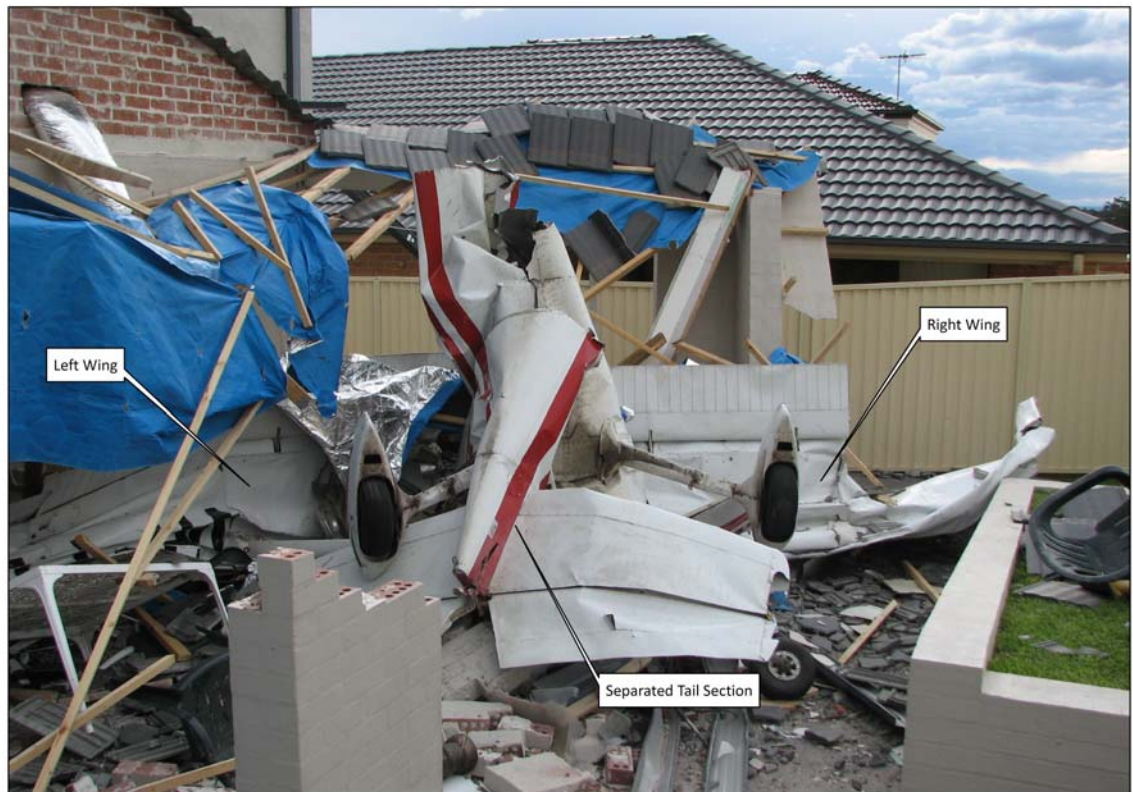
Figure 2: Cessna wreckage and house damage

A house was damaged as a result of the impact from the Cessna (Figure 2). A pergola attached to the rear of the house was destroyed, along with its contents. A number of houses surrounding the impact site also sustained damage to roofing tiles, internal roofing structures and guttering.

The Cessna impacted the ground in a vertical nose-down attitude. The damaged tail section remained attached by the flight control cables and was located on the bottom of the fuselage after the aircraft came to rest. There was significant compression damage to the leading edges of both wings, consistent with impact with the structure of the house and the ground.

The tail of the Cessna had separated approximately midway between the cabin and tail. The separation exhibited signs of tension overload failure along the rivet line on the left side with compression of the structure on the right side. The rudder, elevator and trim control cables had remained intact, allowing the separated section to remain connected to the main wreckage following the collision.

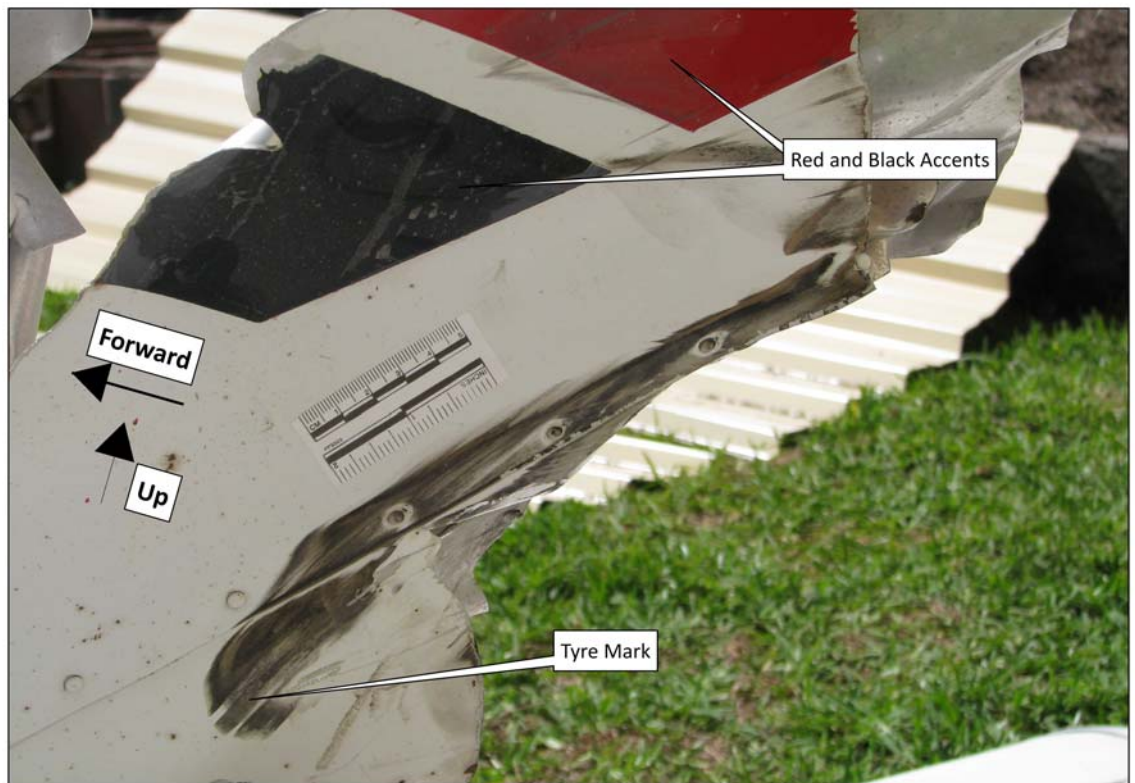
Figure 3: Tyre mark on Cessna vertical fin

Examination of the vertical fin of the Cessna revealed impact damage on the left side of the fin that was consistent with contact with another aircraft.

Later examination revealed that this damage was consistent with impact from the exhaust pipe of the Liberty aircraft. A single tyre mark was located

on the left side of the Cessna's vertical fin (Figure 3).

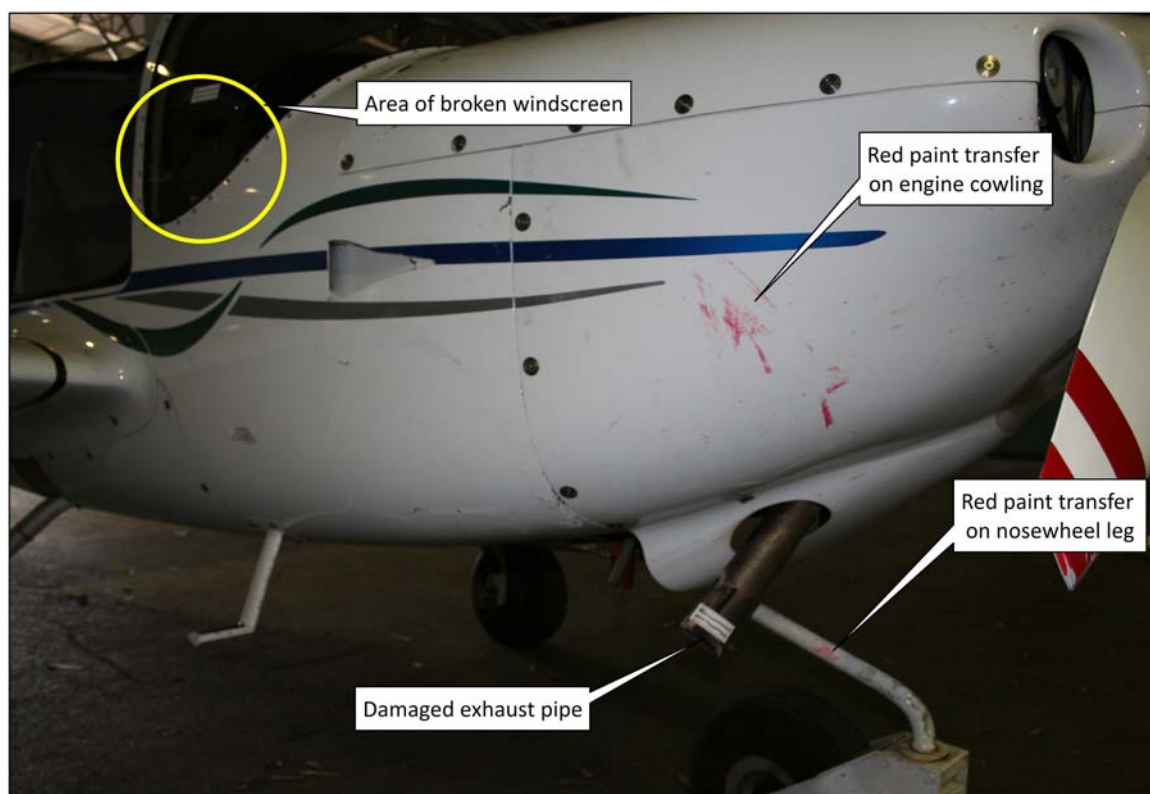
Figure 4: Damage to Liberty nose cowling and paint transfer

Examination of the damage to the right side of the nose cowling revealed red paint transfer at the front of the cowling, with additional crush damage and white paint transfer towards the rear of the cowling.

Inspection of the exhaust pipe revealed that the top section had been partially crushed and it also exhibited white paint transfer.

After landing at Bankstown, the Liberty was secured by the NSW Police Force. Damage to the Liberty consisted of impact damage to the right side of the nose cowling and crushing impact damage to the exhaust pipe located on the lower right side of the engine cowling (Figure 4.) There was damage to the right side of the nosewheel, paint smearing on the leading and trailing surfaces of the propeller, along with impact damage. There was also a break in the cockpit windscreen on the lower right side. There was additional damage to the underneath surface of the left wing tip.
