INFRA-08440

Collision with terrain, VH-IGT, PZL-M18A (Dromader), 58 km SW of Nyngan, NSW

29 December 2008

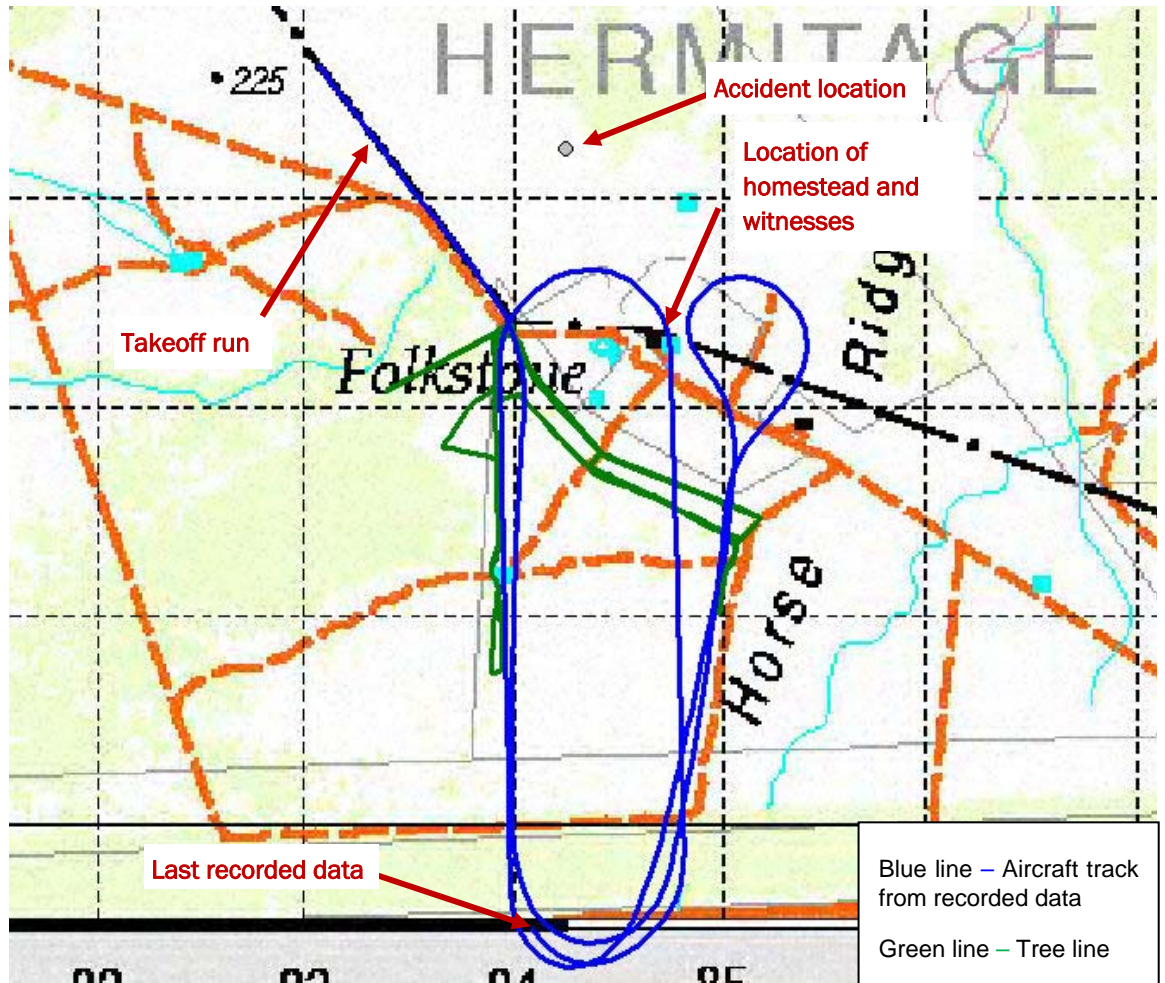
Figure 1: Recorded aircraft track

The aircraft was fitted with an electronic system to assist in and record the agricultural spraying. The system recorded the aircraft's location and altitude approximately every 1.5 seconds. The recorded data was downloaded by the Australian Transport Safety Bureau (ATSB) and showed the aircraft takeoff and survey of the paddock to be sprayed (Figure 1). The data was incomplete and stopped about 7 minutes after takeoff at the southern end of the paddock being sprayed and prior to the time of the accident.

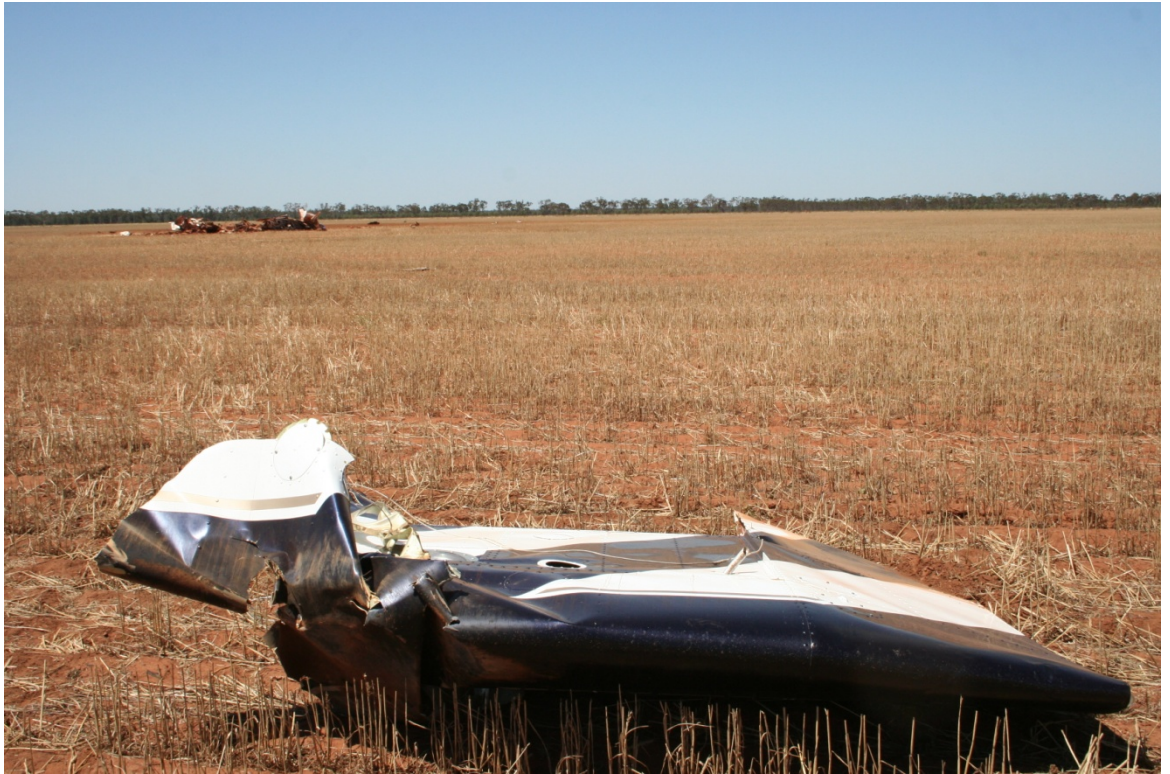
Figure 2: Outboard section of right wing and main wreckage

The wreckage trail extended for about 330 m in a north-easterly direction. The first items in the wreckage trail, prior to ground impact, were the outboard section of the right wing and items of debris from the hopper, the light bar and the canopy Perspex. The outboard section of the right wing was located approximately 100 m prior to the initial impact point of the main wreckage (Figure 2).

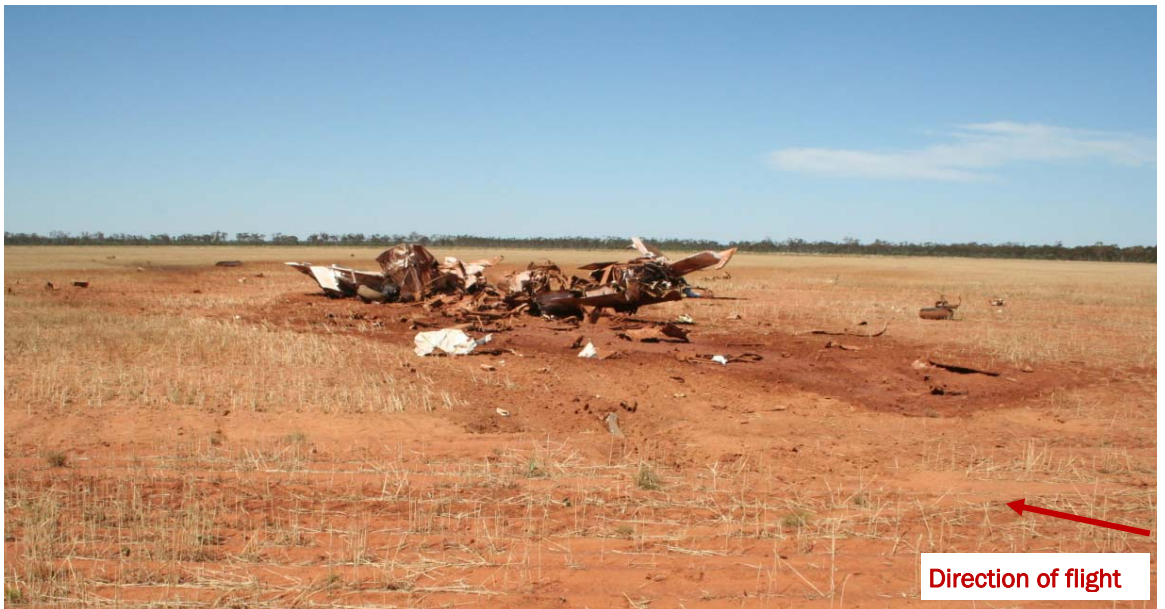
Figure 3: Main wreckage

The tip of the remaining attached section of the right wing was the first point of the aircraft to impact the ground. The aircraft then impacted the ground in about a 30° nose-down attitude. The right wing then separated from the fuselage due to the impact forces. The fuselage and tail rotated to be facing a westerly direction (Figure 3).

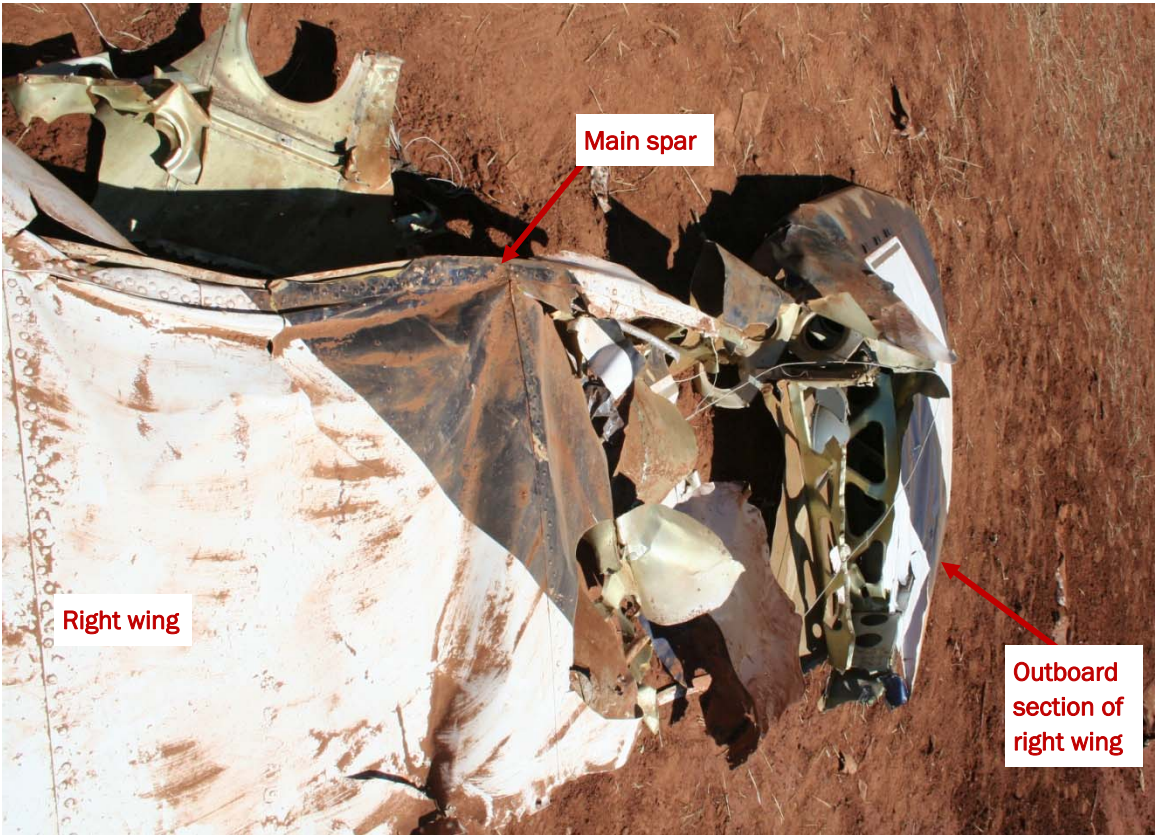
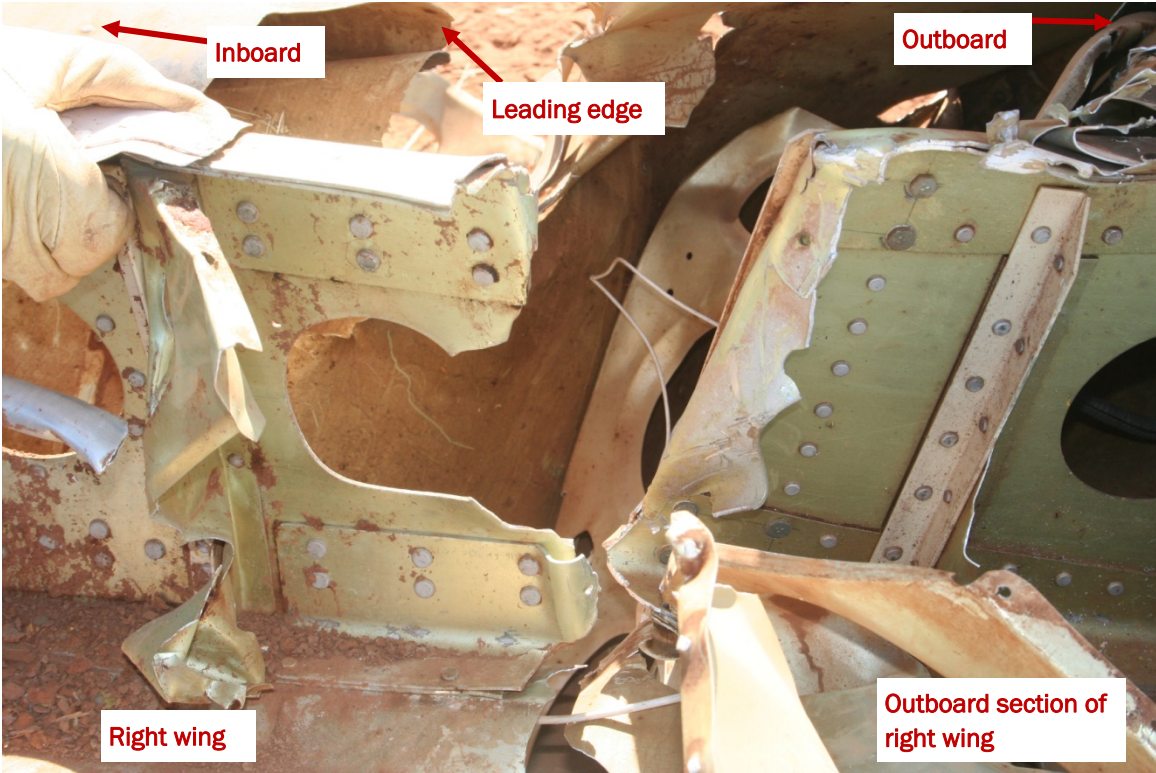
The outboard section of the right wing had separated approximately 1.8 m from the tip. The

location of the separation was between the tie-down hard point and the straps along the forward face of the main spar (Figures 4 and 5).

Figure 4: Reconstructed right wing

Figure 5: Two sections of the right wing main spar looking forward
