Derailment of Train 1MA6Q

near Pura Pura, Vic.
30 March 2008

INFRA-08533

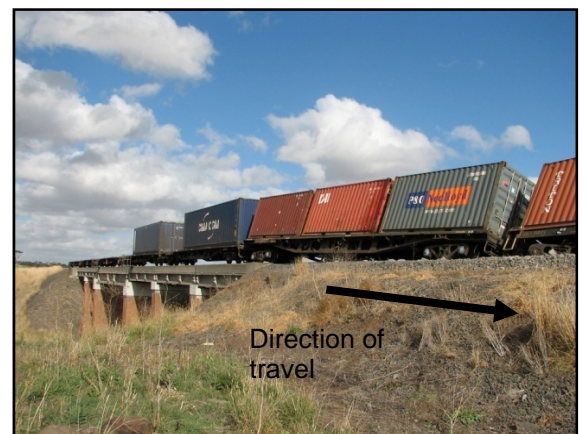
Figure 1: Point of derailment on bridge

Mount Emu Creek bridge is constructed of brick piers and concrete spans with an encapsulated top (Figure 1).

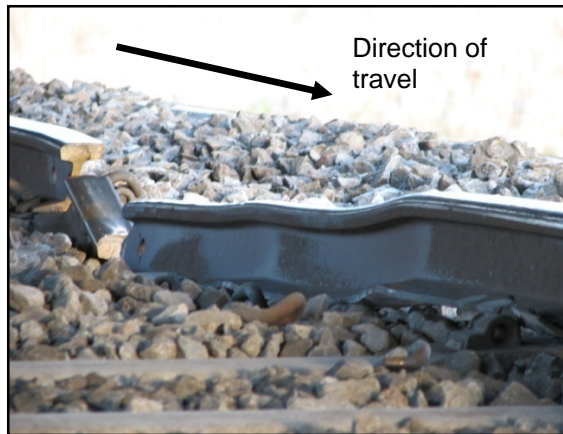
Figure 3: The fractured rail in-situ

Further examination of the site revealed a fractured rail on the Mount Emu Creek bridge, under the 43rd position in the consist (Figure 3).

Of note was the deformation of the rail in the trailing section caused by the wheels 'landing' after traversing the fracture.

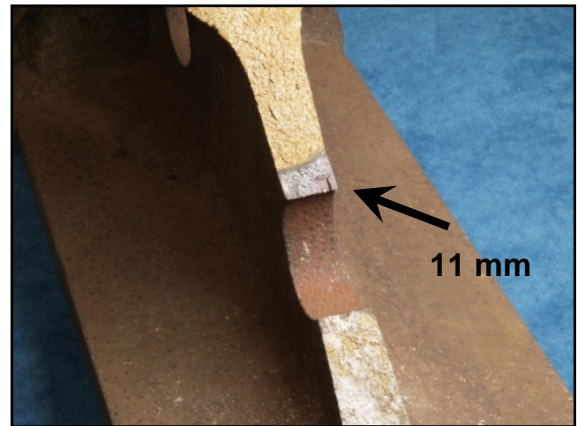
Figure 8: Bolt-hole and fracture at 'B'

The largest fatigue crack extended 11 mm towards the head of the rail from the bolt-hole at fracture B (Figure 8).

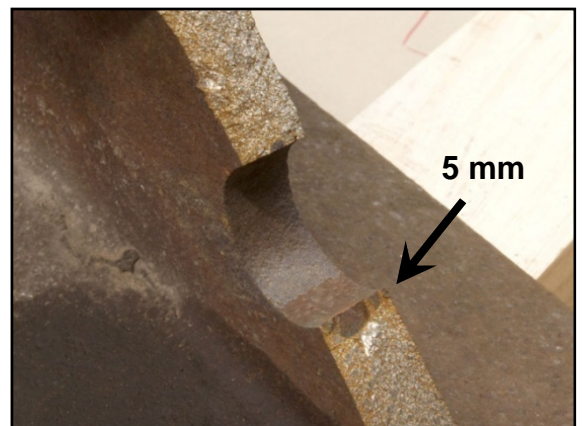
Figure 9: Bolt-hole and fracture at 'A'

The major fatigue crack at fracture A extended 5 mm towards the foot of the rail (Figure 9). No evidence of pre-existing cracking was observed on the fracture face at C.

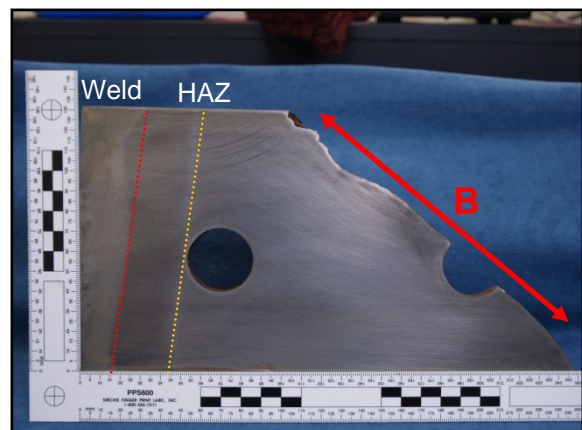
Figure 10: Section of the heat affected zone

The weld was sectioned and etched using 5 per cent nital solution (Figure 10).

The heat affected zone (HAZ) extended about 30 mm from the weld up to the first bolt-hole. The second bolt-hole, with the fatigue crack origin, was about 130 mm outside the heat affected zone. The heat affected zone of the weld was not contributory to the initiation, propagation, or failure of the rail.
