ATSB TRANSPORT SAFETY REPORT
Aviation Occurrence Investigation A0-2009-051
Final

Collision with terrain, VH-KVT 81 km NE of Winton, Queensland 17 August 2009

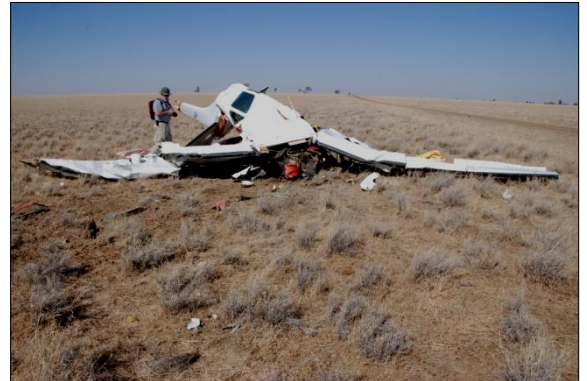
Figure 1: Accident site

The aircraft was seriously damaged² by impact forces (Figure 1). The right wingtip (Figure 2) struck the ground first, followed by the propeller and engine. There was extensive impact damage to the right wing. Those observations indicated that the aircraft was turning right at impact and was in a nose-low, right wing-low attitude. There was no fire. Both the left and right wing fuel tanks had been ruptured during the impact sequence and contained no fuel. There was fuel staining on the bottom surface of the right wing and a strong smell of fuel in the vicinity of the wreckage.
