Bureau of Air Safety Investigation

**MU-2 ACCIDENT INVESTIGATION**  
and  
**RESEARCH REPORT**

**VH-BBA near Leonora WA, 16 December 1988**  
**VH-MUA at Meekatharra WA, 26 January 1990**

January 1992

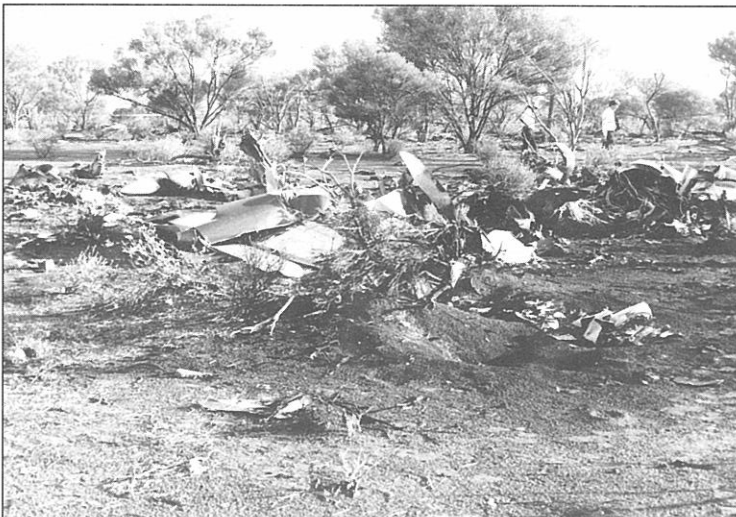
The aircraft was destroyed by impact forces and the subsequent fire.

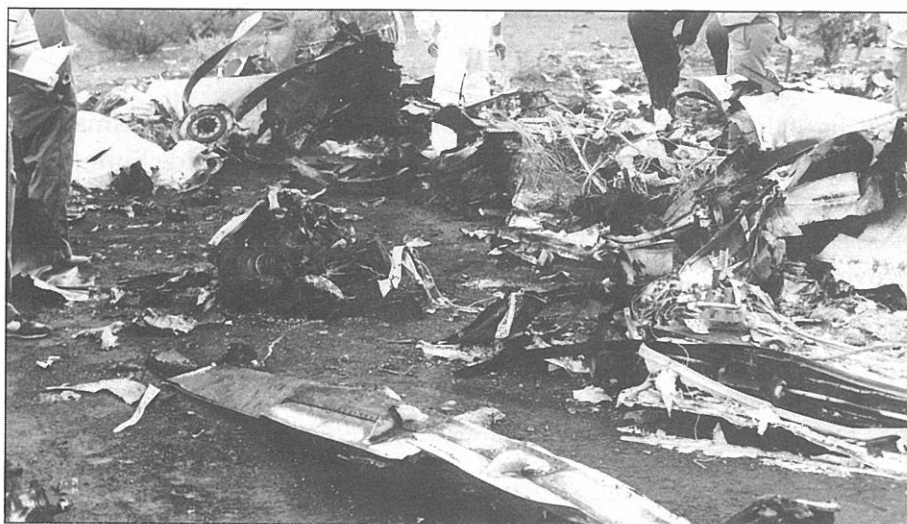
Wreckage with control surface in foreground and a propeller assembly in top left.

All aircraft extremities were identified as well as the control surfaces, trim tabs, doors and windows, suggesting that the aircraft did not suffer an in-flight break-up or control surface separation.

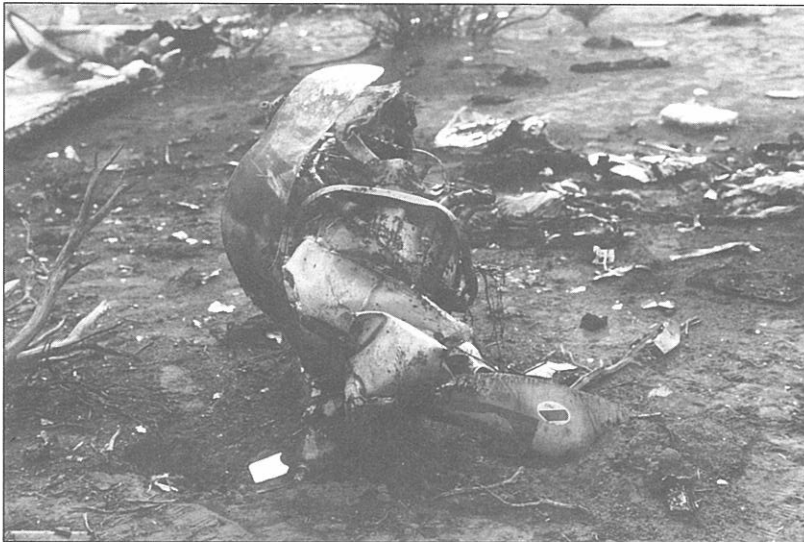
Propeller assembly

The propellers had both suffered extensive damage to their blades and mechanisms consistent with high rotational speed at impact.

An examination revealed that the engines and the propellers were fully serviceable and were operating at impact. The equivalent damage in both engines was matched by tachometer readings of about

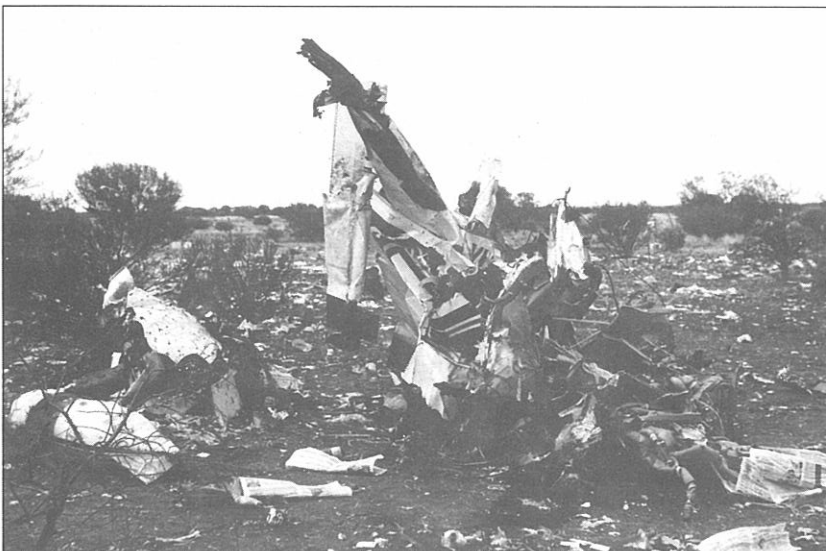
The aircraft was destroyed by impact forces and post-impact fire.

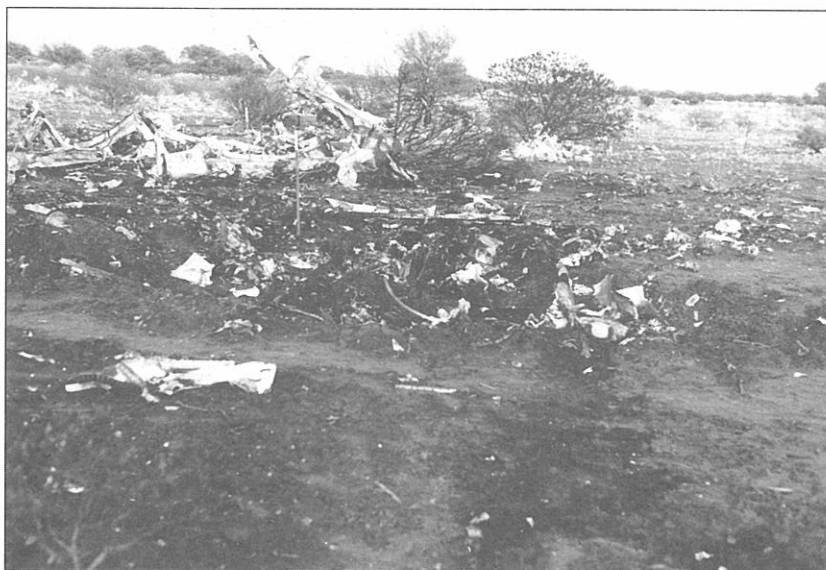
The aircraft impacted the ground in a near-vertical attitude and much of the forward section of the aircraft had penetrated the ground to a depth approaching 1 m. The vertical attitude was confirmed by forward-to-aft compression buckling of the wings along with the impact damage to the left tip tank. A lot of soil had been displaced by the impact and a crater approximating the head-on profile of the aircraft was created. Most of the wreckage lay in the crater and its immediate vicinity. At either end of the crater were imprints of both tip tanks and the imprints indicated left rotation at impact.

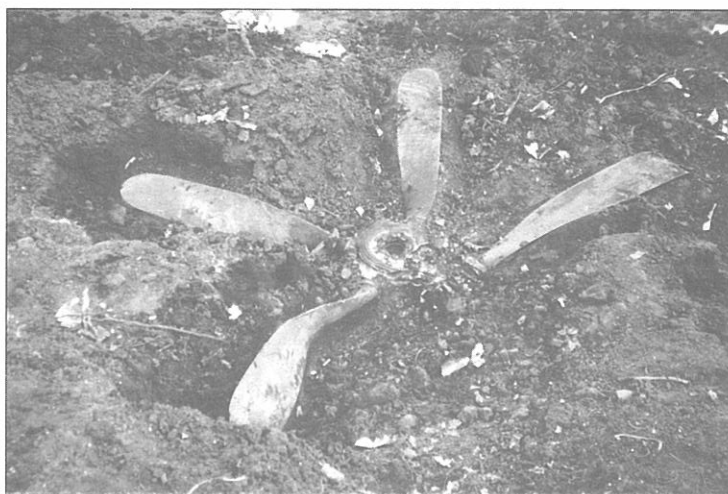
Each propeller had separated from its engine. The propellers were driven almost 1 m into the ground and their blades were detached. Workshop inspection concluded that both propellers were rotating in excess of 800 RPM at nearly identical power settings. At impact, the blade angle of both propellers was at least 29° with power settings approximating flight idle. No pre-existing defects were found in either propeller that would have prevented normal operation.

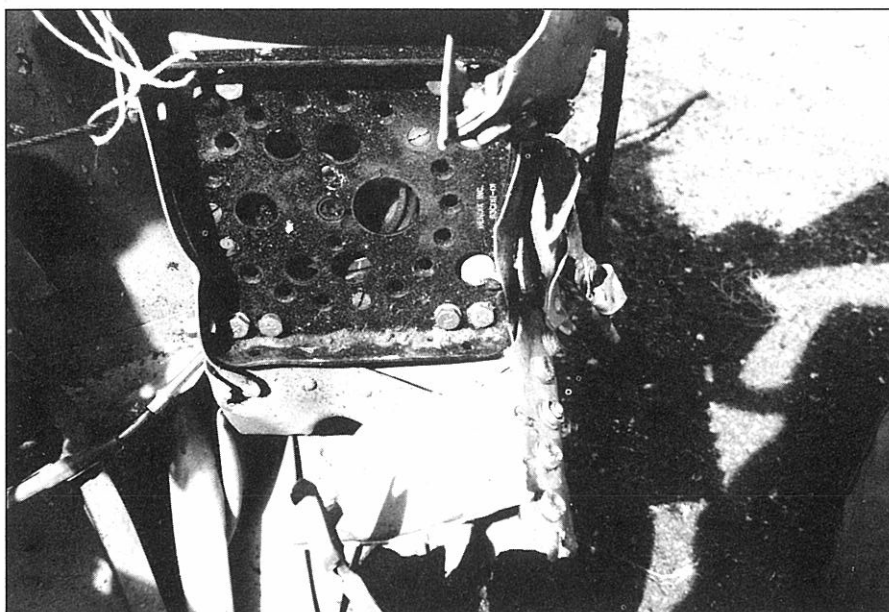
Yaw-damper servo attachment bracket

During the inspection of the wreckage, it was noted that the yaw-damper servo was missing. It was determined that this component was not in the aircraft before the flight left Perth, i.e. it had not become detached during the impact sequence. It was also noted that the rudder servo was electrically disconnected before the flight commenced and the plug had been tied back away from the servo attachment area.

Investigations revealed that the servos had probably been removed from the aircraft prior to its arrival in Australia in July 1988. There was no evidence that they had been refitted to the aircraft prior to the accident flight.

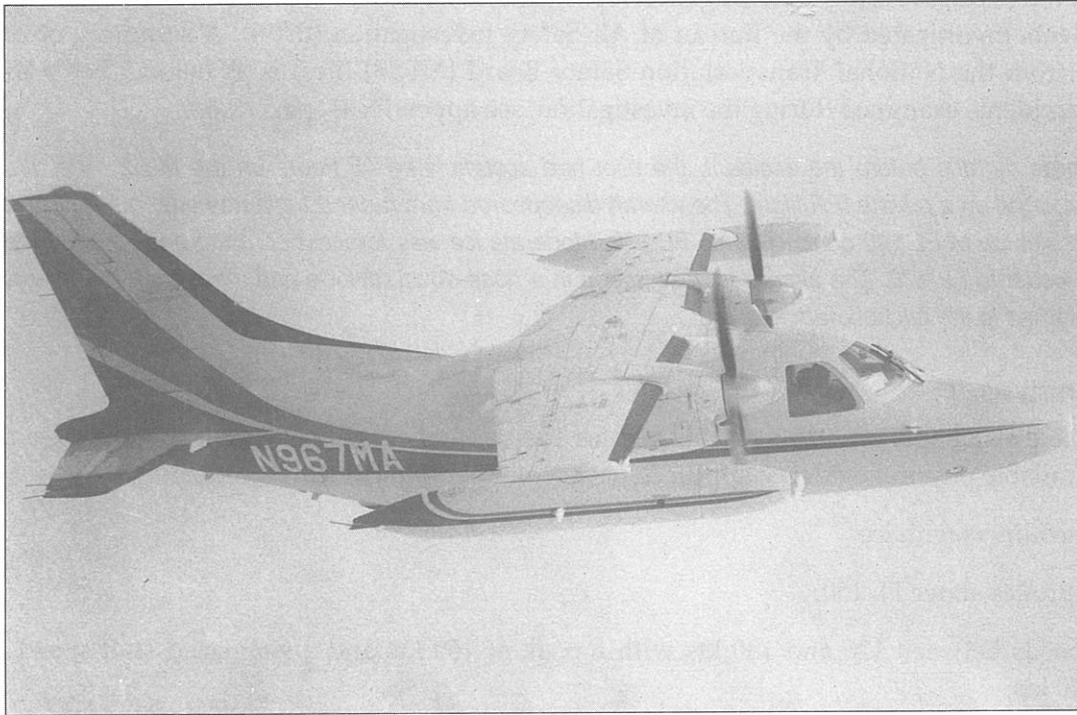
MU-2 aircraft showing commencement of ice accretion on leading surfaces
