Department of Transport
Bureau of Air Safety Investigation

INVESTIGATION REPORT
B/902/1080

Cessna 210N VH-PLD
Near Oakdale, New South Wales
22 December 1990

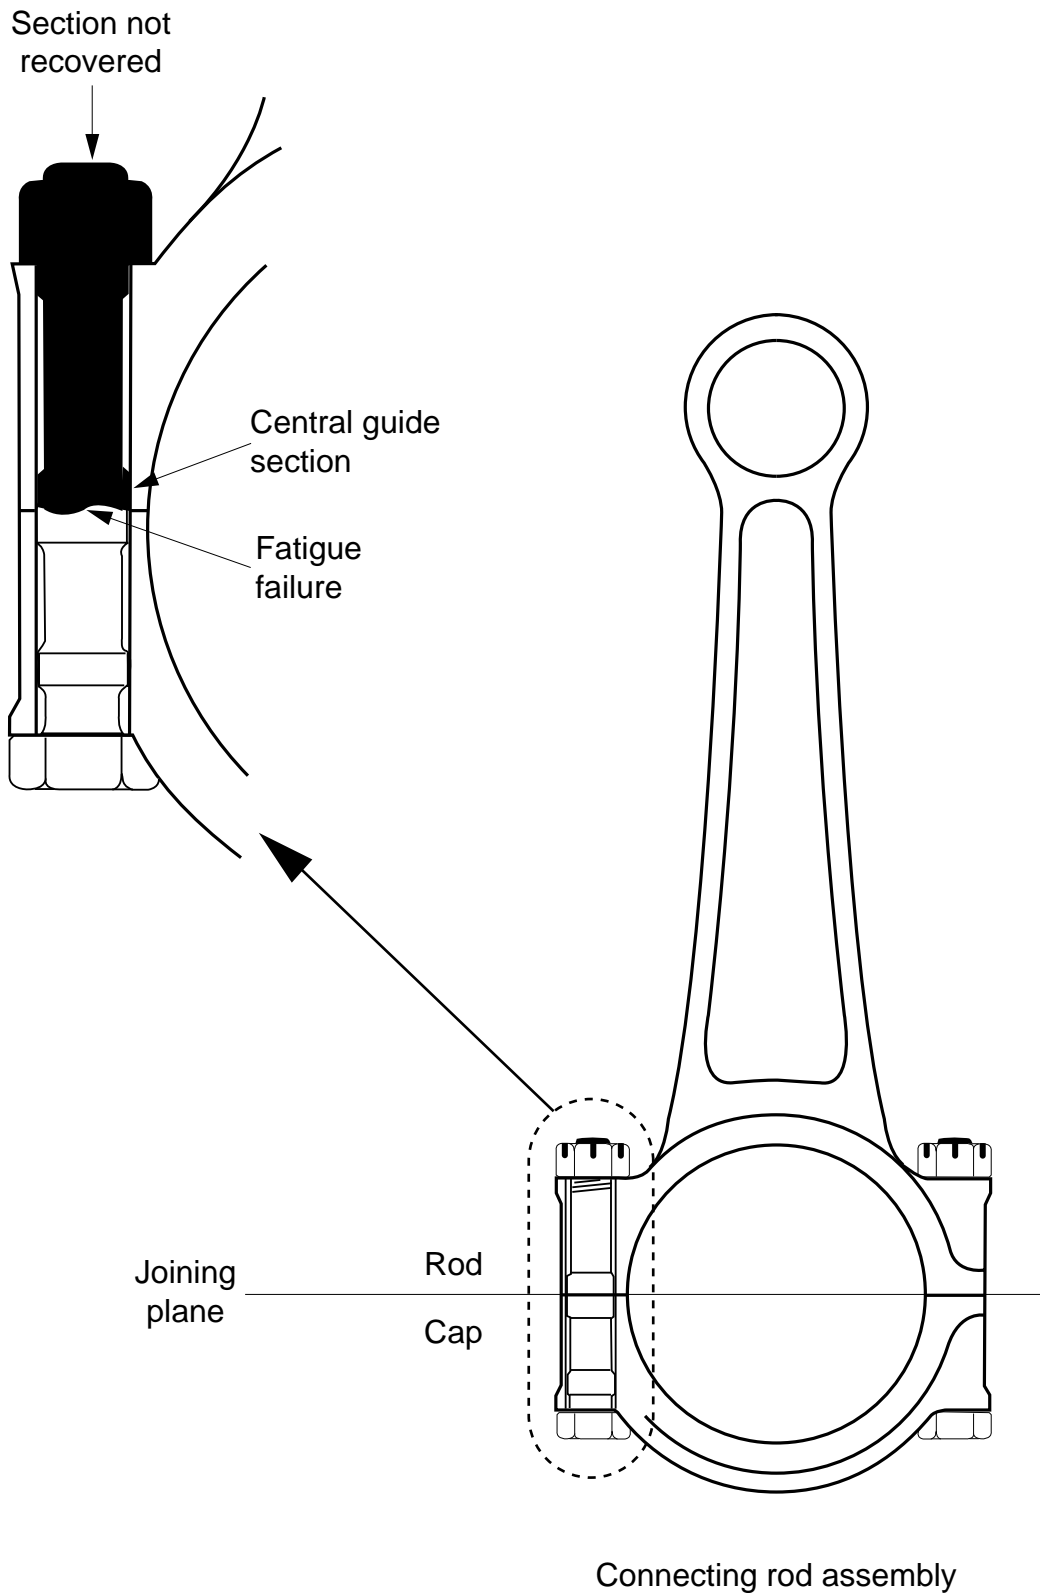
Connecting rod bolt failure

The engine suffered an internal material failure. The number 6 connecting rod cap bolts had failed and liberated the connecting rod. The rod punctured, and became jammed in, the top of the crankcase. Further internal damage after the bolt failure resulted in the loss of oil pressure and the subsequent total loss of engine power. Oil from the ruptured crankcase flowed back over the windscreen.

A detailed investigation of the connecting rod bolt failure mode determined that the failure was due to fatigue cracking at the central guide portion of the bolt, an area where no manufactured geometric stress concentrator exists. The crack had initiated from fretting damage as a direct result of movement between the connecting rod and the cap because bolt tension was insufficient to arrest the movement. Poor surface finish and lubrication between the surfaces were noted. The threaded end of the bolt with the nut and safety pin were not recovered so no determination could be made of the reason for the low bolt tension. Examination of the bolts from numbers 1, 2, 3 and 4 connecting rods revealed that fretting was present on the central guide portion of the bolts. The extent of the fretting was variable. The bolt extensions were not measured prior to disassembly of the engine.

The fatigue crack of the bolt was initiated by fretting damage at the mid-point of the bolt. The fretting resulted from movement of the mating surfaces of the connecting rod and cap. This movement is normally restrained by big-end bolt tension or pre-load obtained by applied torque on the nut. The investigation determined that the presence of a lubricant between the cap and rod assembly may have been a contributing factor in allowing slip to occur between the connecting rod and cap. In this case, the threaded end of the failed bolt together with its nut and safety pin was not recovered after the accident, so no determination of the reason for the low bolt torque could be made.
