AIR SAFETY INVESTIGATION REPORT
200105715

SAAB 340B, VH-XDZ
93 km North East of Trepell, Qld
5 December 2001

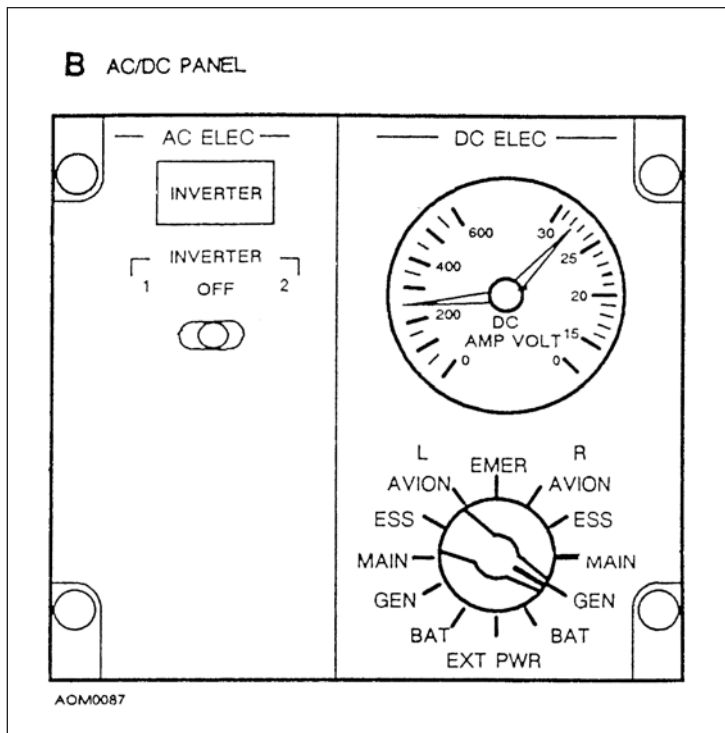
FIGURE 2:
Overhead AC/DC panel

As a result of the above design characteristic, the DC generator-out light would not immediately illuminate if generator output is below a value insufficient to charge the battery. The only definitive indication then, of a lack of effective generator output, was available from the voltmeter/ammeter.

Although a check of the voltmeter/ammeter indications was required after start there were no other routine checks of the indications. The crew could not recall what the voltage and amperage readings were after engine start. Significantly, there was no warning annunciator system alert for system low voltage. It was likely that the generator-out caution eventually illuminated when the right system voltage decreased below the value required for operation of the generator control unit.

The design characteristic that produced the delayed disconnection of a failed generator could be rectified by the incorporation of a modification to the electrical system. The aircraft manufacturer had issued Service Bulletin 340-24-026 on 9 January 1996, with optional compliance. That bulletin introduced modification number 2533 that provided for the installation of a generator control unit that could detect a generator under-voltage condition and as a consequence take the generator off-line.

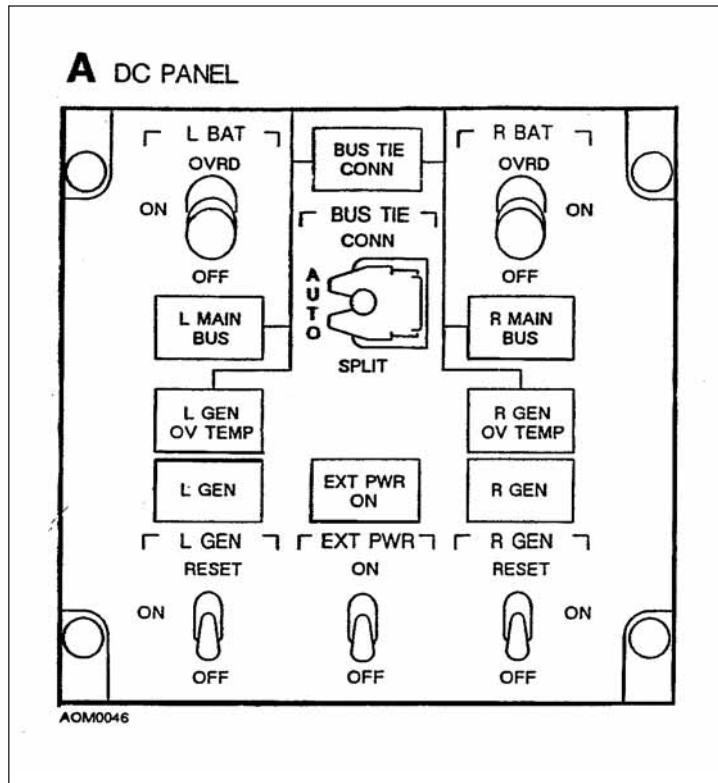
FIGURE 3:
Overhead DC panel

The right DC electrical system components remained underpowered throughout the occurrence because the bus tie relay did not connect. The bus tie relay provided the means to connect the left and right electrical systems in the event of a generator failure, thereby allowing the operative generator to provide power to both systems. Automatic operation of

the bus tie relay, with the bus tie switch to AUTO, relied on a generator being taken off-line as indicated by a generator-out light. However, in this occurrence, when the right generator-out light illuminated late in the failure sequence, indicating an off-line generator, the bus tie relay did not activate. The failure of the bus tie relay to operate was due to active over-current protection. That is consistent with either incorrect start sequence actions or excessive current during failed automatic relay activation, an explanation favoured by the aircraft manufacturer.

Reset of the bus tie relay, although possible by selection of CONN and actuation of the 'K-1' switch located on a circuit breaker panel, was not always prescribed by the checklists. A description of the crew's response to non-activation of the bus tie relay is at 1.6.2.4

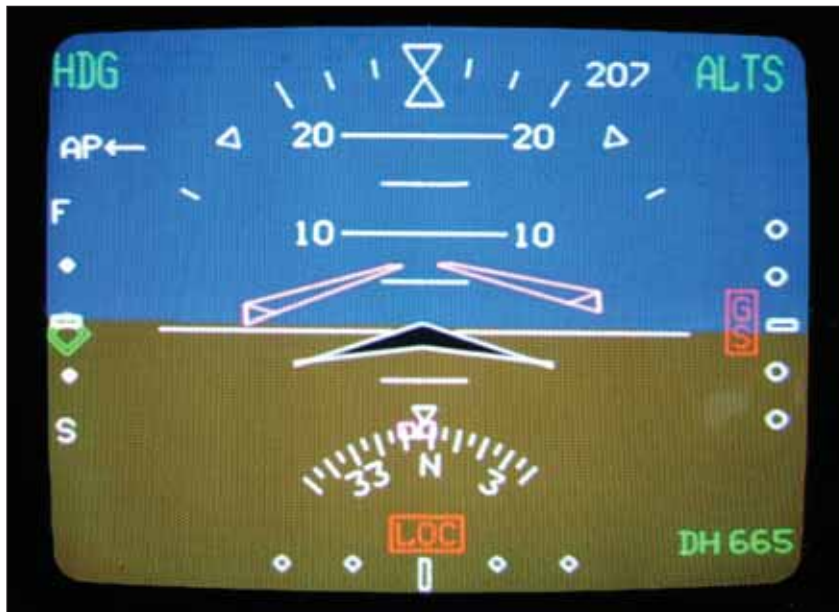
FIGURE 4:
EFIS screen in composite mode

Given the prior failure of the upper left EFIS screen, the information normally displayed on that screen had been added to the information displayed on the adjacent screen in a composite (reversionary) mode. That composite mode provided a display of condensed EADI and EHSI information.

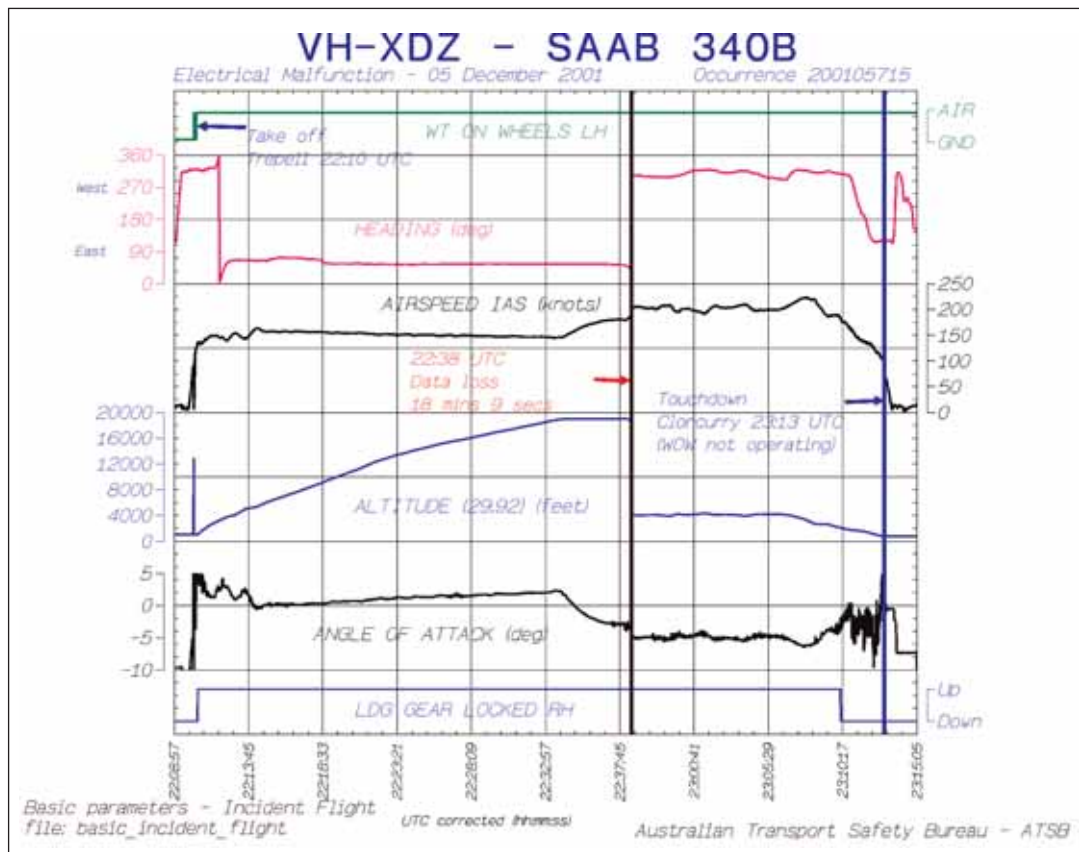
FIGURE 5:
Example of FDR data plot

Analysis of the recorded data revealed that the coordinated universal time (UTC) time recorded by the FDR did not correlate with the timings reported by ATS. An addition of 1 hr, 13 minutes and 14 seconds to the recorded time was required. During the analysis it was discovered that about 18 minutes of recorded data was missing. The FDR stopped recording at 2238:31 UTC and resumed recording at 2256:39 UTC. When the FDR stopped recording, the aircraft's airspeed was 187 kts, altitude was 18,688 ft and heading was 039 degrees magnetic. When the FDR resumed recording, the aircraft's airspeed was 202 kts, altitude was 4,112 ft and heading was 302 degrees magnetic.

The reason for the loss of FDR data is discussed in section 1.6.2.3.
