**Boeing 747-438, VH-OJU
Sydney Aerodrome, NSW
2 July 2003**

**INVESTIGATION REPORT
BO/200302980**

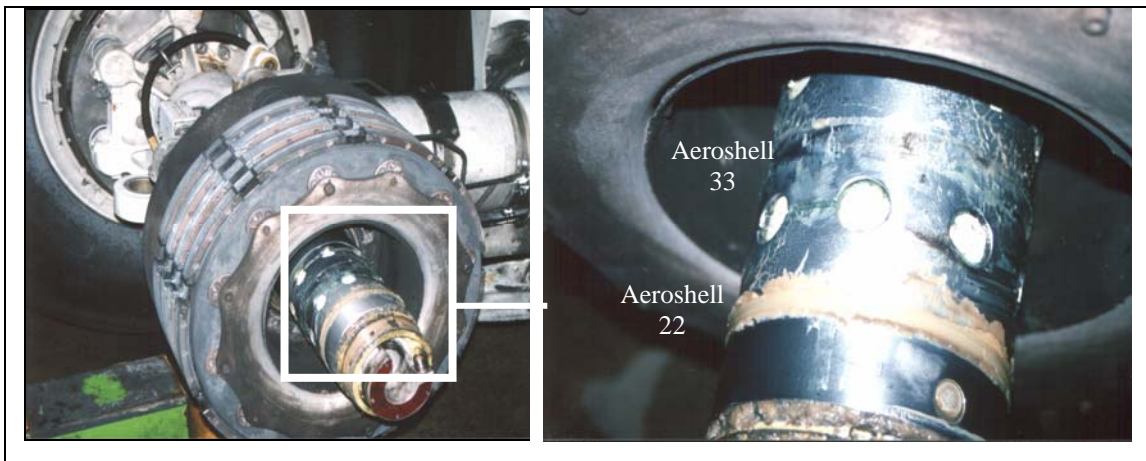
Figure 3: Incorrect grease on axle

An examination of the axles after wheels 9 and 13 were removed revealed the presence of the correct Aeroshell 22⁵ grease and a green-blue grease later identified as Aeroshell 33. Although not recommended for use in the high temperature axle area as it had a lower flashpoint⁶ than the approved Aeroshell 22 grease, Aeroshell 33 was an approved lubricant for other areas of the landing gear. The Aeroshell 33 grease was most predominant on the inboard area of the axle, with the correct Aeroshell 22 grease visible toward the axle's outer region (see Figure 3).

The grease manufacturer confirmed that Aeroshell 33 grease had a lower flash point than the approved Aeroshell 22 axle grease making it more susceptible to ignition under normal braking conditions.

The presence of Aeroshell 33 and excessive amounts of grease on the axles, may have led to a condition where a fire could initiate under normal brake operating temperatures. All wheel axles contained the incorrect grease in excessive amounts and were subjected to the same braking forces, however, only three actually ignited.

Maintenance memo M0429-GEN-32-41-JUL 10/03 has been issued, to highlight the hazards and precautions to be taken when carrying out wheel and brake assembly lubrications.

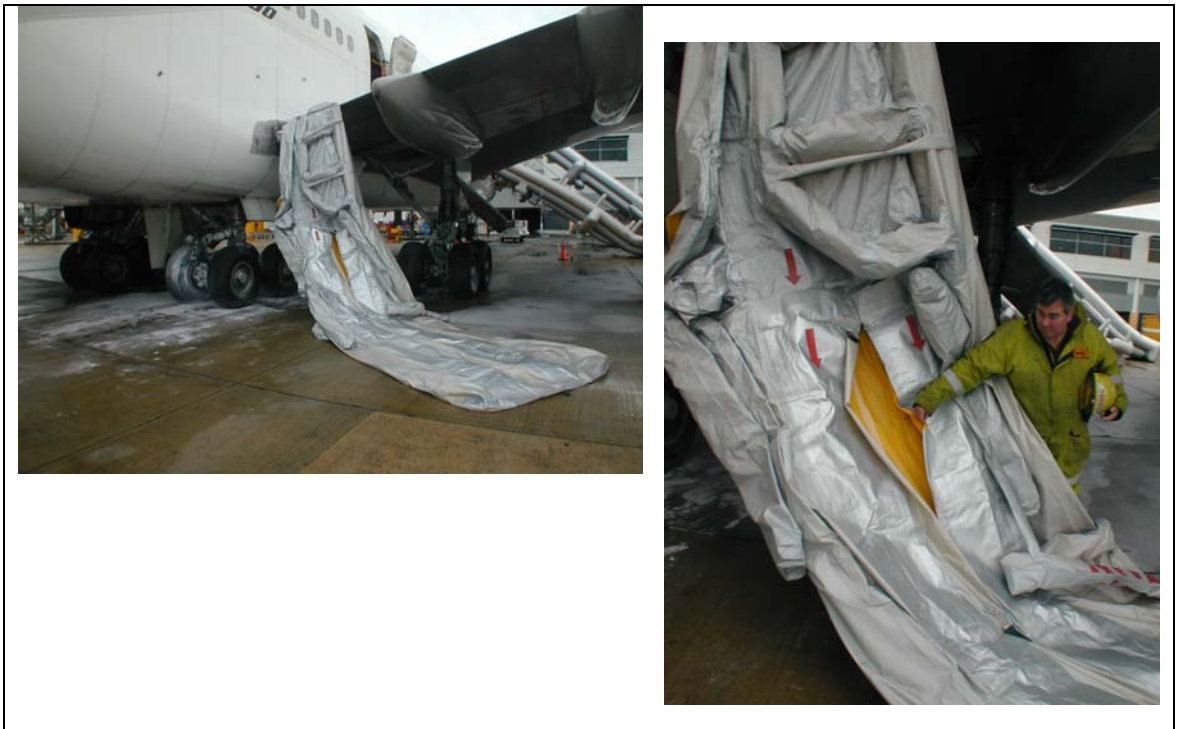
Figure 5: Door R3 slide deflated

Initial inspection of the right over-wing (R3) slide, indicated a longitudinal tear of approximately 1.5 metres down its centre tube (see Figure 5). The slide was removed from the aircraft and sent to the Australian Transport Safety Bureau (ATSB) for technical examination.

The examination revealed that the longitudinal tear was 154 cm long. There was a small transverse tear, extending 2.8 cm from the longitudinal tear toward the right slide-way reinforcement, 71 cm from the longitudinal tear's upper end.

Visual inspection of the slide material did not reveal any indication of fabric fibre or fabric proofing deterioration. A microscopic examination of the tear features determined

that both tears followed the weave of the fabric, with tearing occurring due to a tensile fracture of the fibres.

The examination of the failed door R3 slide, found there was no evidence of fibre cutting or sharp object penetration. The failure resulted from high pressure sliding contact between the slide and another object over a short distance, leading to fibre overload. The exact source of the pressure could not be determined, but such an action could have occurred from a number of items including the heel of a shoe, or the corner of an object (such as a brief case or cabin bag) carried by an evacuating passenger.

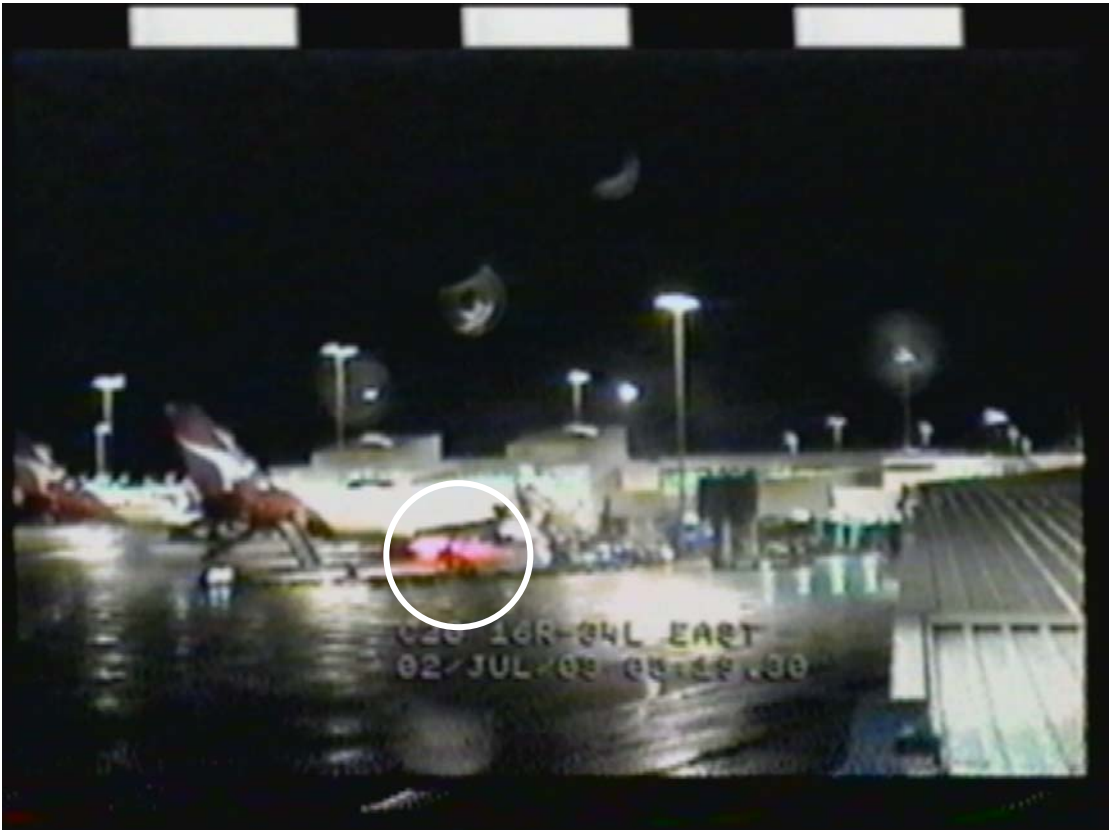
Figure 1: Video frame showing one of the flash fires in the main landing gear

The aircraft had landed at Sydney Airport on 2 July 2003 and was stationary at gate 33, when ground staff noticed at least two flash fires.

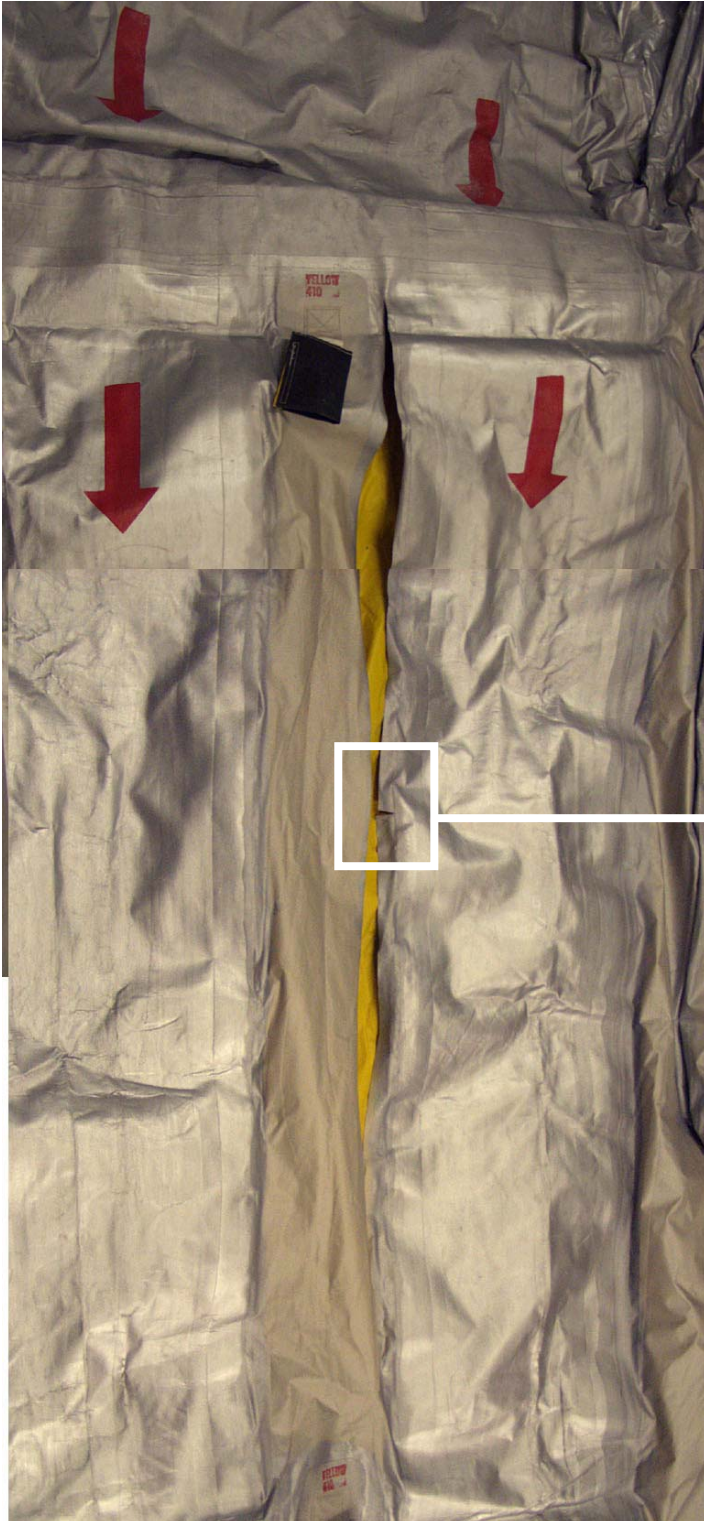
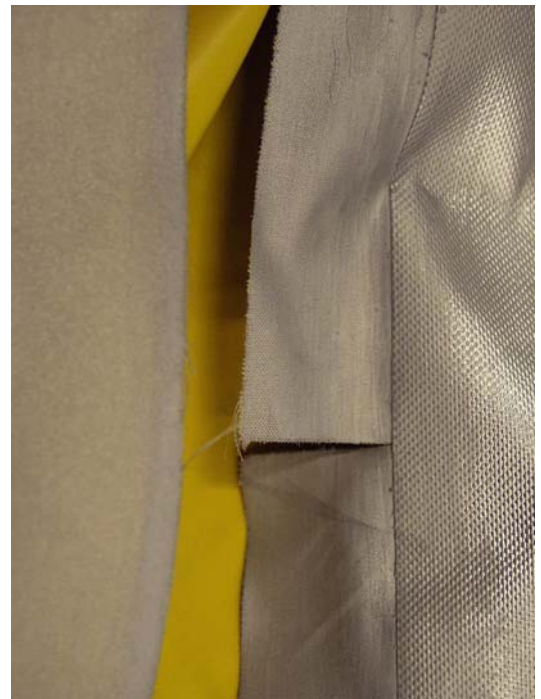
Figure 3: Overview of tearing in the R3 slide, Detail of transverse tear inlayed

The deflation of the slide occurred as a result of a longitudinal tear in the central tube in the section of the slide extending from the wing trailing edge to the ground. The location and features of the tearing in the slide are shown in Figure 3. The length of the longitudinal tear was 154 cm. A small transverse tear, extending 2.8 cm from the longitudinal tear to the right slideway reinforcement, was located 71 cm from the upper end of the longitudinal tear.

Microscopic examination of the features associated with the tear revealed that both the longitudinal and transverse tears were aligned with the weave of the fabric. Tearing occurred by the tensile fracture of fibres comprising the warp or weft of the fabric.

the slide and another object occurred under high contact pressure over a short distance. In addition, no evidence of fibre cutting or sharp edged object penetration was observed.

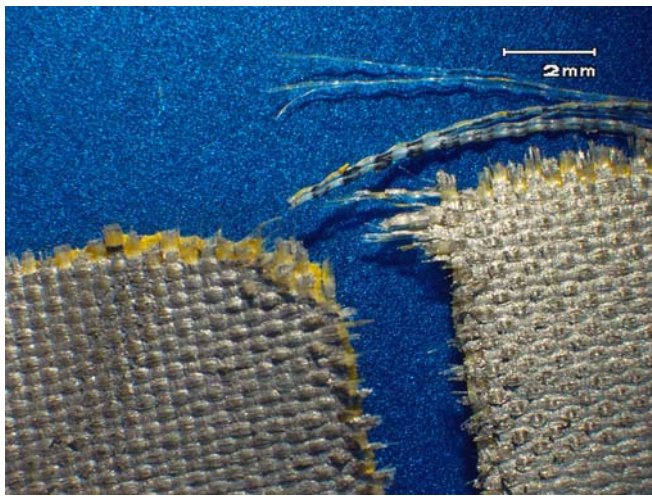
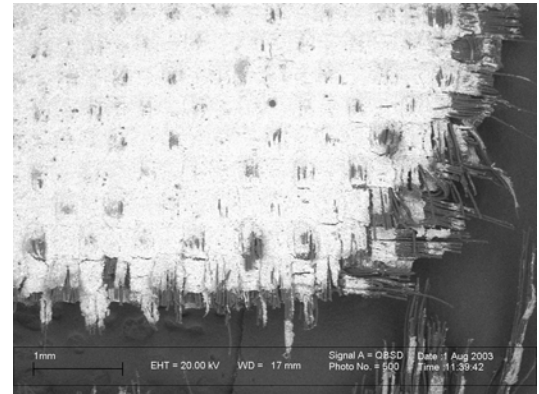
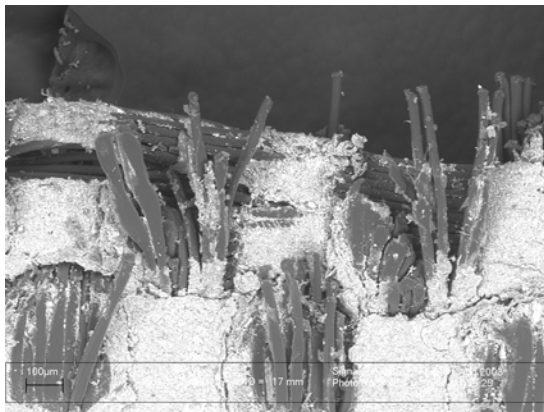
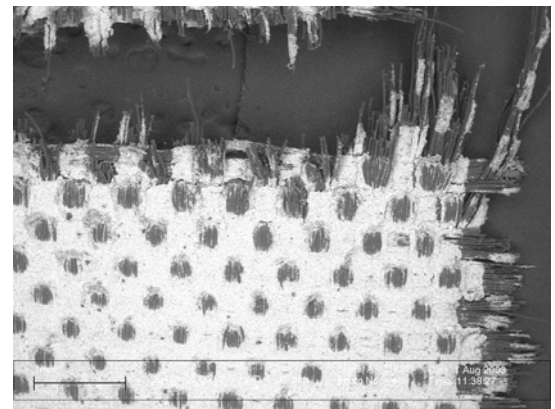
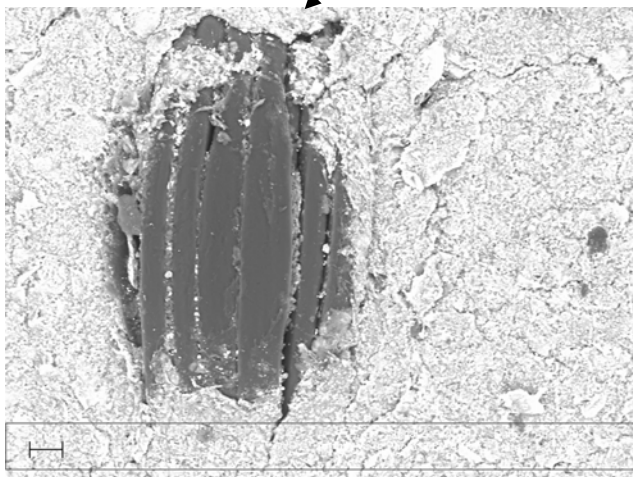
Figure 4: Examples of the features present at the junction of the longitudinal and transverse tears

Weave damage on the upper side of the transverse tear
