Australian Transport Safety Bureau

AVIATION SAFETY INVESTIGATION
200303579

Cessna 404, VH-ANV
Jandakot Airport, WA
11 August 2003

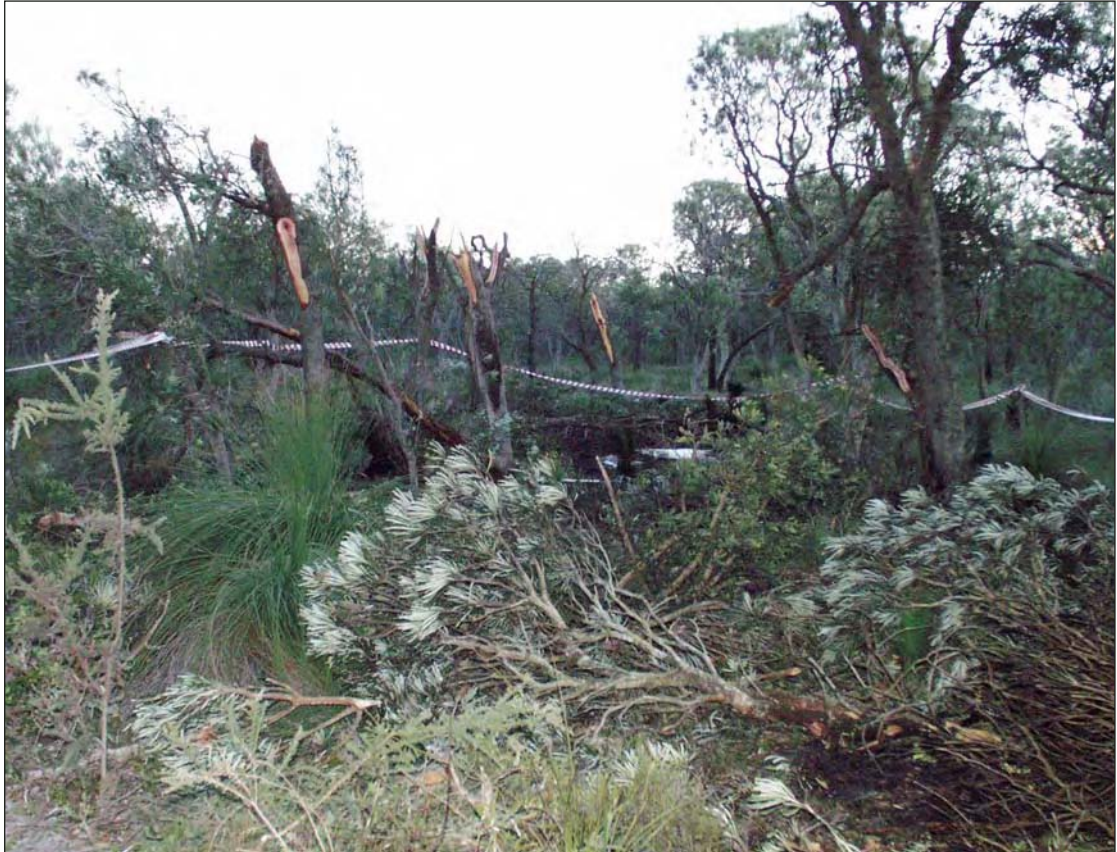
FIGURE 2: Initial impact with trees, looking back along the aircraft's flight path

The outboard portion of the left wing collided with the trunk of a tree during the impact sequence and was sheared off. That impact ruptured the left fuel tank and spilled a significant quantity of fuel.

The aircraft collided with several other trees during the impact sequence and there was evidence of significant damage to the leading edge of the wings and horizontal stabilisers. The fuselage came to rest with the cabin area intact, on a heading of approximately 290 degrees magnetic and about 20 m from where the fuselage initially impacted the ground. The wing flaps and landing gear were retracted (up) at the time of impact. The aircraft was consumed by the post-impact fire (see Figures 3 and 4).

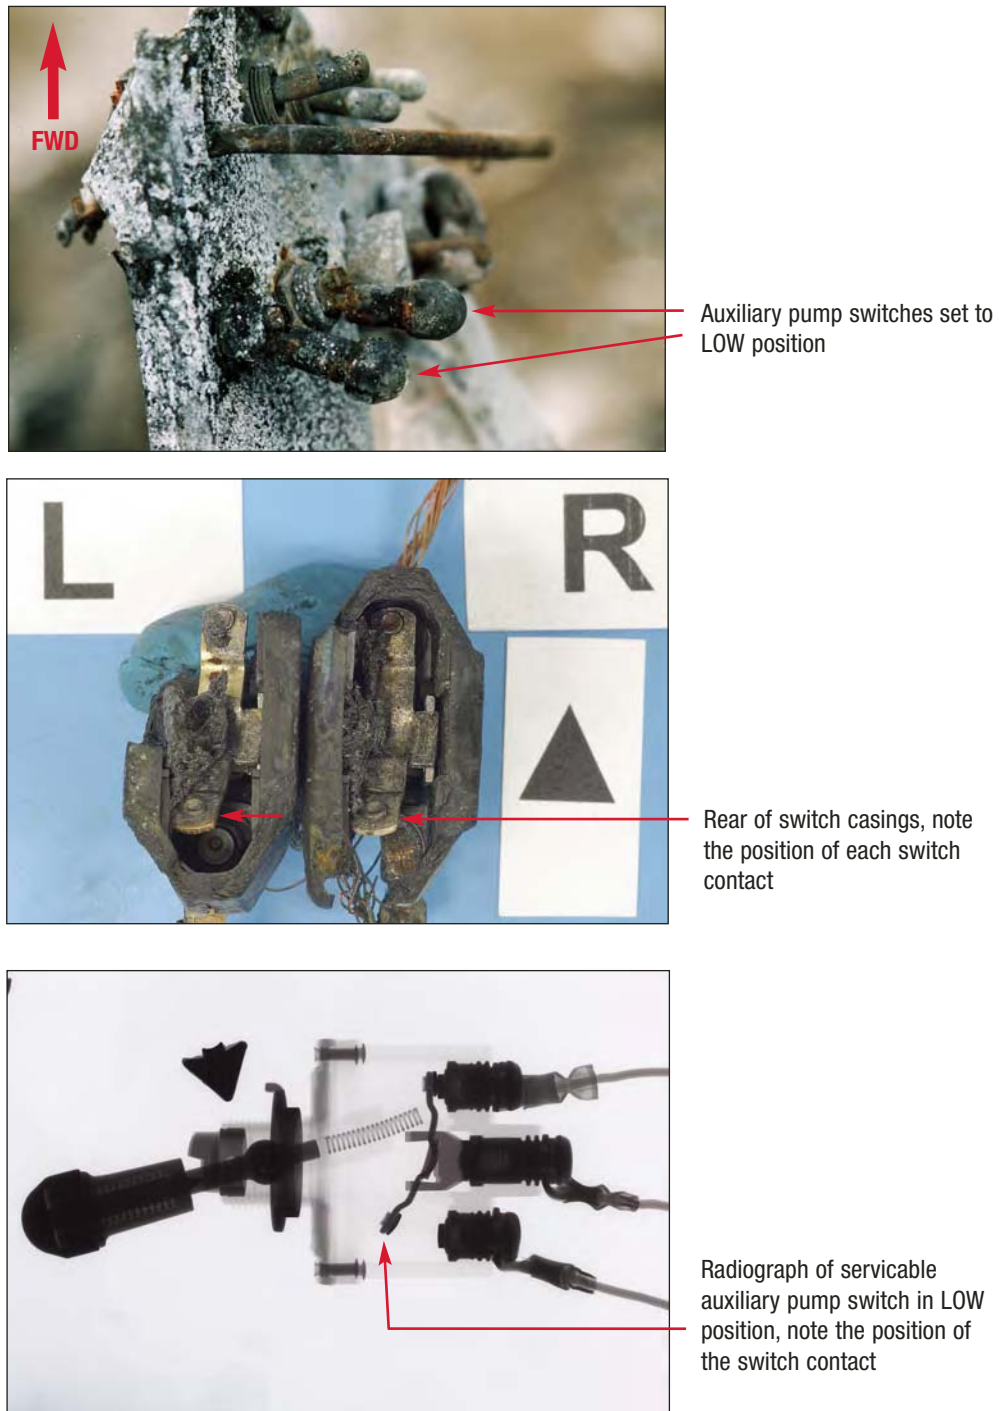
FIGURE 5: Auxiliary pump switch position and comparison with serviceable switch

Technical examination of switch fragments from the left and right auxiliary fuel pumps confirmed that both switches were in the LOW position at the time of the post-impact fire (see Figure 5).

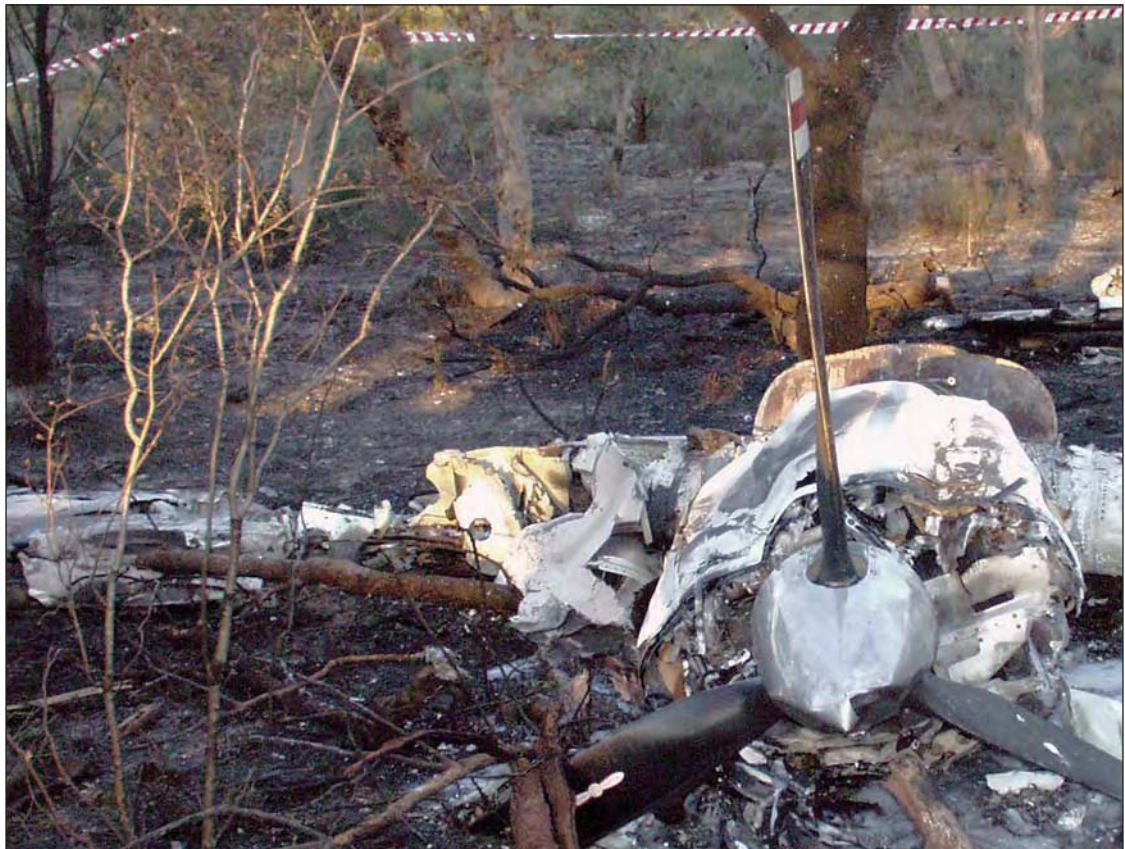
FIGURE 6: Right propeller¹⁹

Examination of the propeller from the right engine confirmed that the blades were in the feathered position at the time of impact. That was consistent with the observed position of the cockpit control lever and the pilot's recollections of having feathered the propeller of the right engine (see Figure 6).

¹⁹ Separation of the pitch-change mechanism of one blade had allowed it to rotate from the feathered position. That damage was assessed as having occurred during the impact sequence.

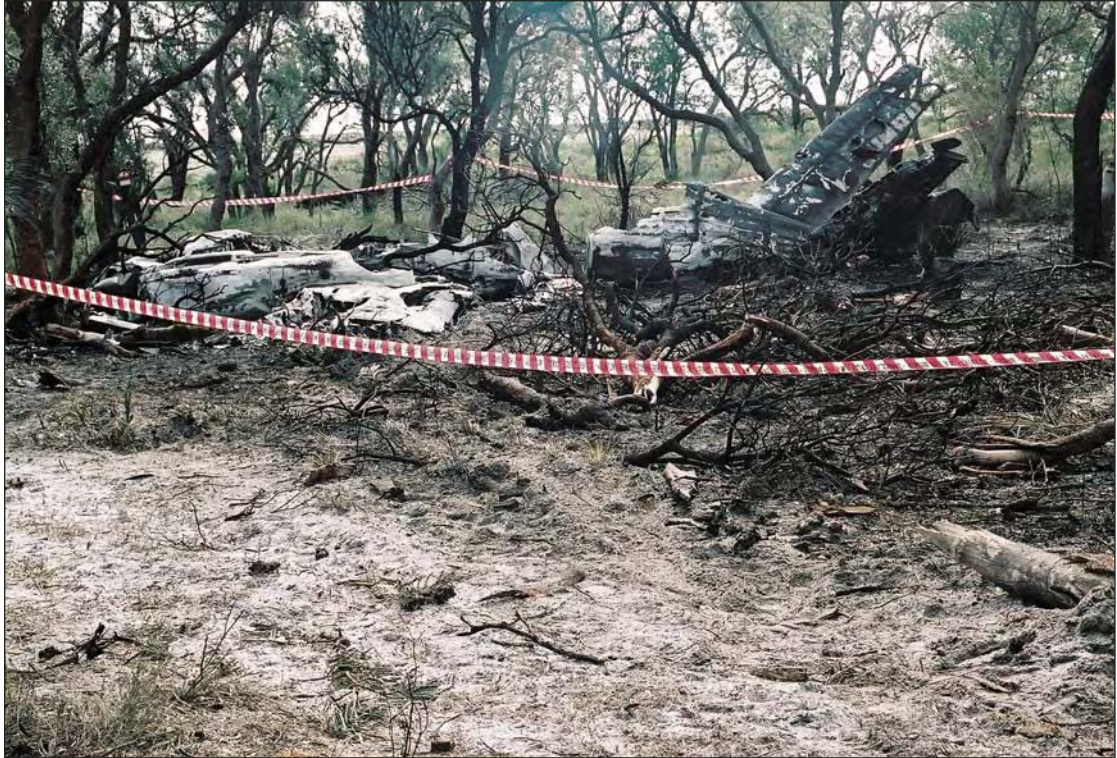
FIGURE 7: View of aircraft wreckage

There was no evidence of an in-flight fire. During the impact sequence, the aircraft's fuel tanks were ruptured and a large amount of fuel spilled and ignited. Avgas is a volatile and highly flammable hydrocarbon aviation fuel. Temperatures produced by an aviation fuel-fed ground fire are typically in the range of 870 to 1,100 degrees C. Fire had consumed most of the aircraft's structure before the fire was extinguished by emergency services (see Figure 7).

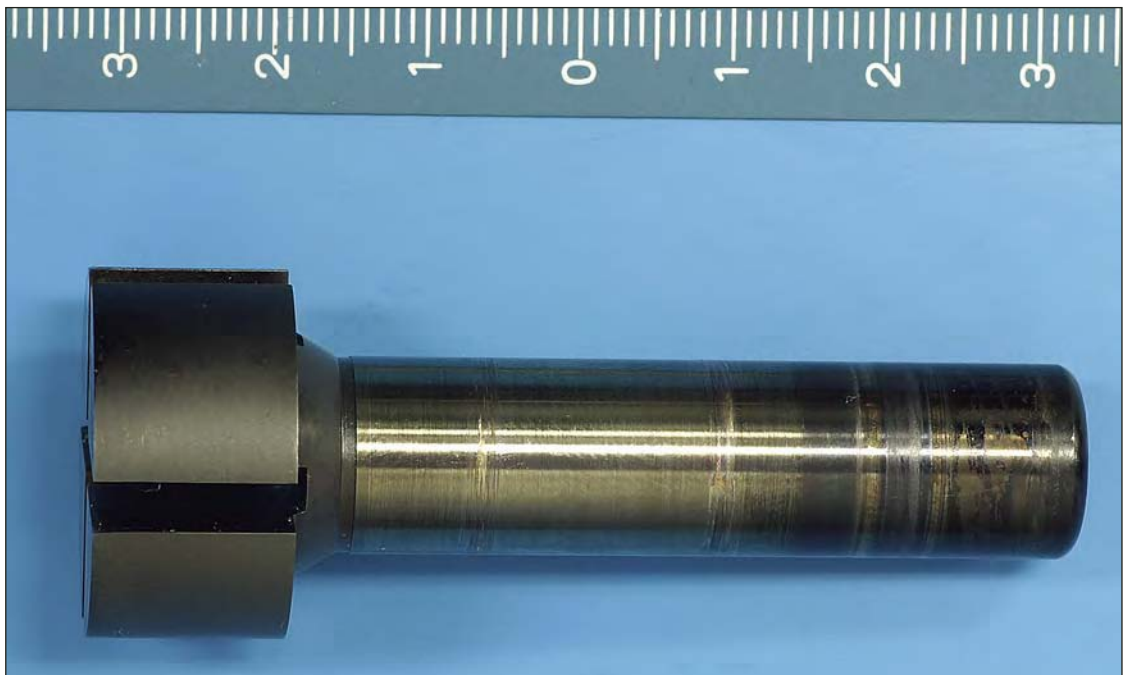
FIGURE 4: Right EDFP spindle shaft, as removed from the pump body

The pump shaft (see Figure 4) exhibited some staining and blackening around the driven end and two circumferential bands of galling⁴⁷ and pick-up of metal from the sleeve bearing (see Figure 5). Between those areas, the shaft surfaces appeared sound and undamaged, with no other indications of anomalous operation.

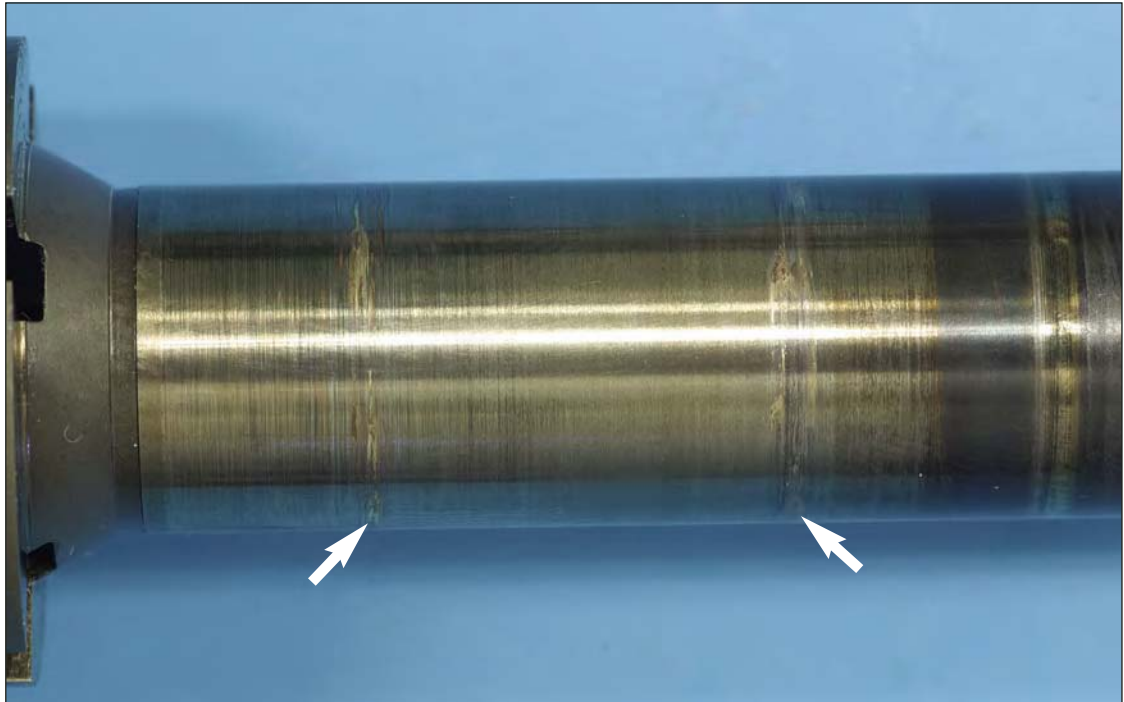
FIGURE 5: Right EDFP spindle shaft, with the two localised areas of galling damage indicated

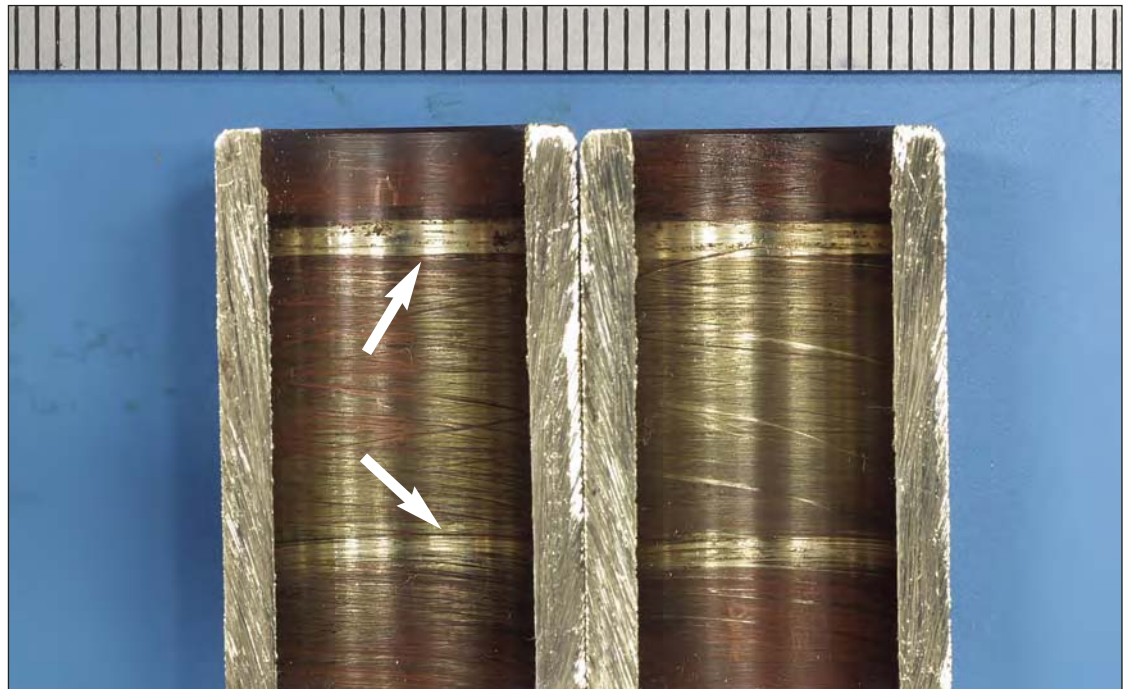
Removal and axial sectioning of the sleeve bearing revealed two bands of galled and polished material that corresponded with the galled areas identified on the surface of the spindle shaft (see Figure 6). Both bands were localised and equidistant from the inner and outer ends of the sleeve bearing. The internal running surfaces of the sleeve bearing presented a generally coarse, spiral honed finish with a pronounced copper colouration between the galled bands (figure 7).

FIGURE 6: Right EDFP sleeve bearing, sectioned to show the internal condition

Note the polished bands corresponding with the areas of galling on the spindle shaft

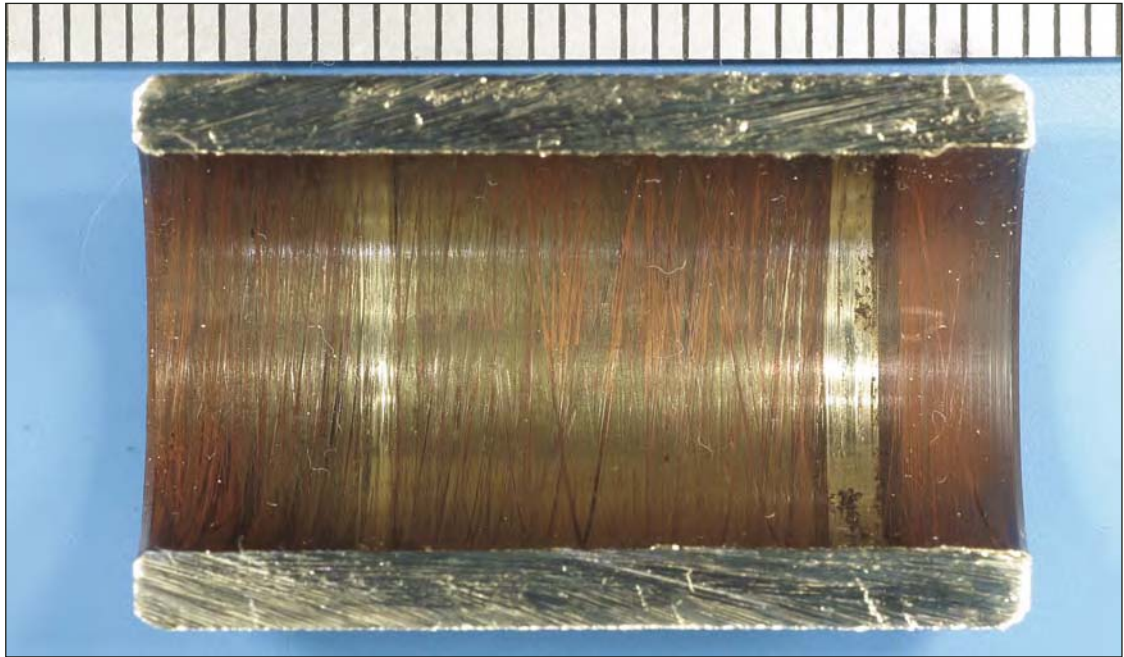
FIGURE 7: Right EDFP sleeve bearing half showing the general coarse honed surface finish

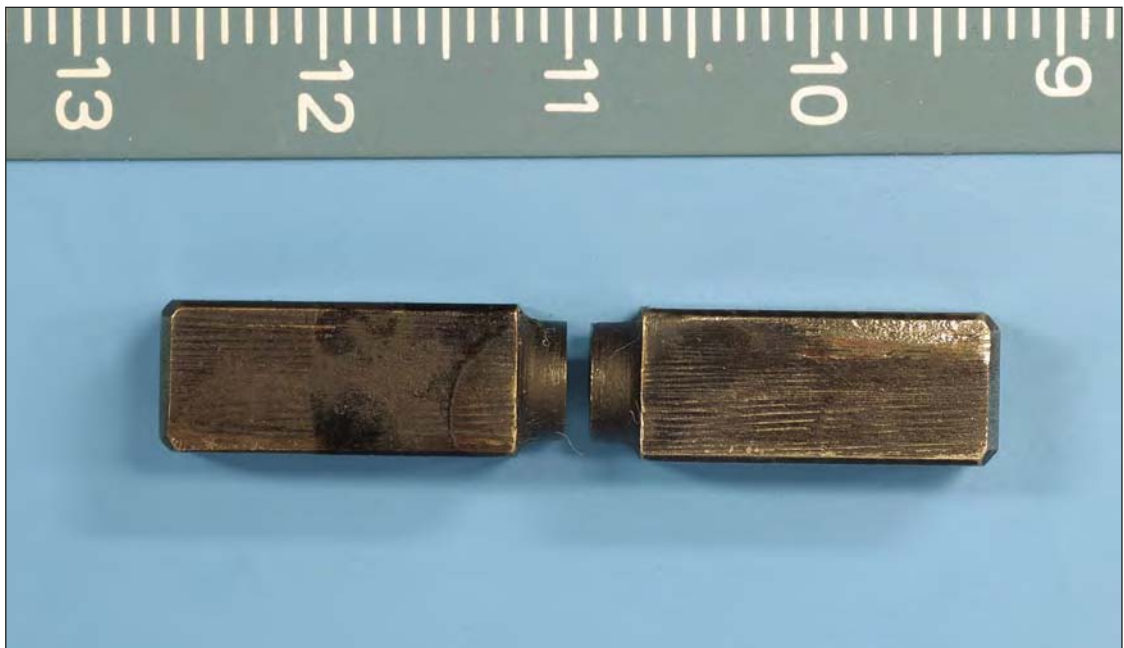
The fuel pump was coupled to the engine through a square drive pin that contained a central reduced section shear point (see Figure 8). That shear point was designed to protect the engine accessory drive train from damage by disconnecting the pump in the event of any failure that increased pump drive loads. Examination of the drive pin indicated that it had failed transversely through the shear point and exhibited uniform fracture surfaces. Low-power microscopic study of the fractures revealed a faint light brown staining on the pin half that originated on the pump-side of the drive connection (see Figure 9), with similar staining noted on the sides of the pin that protruded from the pump shaft when installed on the engine (see Figure 10). The staining and discolouration was notably absent on those surfaces of the pin that were engaged within or otherwise protected by the coupling assembly (see Figure 11).

FIGURE 8: Fractured drive pin as recovered from the right EDFP

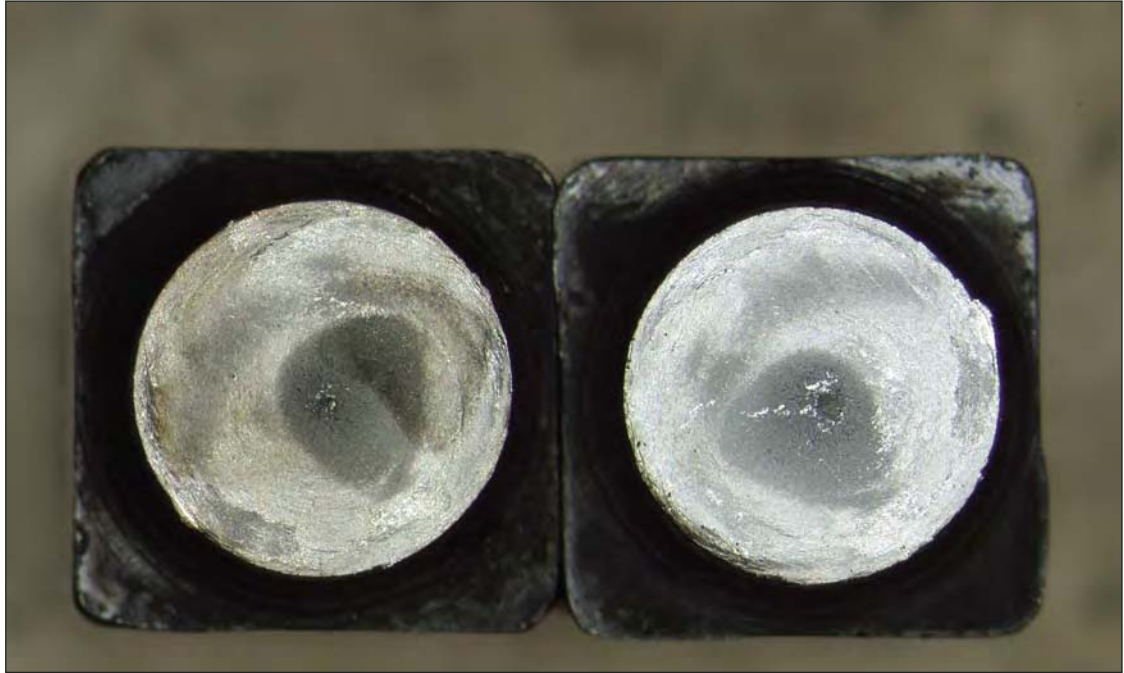
FIGURE 9: Fracture surfaces of the drive coupling

Note the light staining over the left fracture features

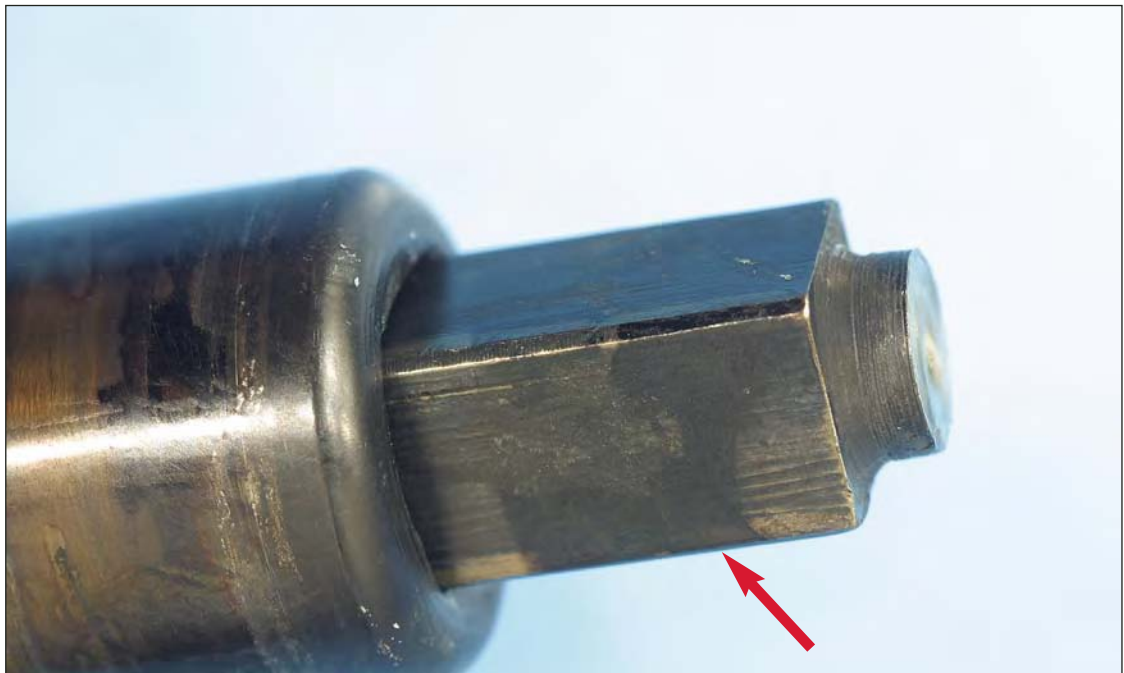
FIGURE 10: Staining and discolouration on the sides of the drive coupling

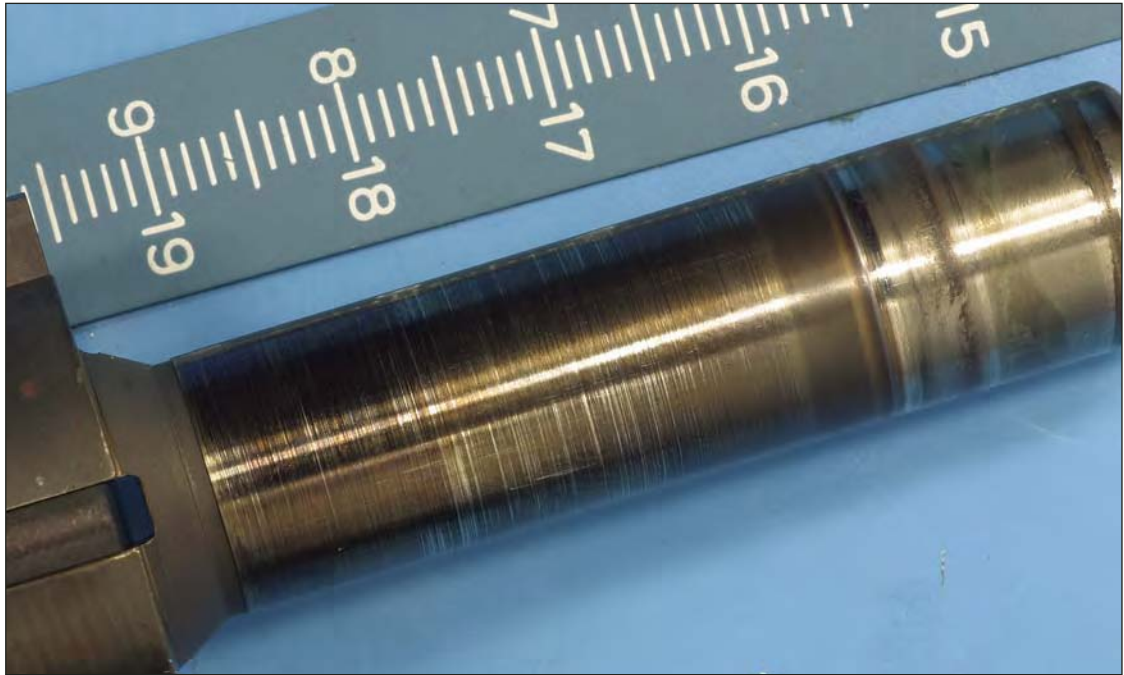
The basic components from the left EDFP were examined and compared with the components from the right EDFP. Components from the left pump generally exhibited greater evidence of heating and discolouration from the post-impact fire, particularly in regard to the discolouration and tinting of the pump shaft and associated components. The pump vanes, thrust plates and chamber liner were intact and in a similar condition to the items from the right EDFP. None of the components showed any mechanical damage, distress or features that may have suggested anomalous operation or the ingress of foreign materials or contaminants.

FIGURE 12: Left EDFP spindle shaft with light scoring, but no surface galling or pickup

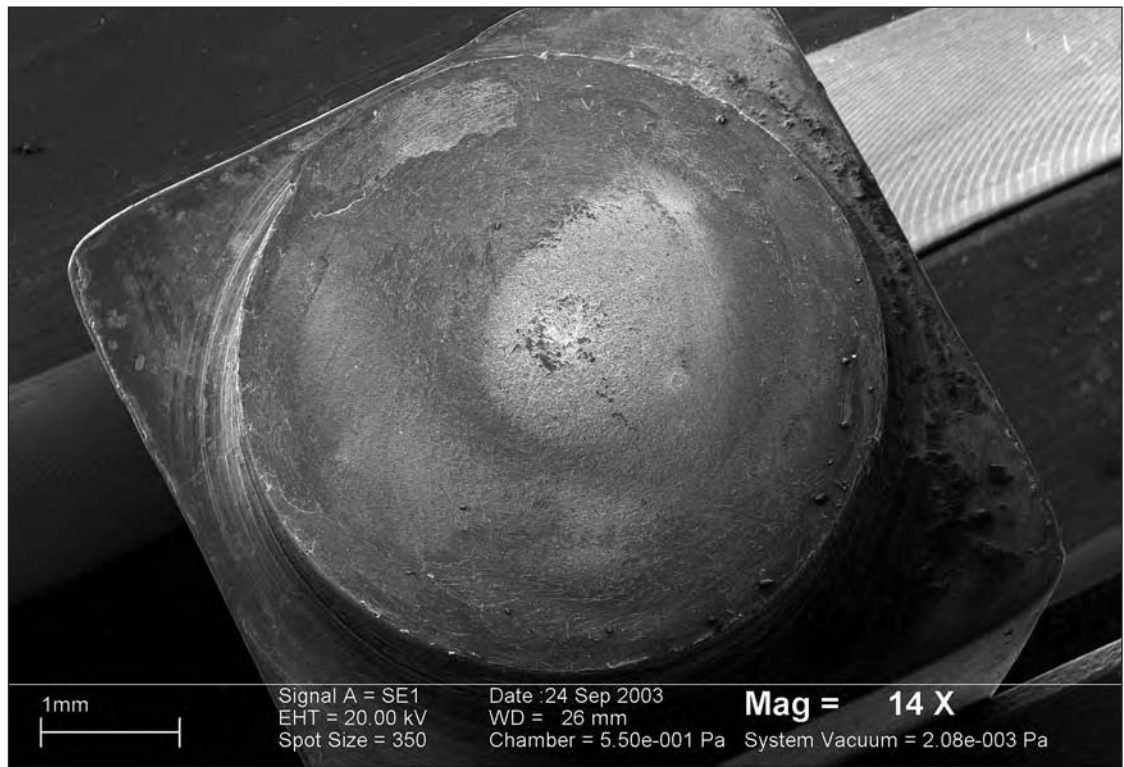
FIGURE 13: SEM image of the drive coupling fracture surfaces – features typical of torsional shear overload

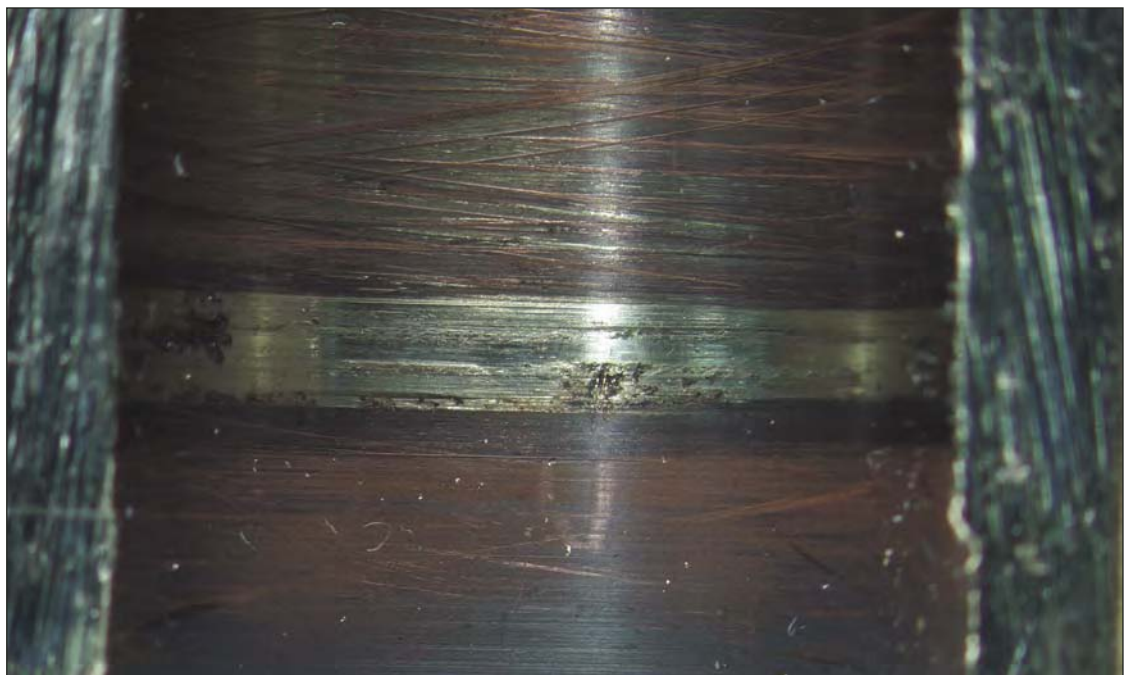
FIGURE 14: Close view of the localised damage exhibited by the right EDFP sleeve bearing

Note the circumferential flow of the polished band

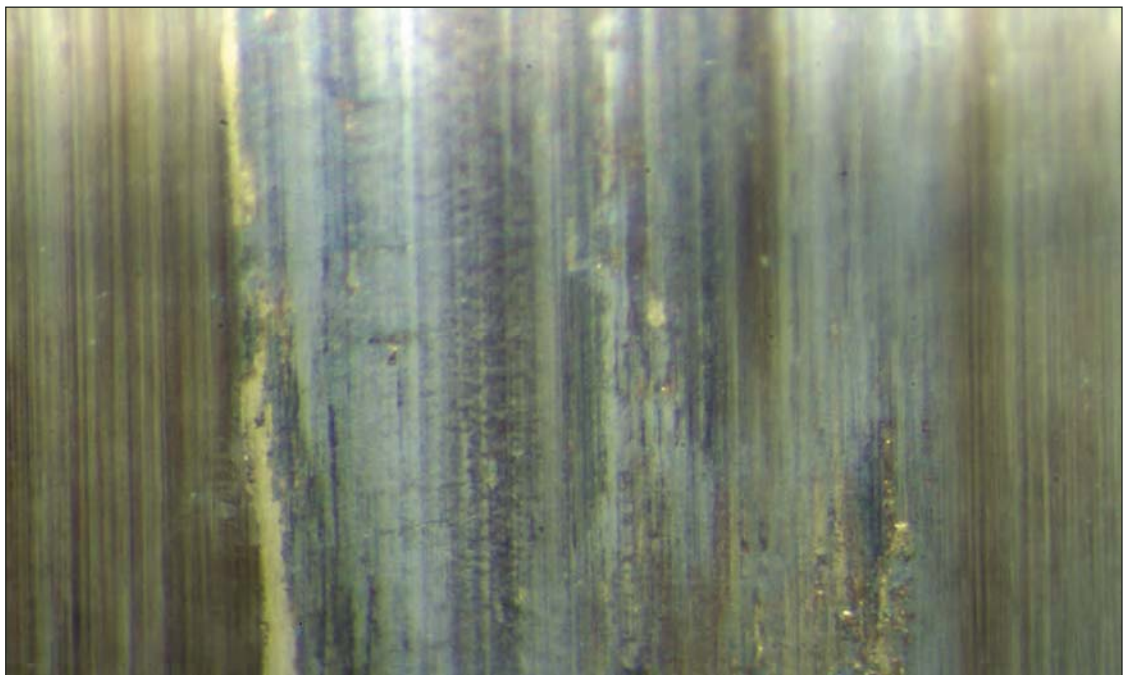
Closer inspection revealed indications of multiple, regularly spaced cracks extending across some of the more heavily galled areas (see Figure 16), with an associated general surface discolouration, typical of frictional heat tinting.

FIGURE 16: Low power optical microscope view of the damaged area shown above

Note the discolouration effects typical of frictional heating

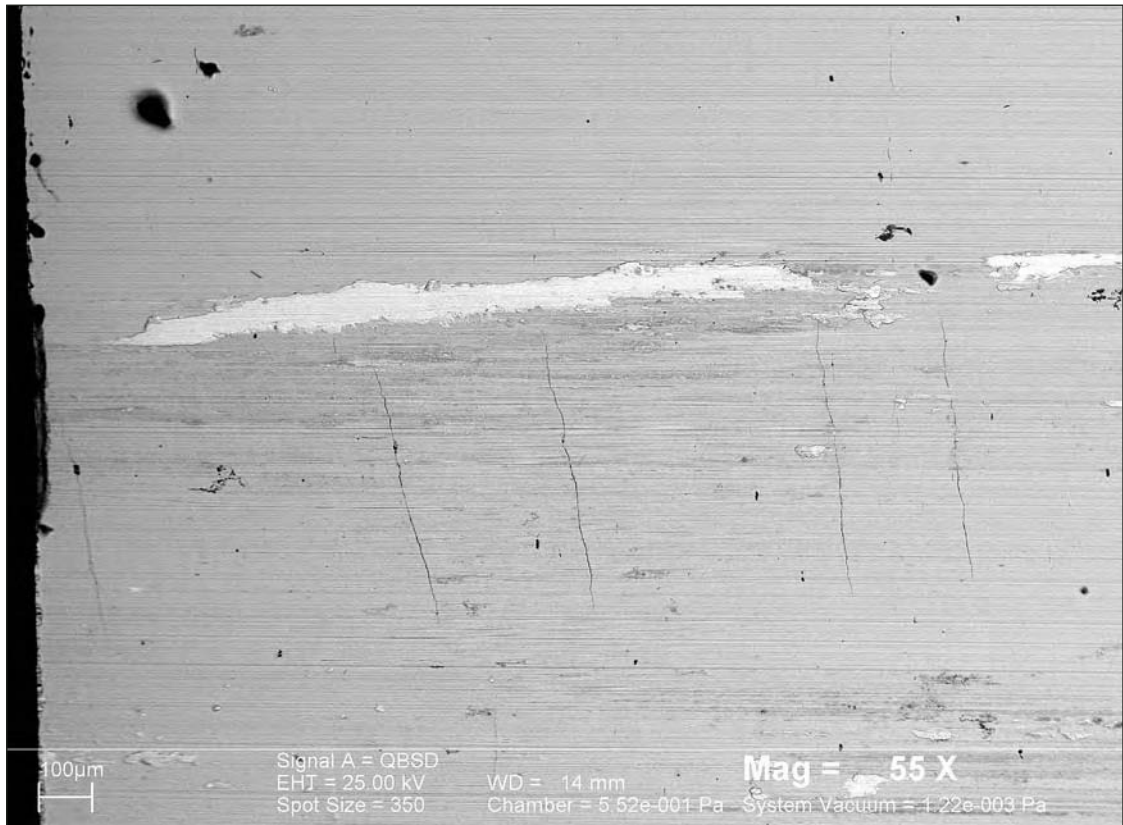
The presence of surface cracking was confirmed when examined under the SEM (see Figure 17), with the regularity in spacing and length of the cracks indicating their formation as thermal ‘checks’ i.e. stress relief cracks formed as a consequence of localised thermal heating and cooling of brittle materials.

FIGURE 17: Electron microscope image of the area above

Note the characteristic thermal stress relief cracks running across the area of galling damage

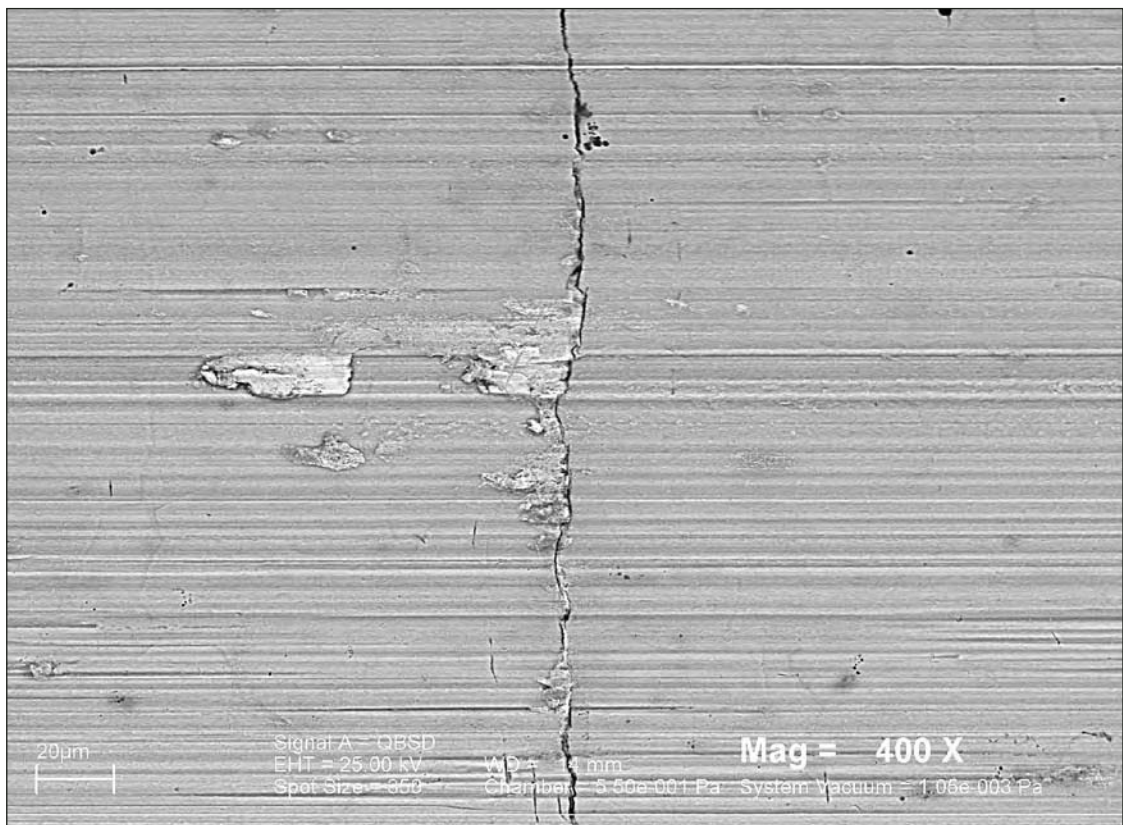
At higher magnifications, several of the cracks displayed the pickup and adhesion of bearing material intermittently along the crack length (see Figure 18).

FIGURE 18: Higher magnification SEM view of a thermal crack in the spindle shaft

Note the collection and pickup of material within the crack

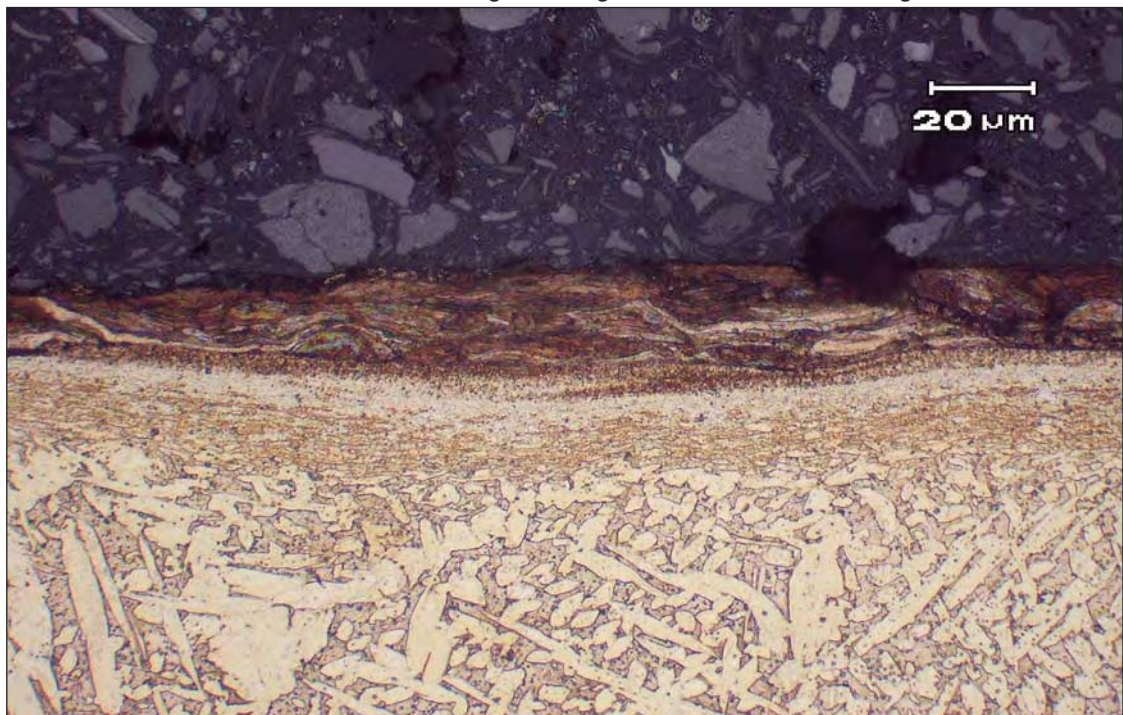
The areas of galling and seizure at the running surface of the bearing were characterised by a twenty micron deep layer of heavily flowed and worked alloy, above a similar thickness of compressively distorted grains with some evidence of partial thermally induced microstructural transformation (see Figure 21).

FIGURE 21: Microstructural cross-section through a damaged area on the sleeve bearing surface⁵³

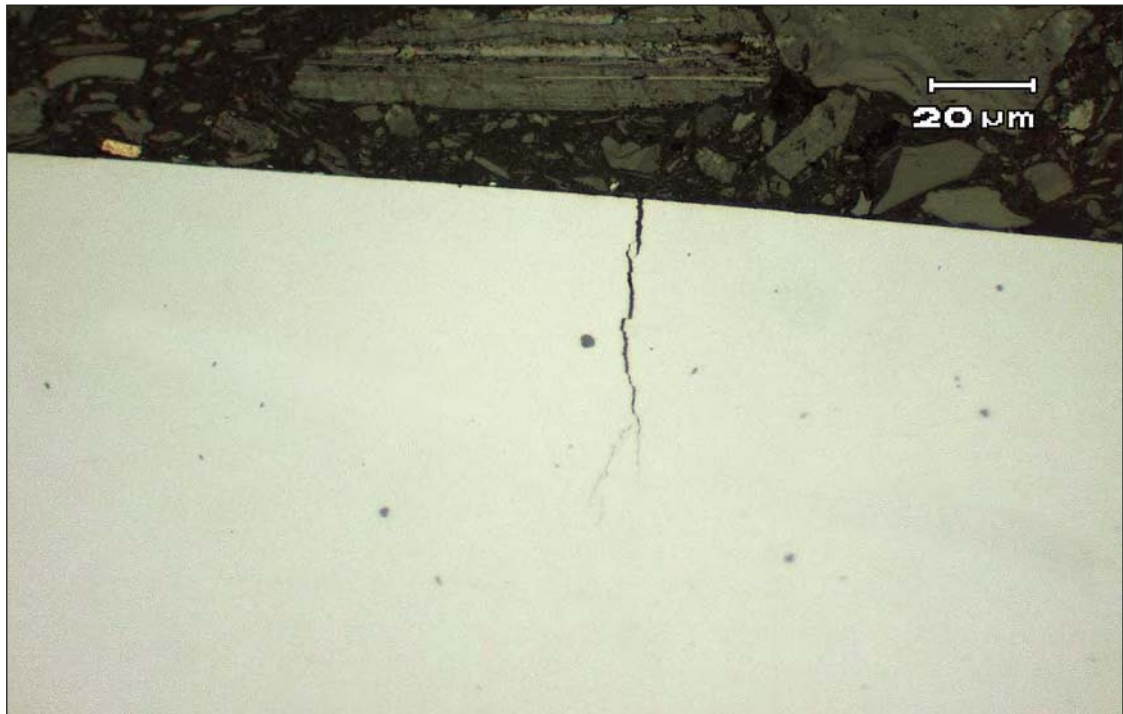
The transverse section through the galled surface areas confirmed the presence of the surface cracking as observed under the SEM. Several shallow cracks were observed (see Figure 24), extending to a typical depth of around 40 to 50 μm . Those cracks were contained entirely within the darker etching, surface-hardened layer (see Figure 25). In some areas, the cracking showed intergranular propagation.

FIGURE 24: Cross section through the area of thermal cracking on the surface of the right EDFP spindle shaft⁵⁶

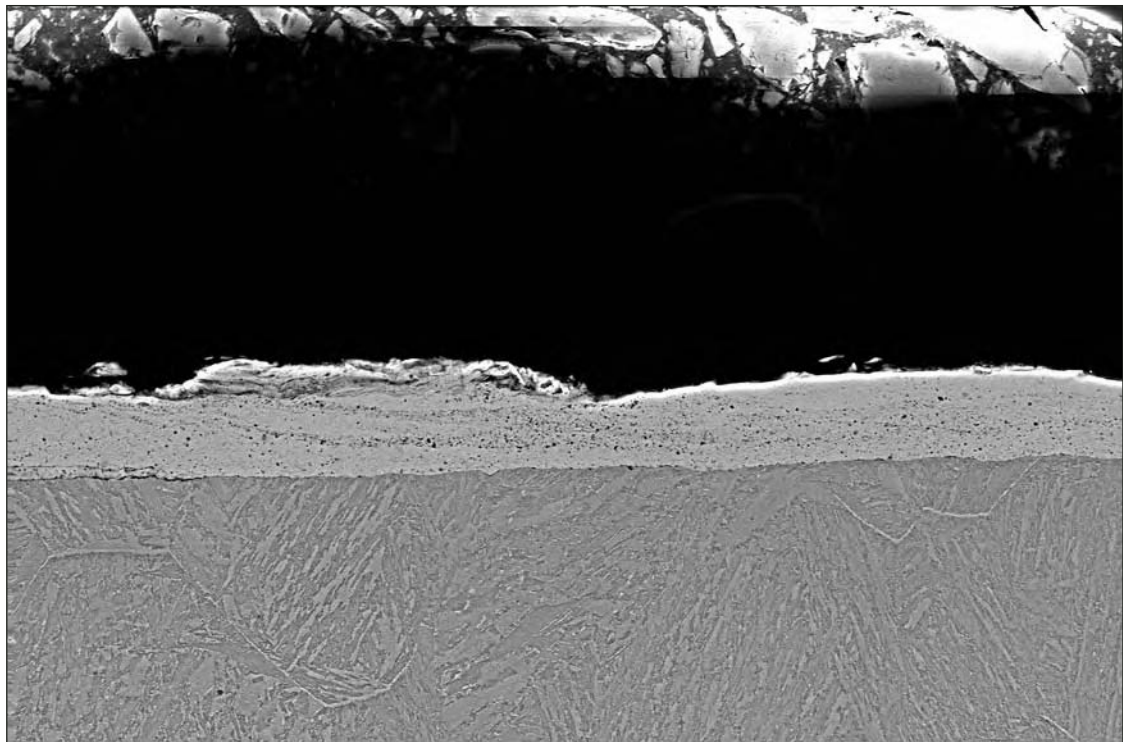
Electron microscopy of areas that had sustained partial seizure and surface damage showed a 5 to 10 μm deep surface layer of the bronze alloy, which had been galled away from spindle bearing (see Figure 26).

Figure 26: Electron microscope image of the surface of the spindle shaft, showing the adhesion and pickup of bronze alloy from the sleeve bearing
