**Air Safety Occurrence Report
200305235**

**Boeing Co
737-700**

**SOCATA – Group
Aerspatiale
Tobago**

24 December 2003

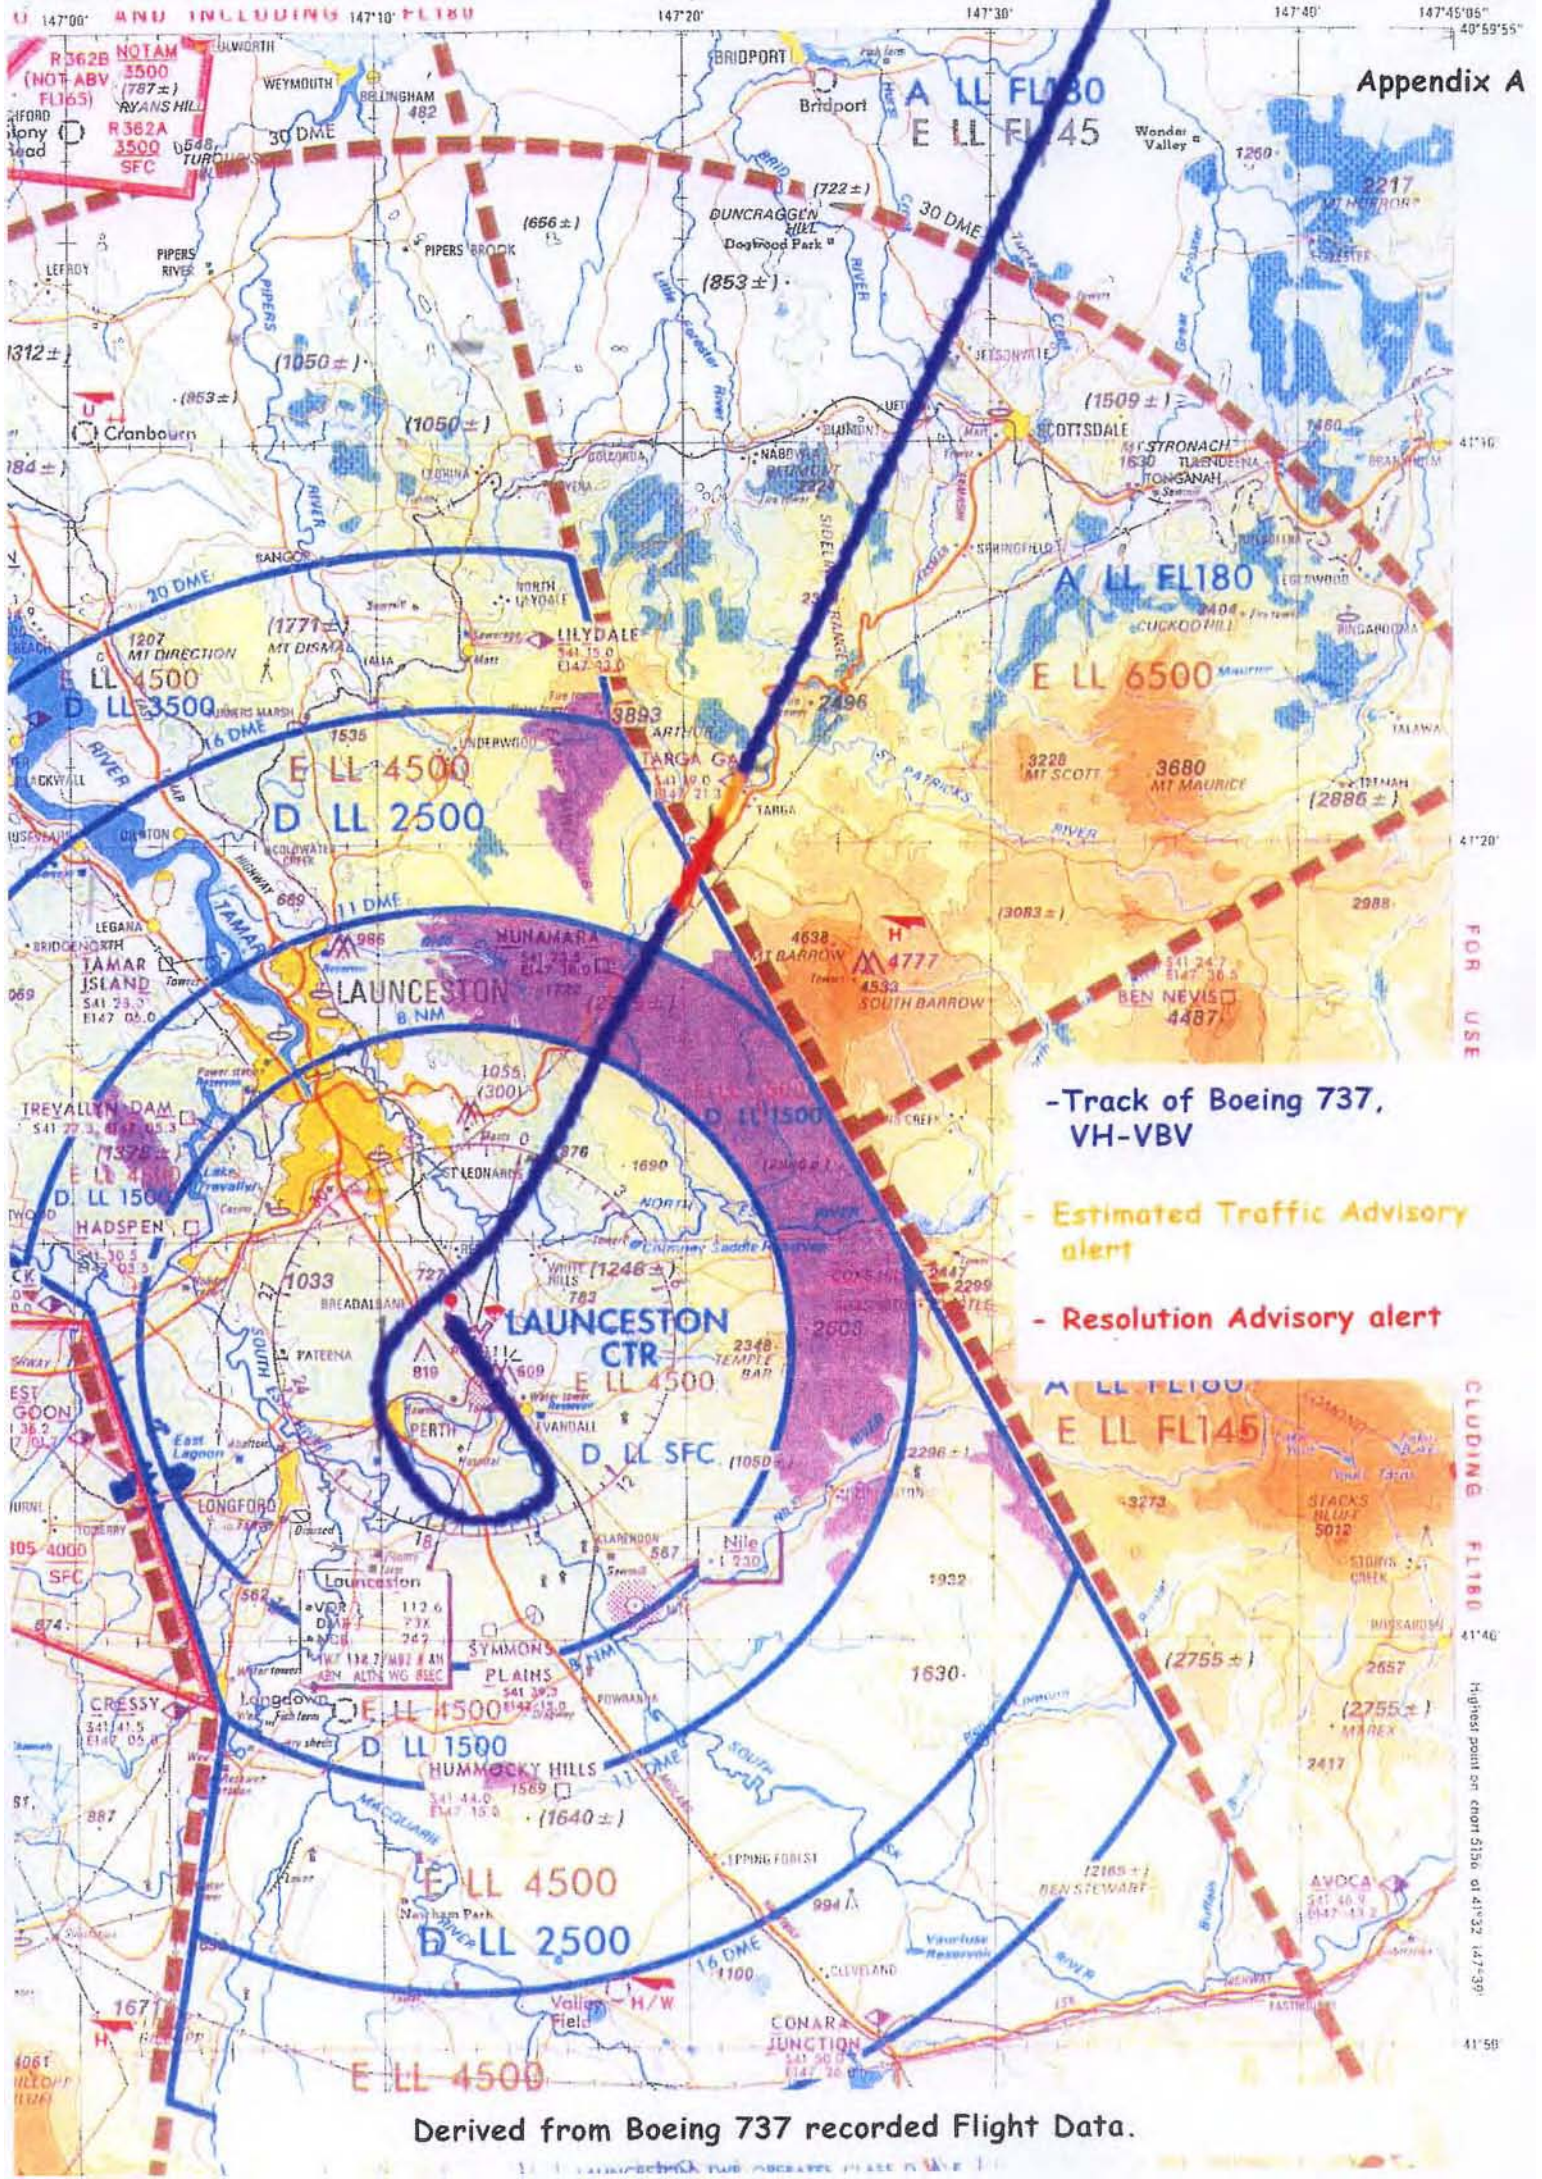
- Track of Boeing 737, VH-VBV
- Estimated Traffic Advisory alert
- Resolution Advisory alert

Derived from Boeing 737 recorded Flight Data.

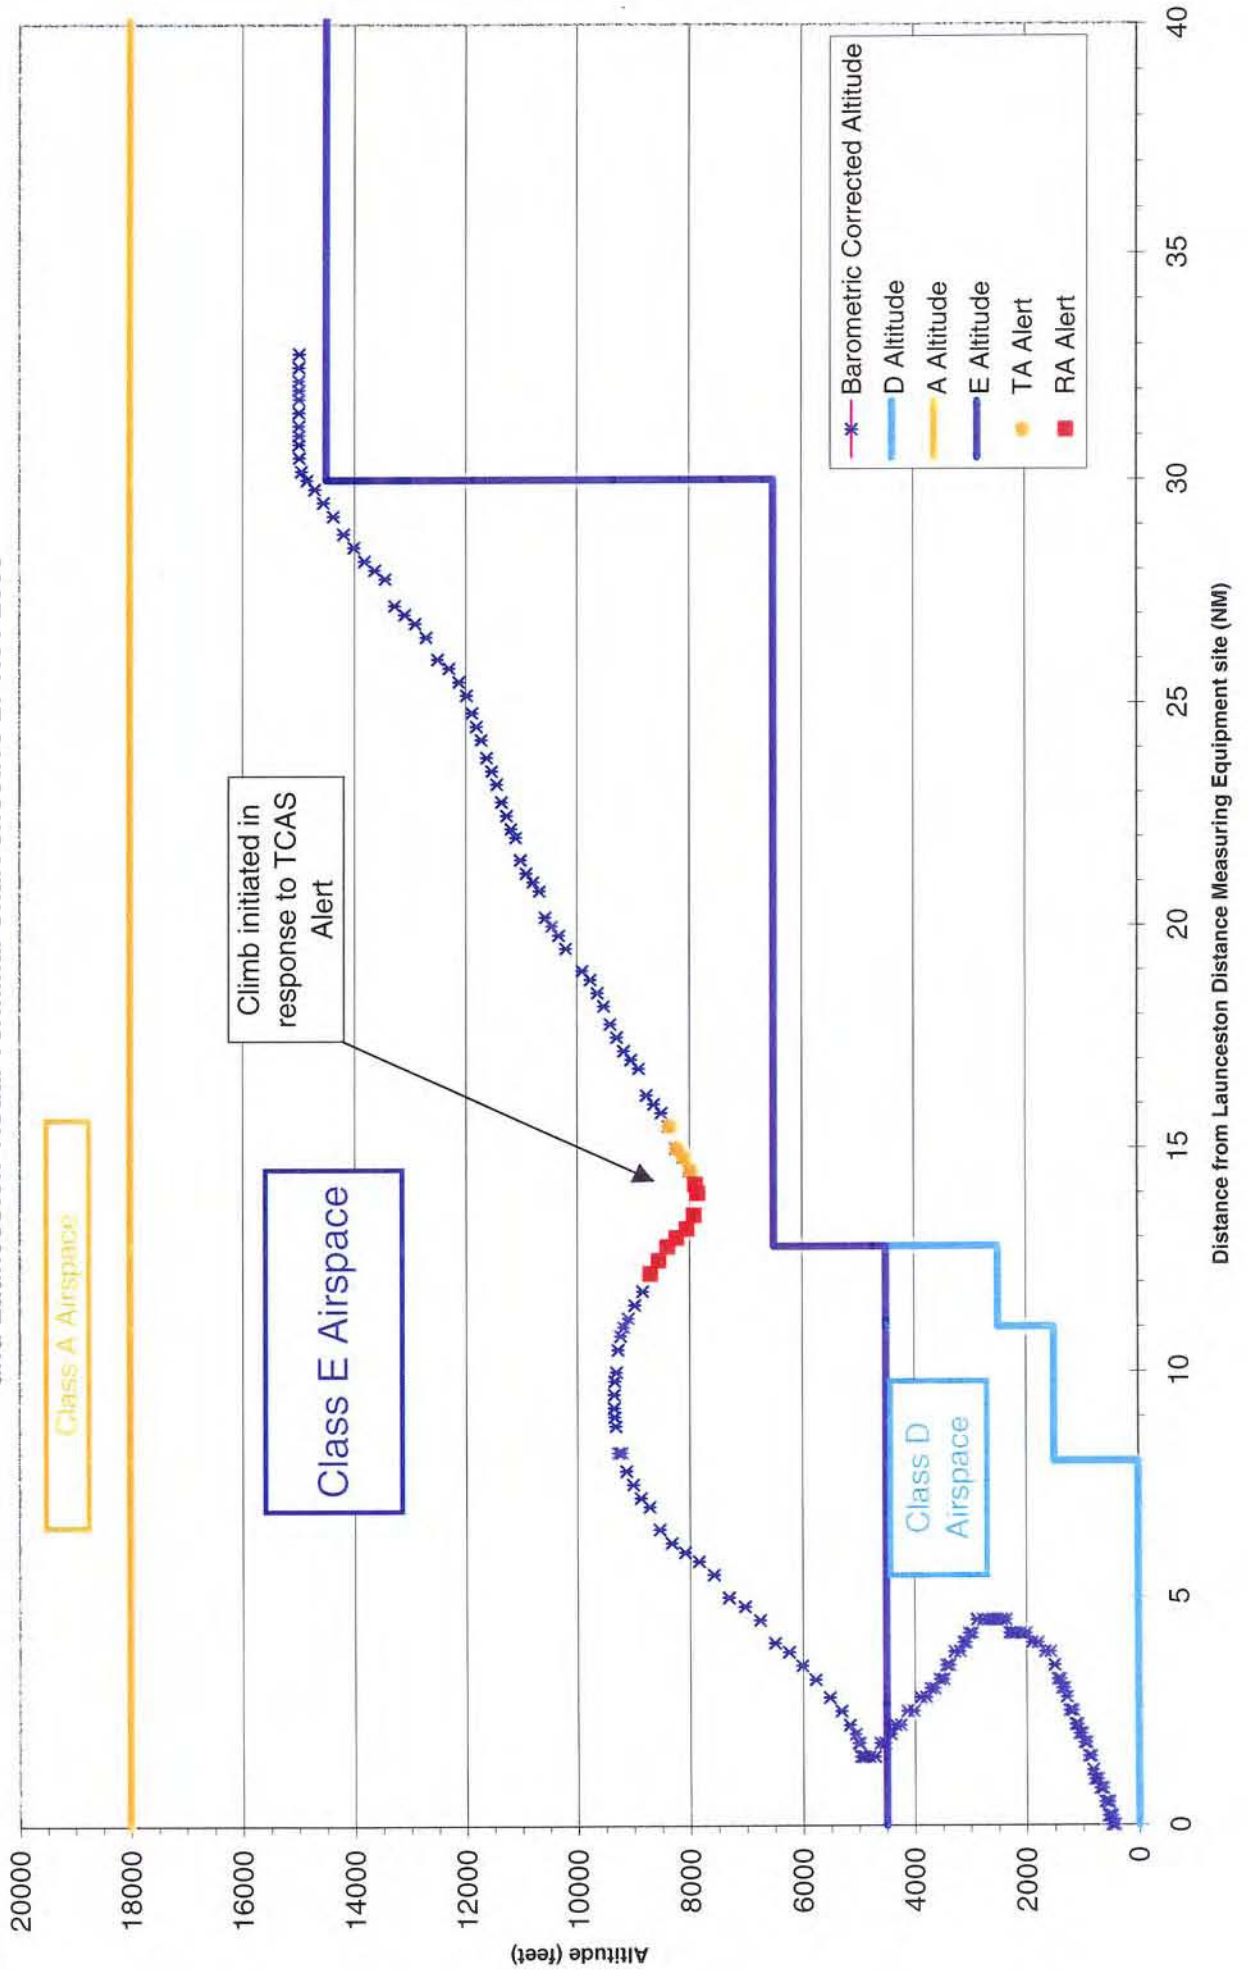
VH-VBV Boeing 737 approach to Launceston on Airways Route J22
 Airspace boundaries are as represented on EnRoute Chart Low, ERC L1,
 and Launceston Visual Terminal Chart effective 27 Nov 2003

From 27 November 2003, the airspace in which the 737 and Tobago were operating at the time of the occurrence was classified as Class E airspace (see Appendix B). In the Class C airspace operative prior to 27 November (see Appendix C), both aircraft

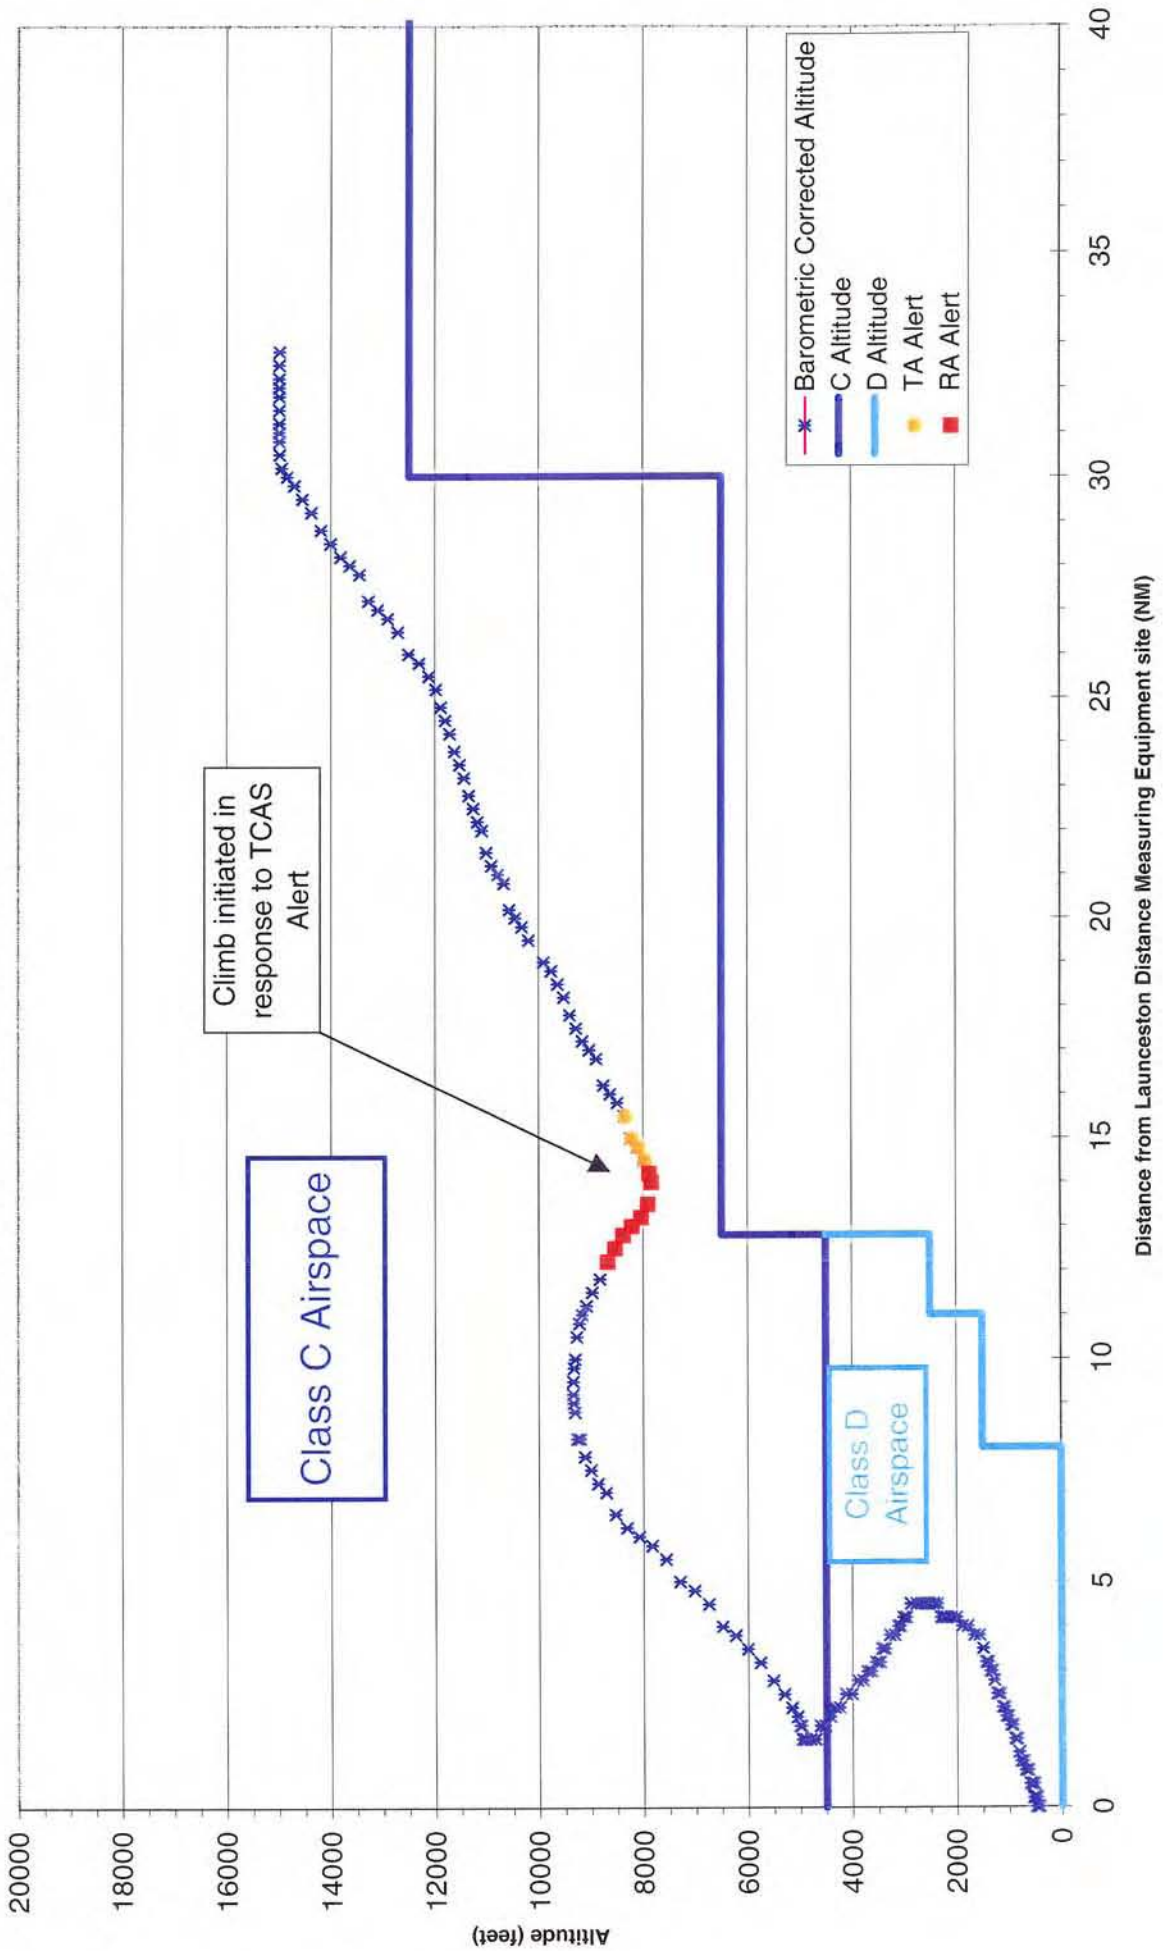
VH-VBV Boeing 737 approach to Launceston on Airways Route J22
Airspace boundaries are as represented on EnRoute Chart Low, ERC L1,
and Launceston Visual Terminal Chart effective 12 Jun 2003

would have been subject to an ATC airways clearance and would have been separated in accordance with prescribed standards.
