ATSB TRANSPORT SAFETY INVESTIGATION REPORT

Aviation Safety Incident Report – 200403110

**Engine failure - Melbourne Airport, Victoria
25-Aug-2004
Boeing Company 777-312
9V-SYB**

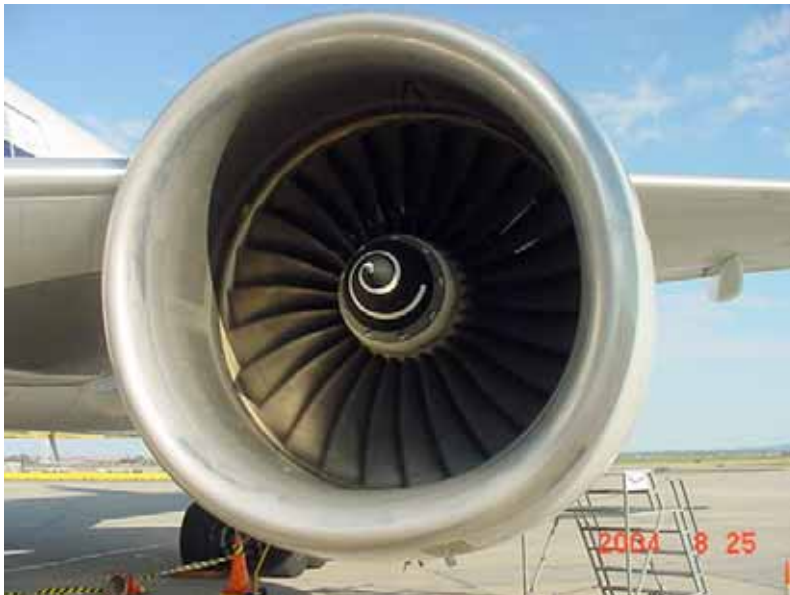
The Australian Transport Safety Bureau (ATSB) dispatched an investigation team to Melbourne to examine the aircraft, where no obvious external damage was evident (Figure 1). The ATSB examination revealed that one of the left engine's composite core panels had broken and separated from the engine during the engine surge (Figure 2). The left engine, a Rolls-Royce Trent 800, Serial number 51067, exhibited only minor damage to a number of components. A borescope inspection of the engine compressor section revealed no significant anomalies with the engine compressor or turbine rotors or stators.

Figure 1: Trent 800 engine S/No. 51067 fitted to the left position of 9V-SYB

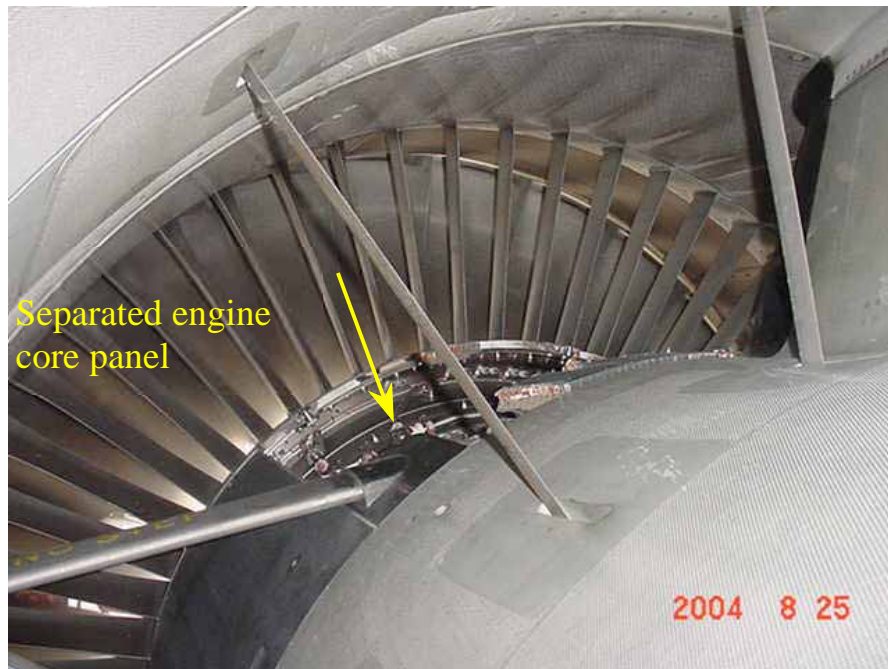
Figure 2: Separated composite engine core panel in cold stream duct

The failed engine core composite panel was secondary to the engine surge event and did not contribute to the engine failure.

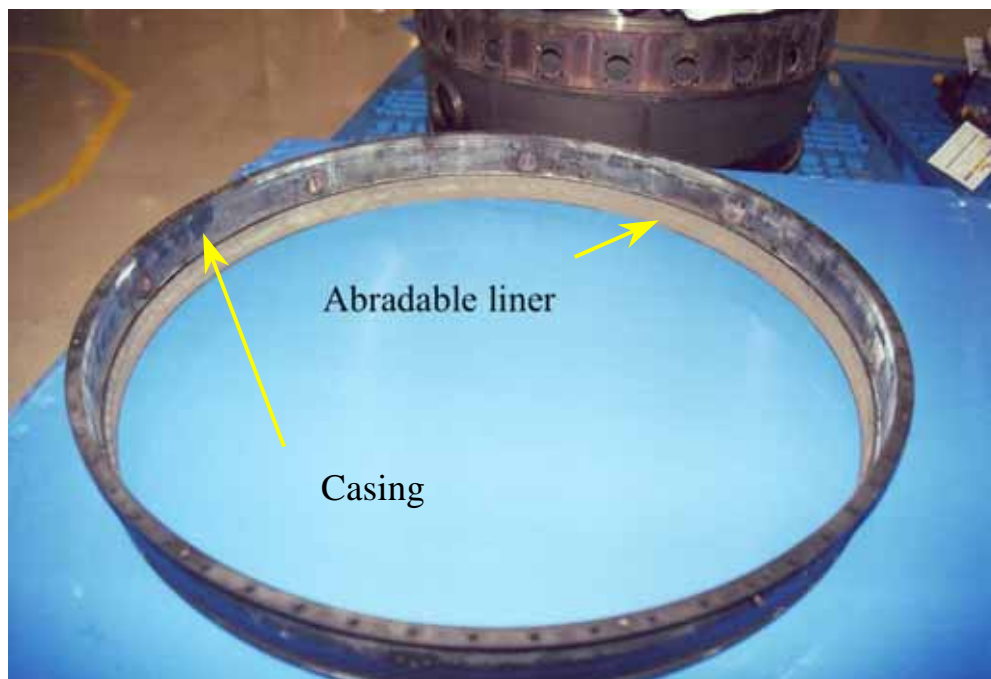
The engine examination revealed that the high pressure compressor (HPC) casing abrasion linings had deteriorated in service. There was a visible loss of abrasion rotor lining on several of the HPC compressor casings (Figures 4 and 5). The engine manufacturer advised that the HPC stage-6 casing-to-rotor clearance was critical to engine airflow control at the take-off thrust setting.

Figure 4: HPC stage 6 casing and liner assembly

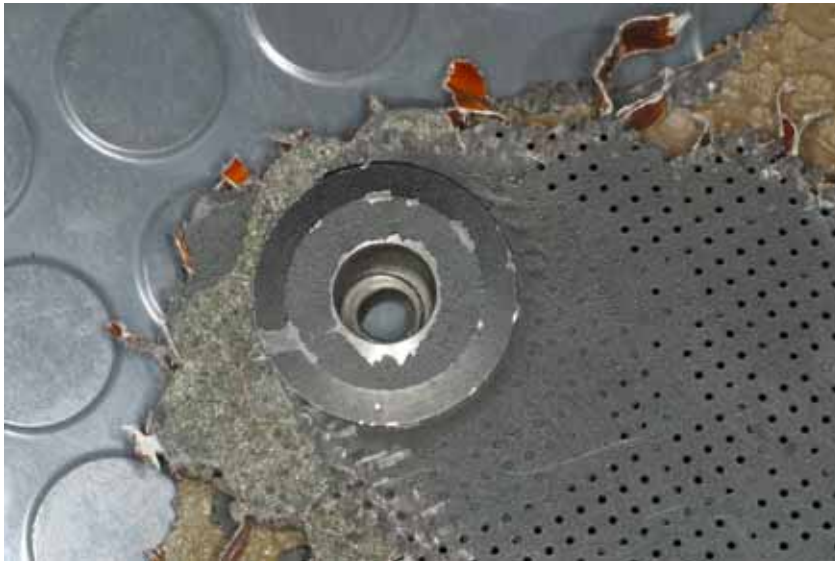
An examination of the separated engine core composite panel indicated that all the panel fasteners were retained in their mounts after the panel failed (Figure 6). One fastener hole showed signs of wear, but there was no direct evidence to suggest that the fitting was loose at the time of the failure (Figure 7). It was apparent from wear in the fastener fitting that it may have been loose previously, and that this looseness may have contributed to some prior weakening of the panel structure, which contributed to the panel failure during the engine surge event.

Figure 6: Typical composite panel failure around mounting point

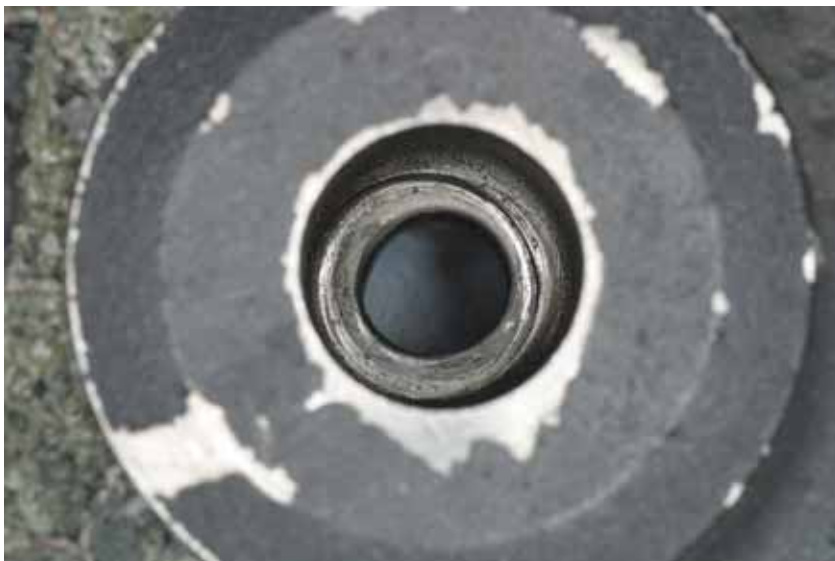
Figure 7: Elongated fastener hole showing signs of wear

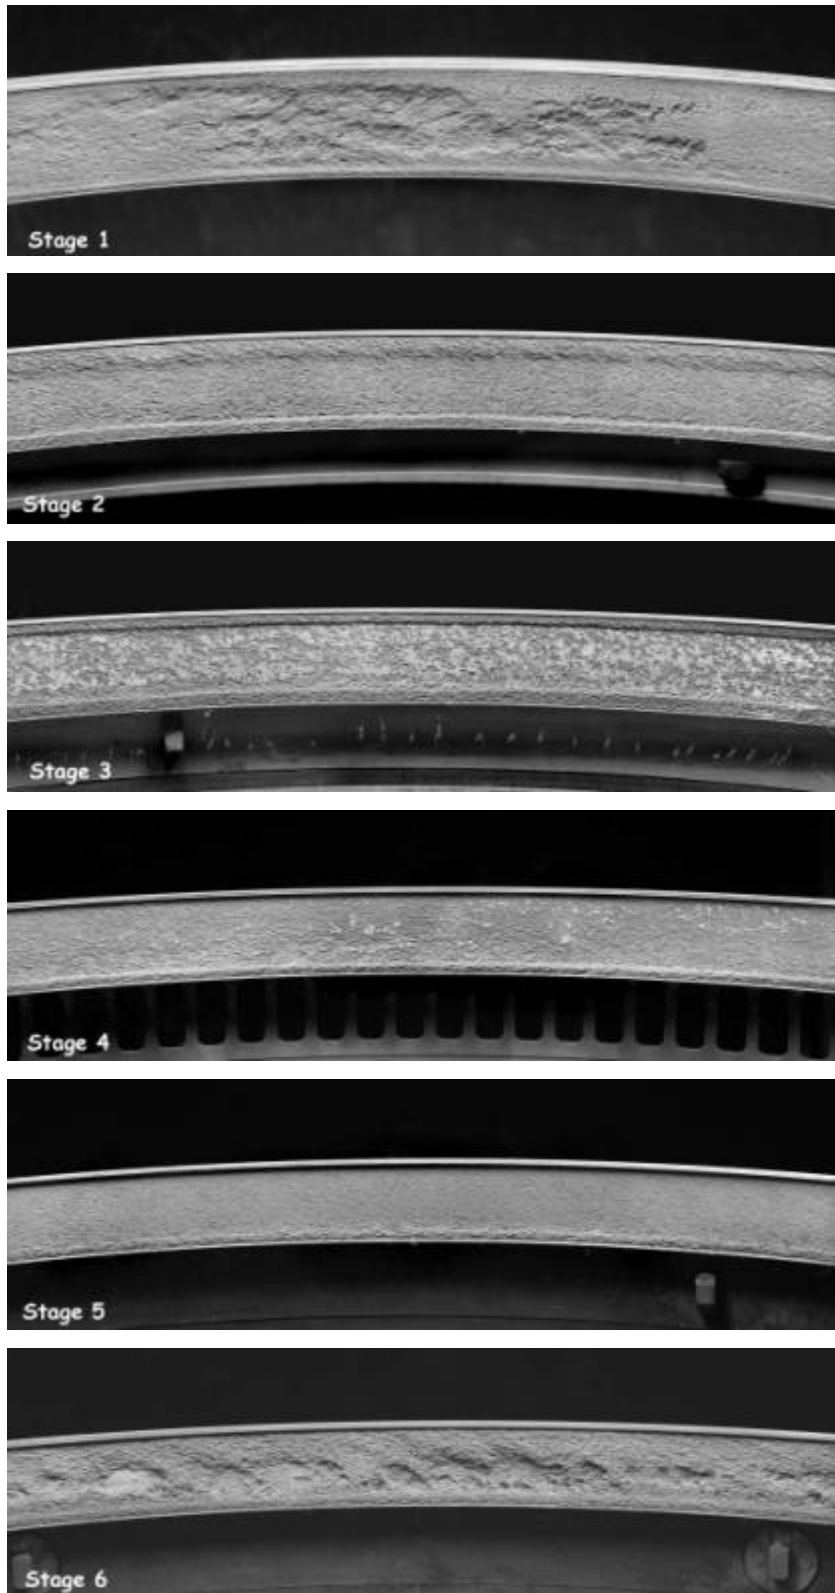
Figure 1 shows the casings. The degree of abradable loss varied from stage to stage but none of the stages showed any signs of cracks in the coating or evidence of gouges from entrapped material.

Figure 1 General view of the HPC casings

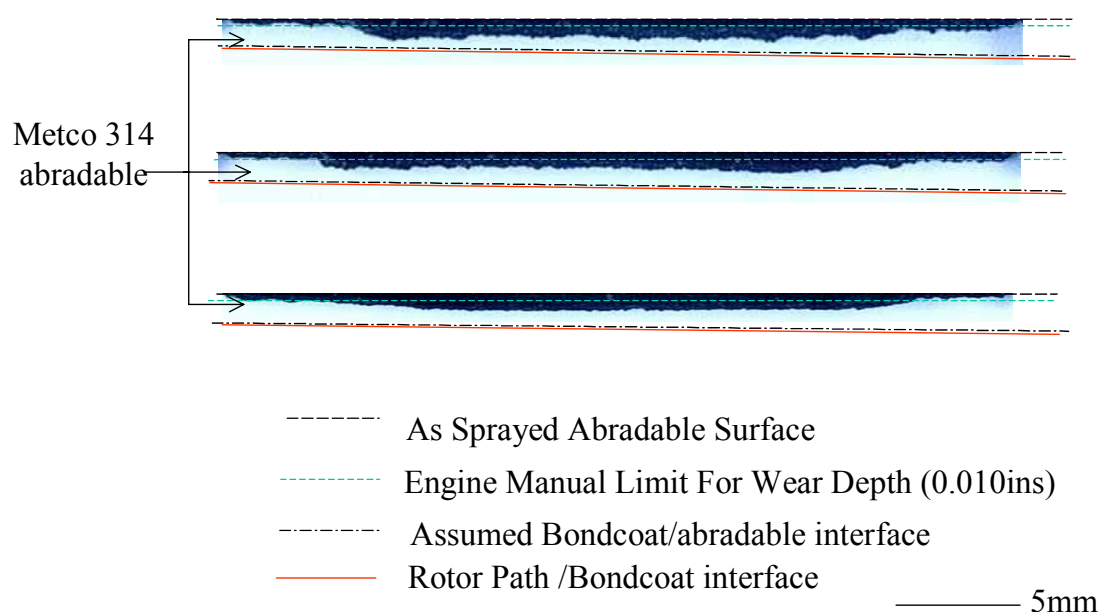
Stage 2 Rotor Path Replica Cross-Sections

The dark regions in the three views above are cross-sections through the synthetic rubber replicas of the abrasible rotor path liner surface at three positions 120° apart. They therefore represent what is missing from the abrasible liner. The light regions labelled Metco 314 abrasible are therefore what remains of the abrasible

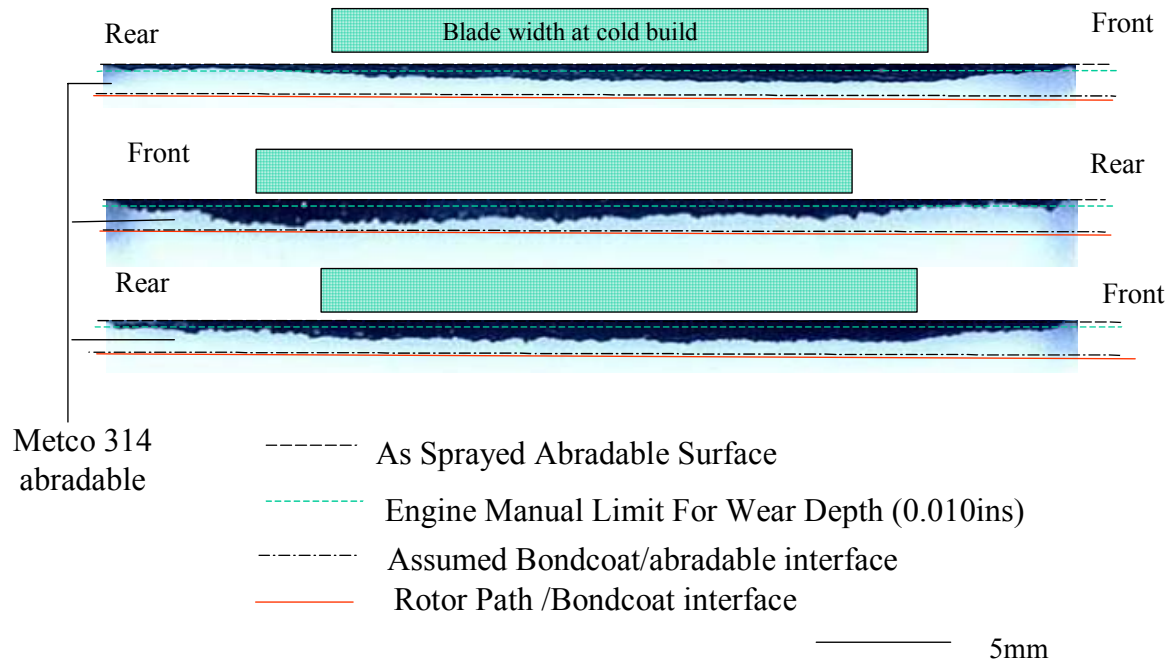
Stage 3 Rotor Path Replica Cross-Sections

The dark regions in the three views above are cross-sections through the synthetic rubber replicas of the abrasable rotor path liner surface at three positions 120° apart. They therefore represent what is missing from the abrasable liner. The light regions labelled Metco 314 abrasable are therefore what remains of the abrasable.

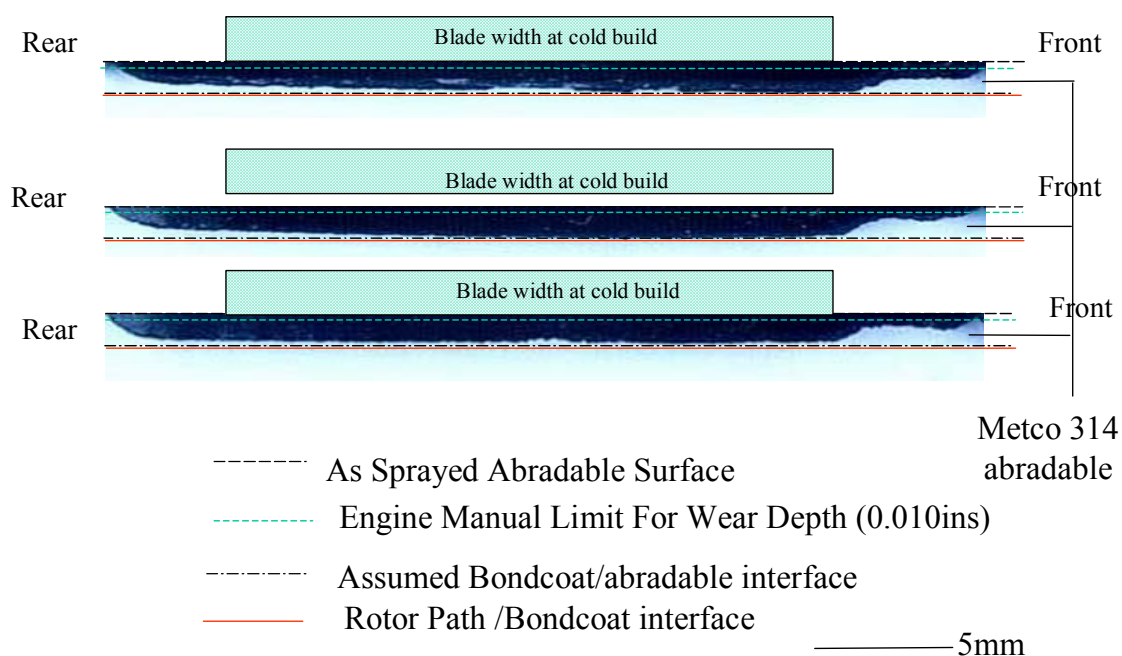
Stage 4 Rotor Path Replica Cross-Sections

The dark regions in the three views above are cross-sections through the synthetic rubber replicas of the abradable rotor path liner surface at three positions 120° apart. They therefore represent what is missing from the abradable liner. The light regions labelled Metco 314 abradable are therefore what remains of the abradable.

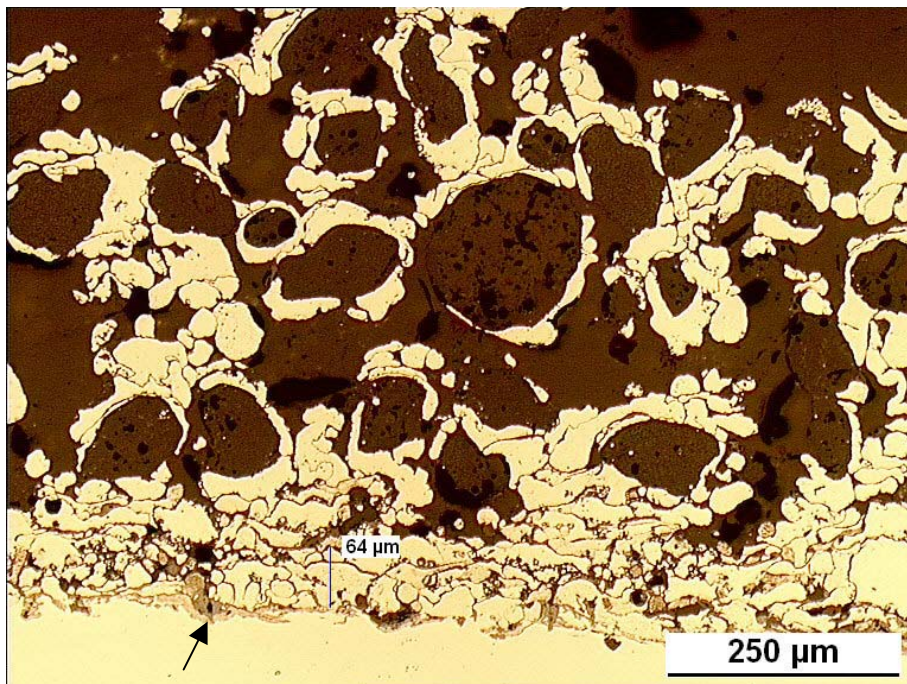
b) Axial cross-section through the abradable showing the bondcoat-IN907 substrate oxidation. Where oxidation is heaviest there are cracks within the oxide (arrowed)

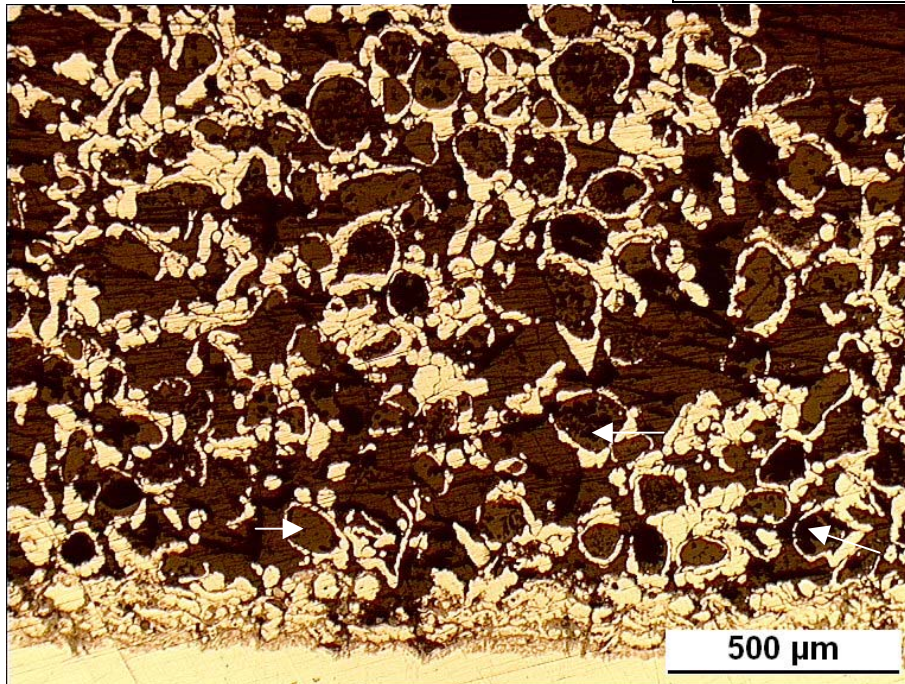
a) Axial cross-section through the coating towards the centre of the casing. Powder particles which have not fused well to contribute to the formation of a metallic network within the coating are arrowed

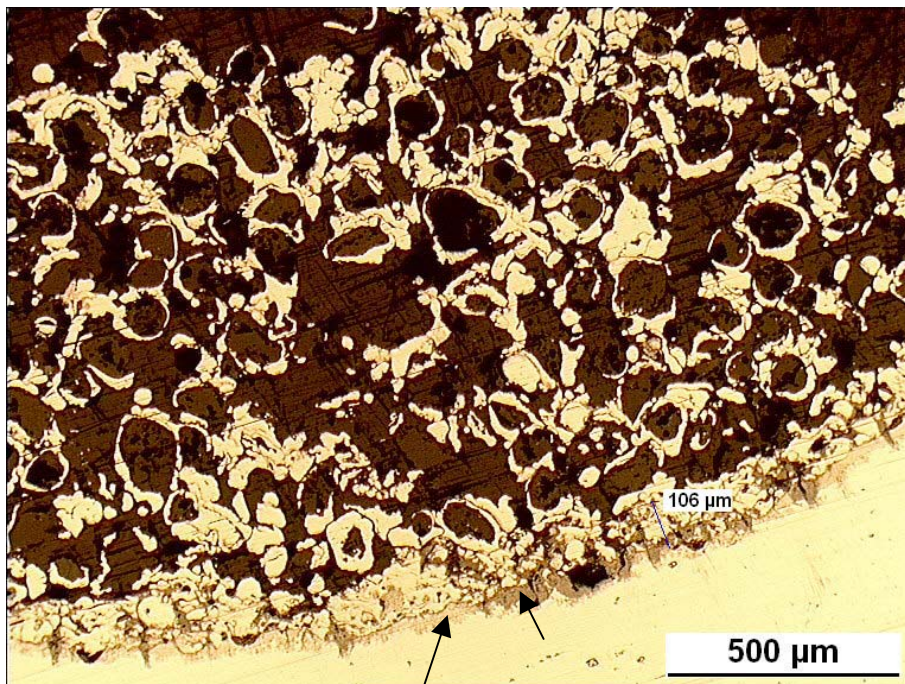
b) Axial cross-section through the coating at the corner of the casing. Possibly more porosity than in a) because of turbulence during spraying caused by the corner geometry. Bondcoat-IN907 substrated interface oxidation arrowed

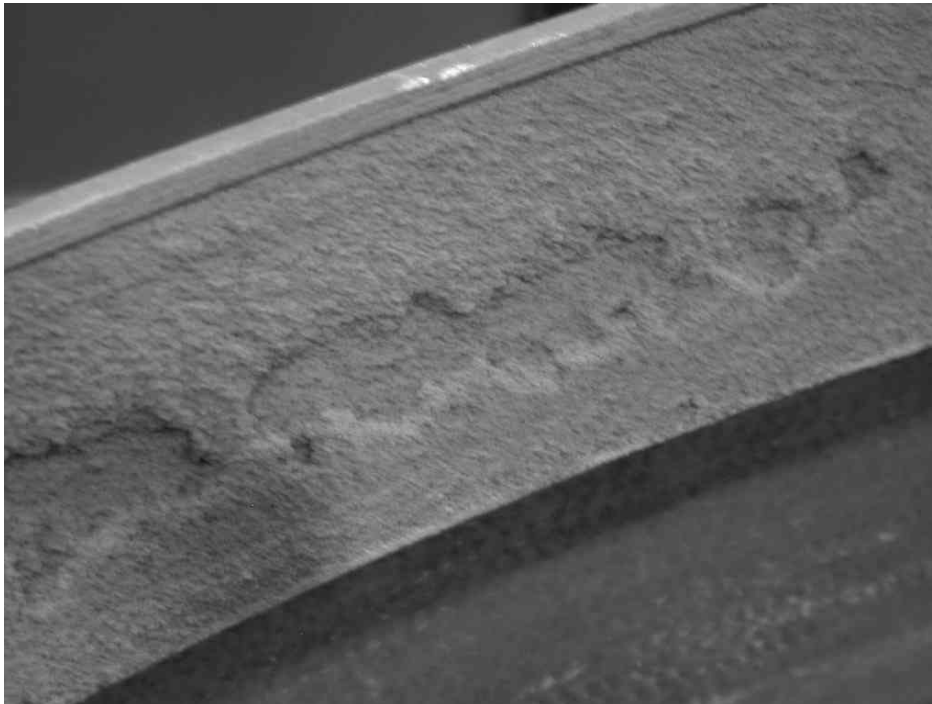
Fig 20 showing condition of the HP compressor stage 5 lining from ESN51363 (not sprayed by company B)

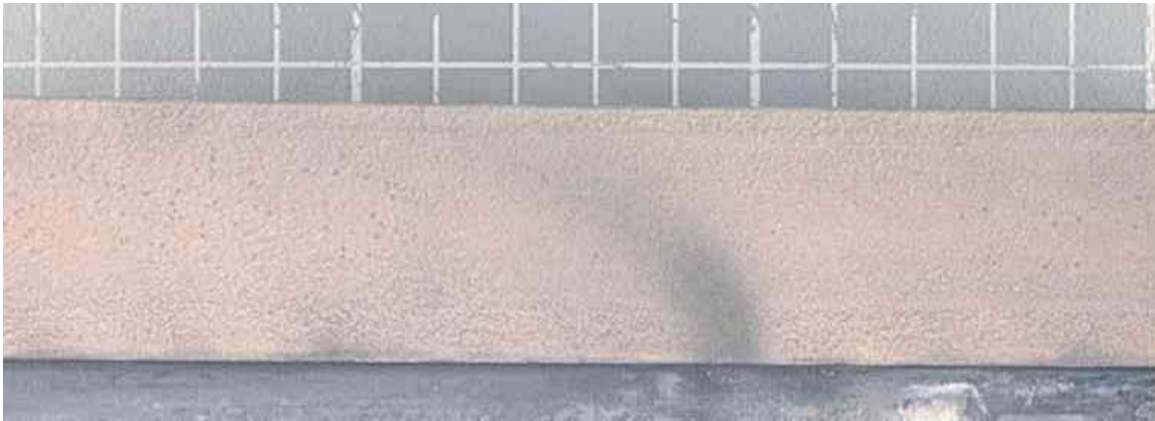
Fig 21 showing condition of the HP compressor stage 6 lining from ESN51363 (sprayed by company B)

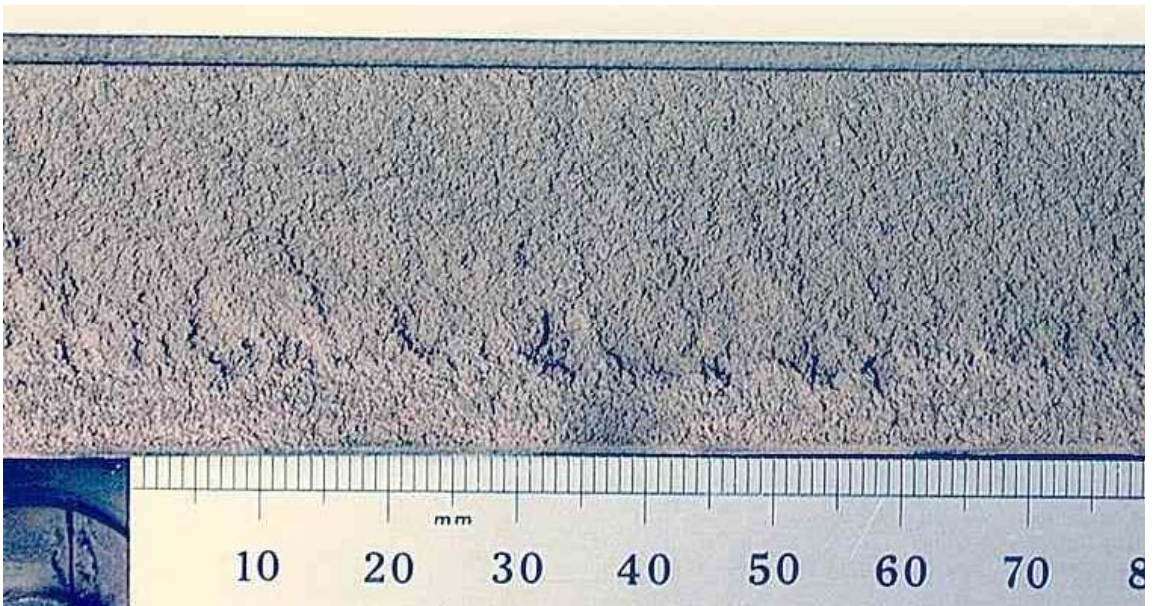
Fig 22 showing condition of the HP compressor stage 5 lining from ESN51058 (not sprayed by company B)

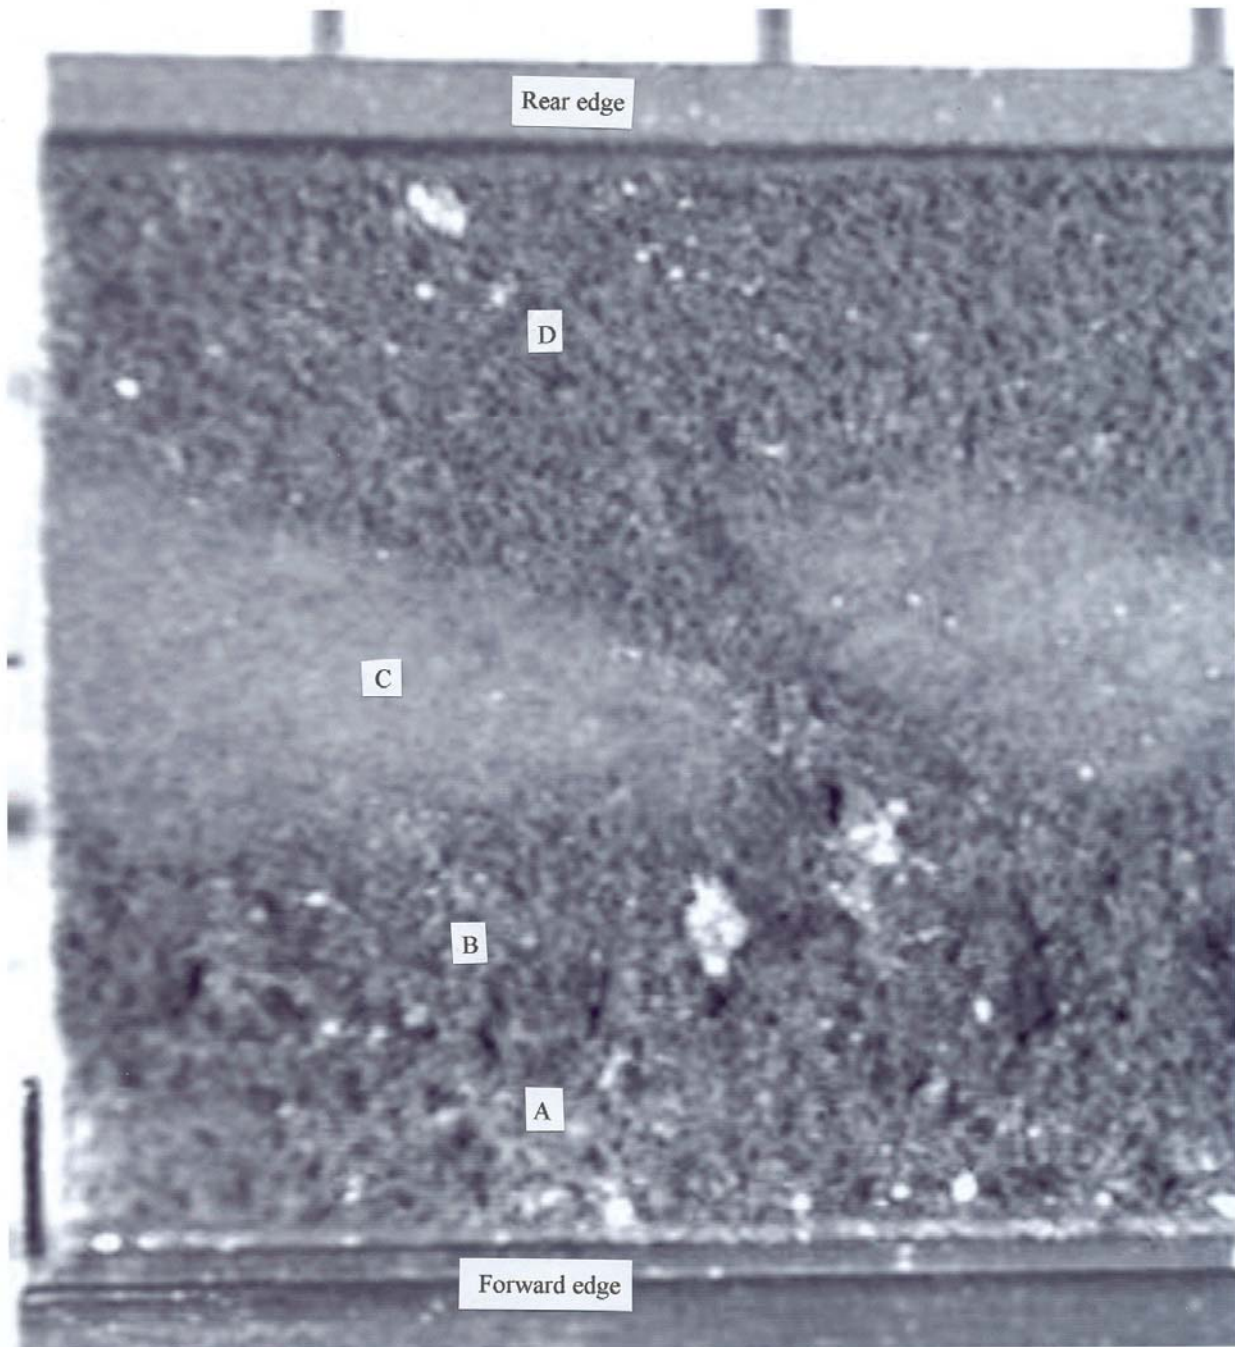
Figure 1. As-received 8.5-inch long segment of stage 6 compressor ring from #51067 Trent 800 engine after flight service with Singapore Airlines. Forward edge on left.

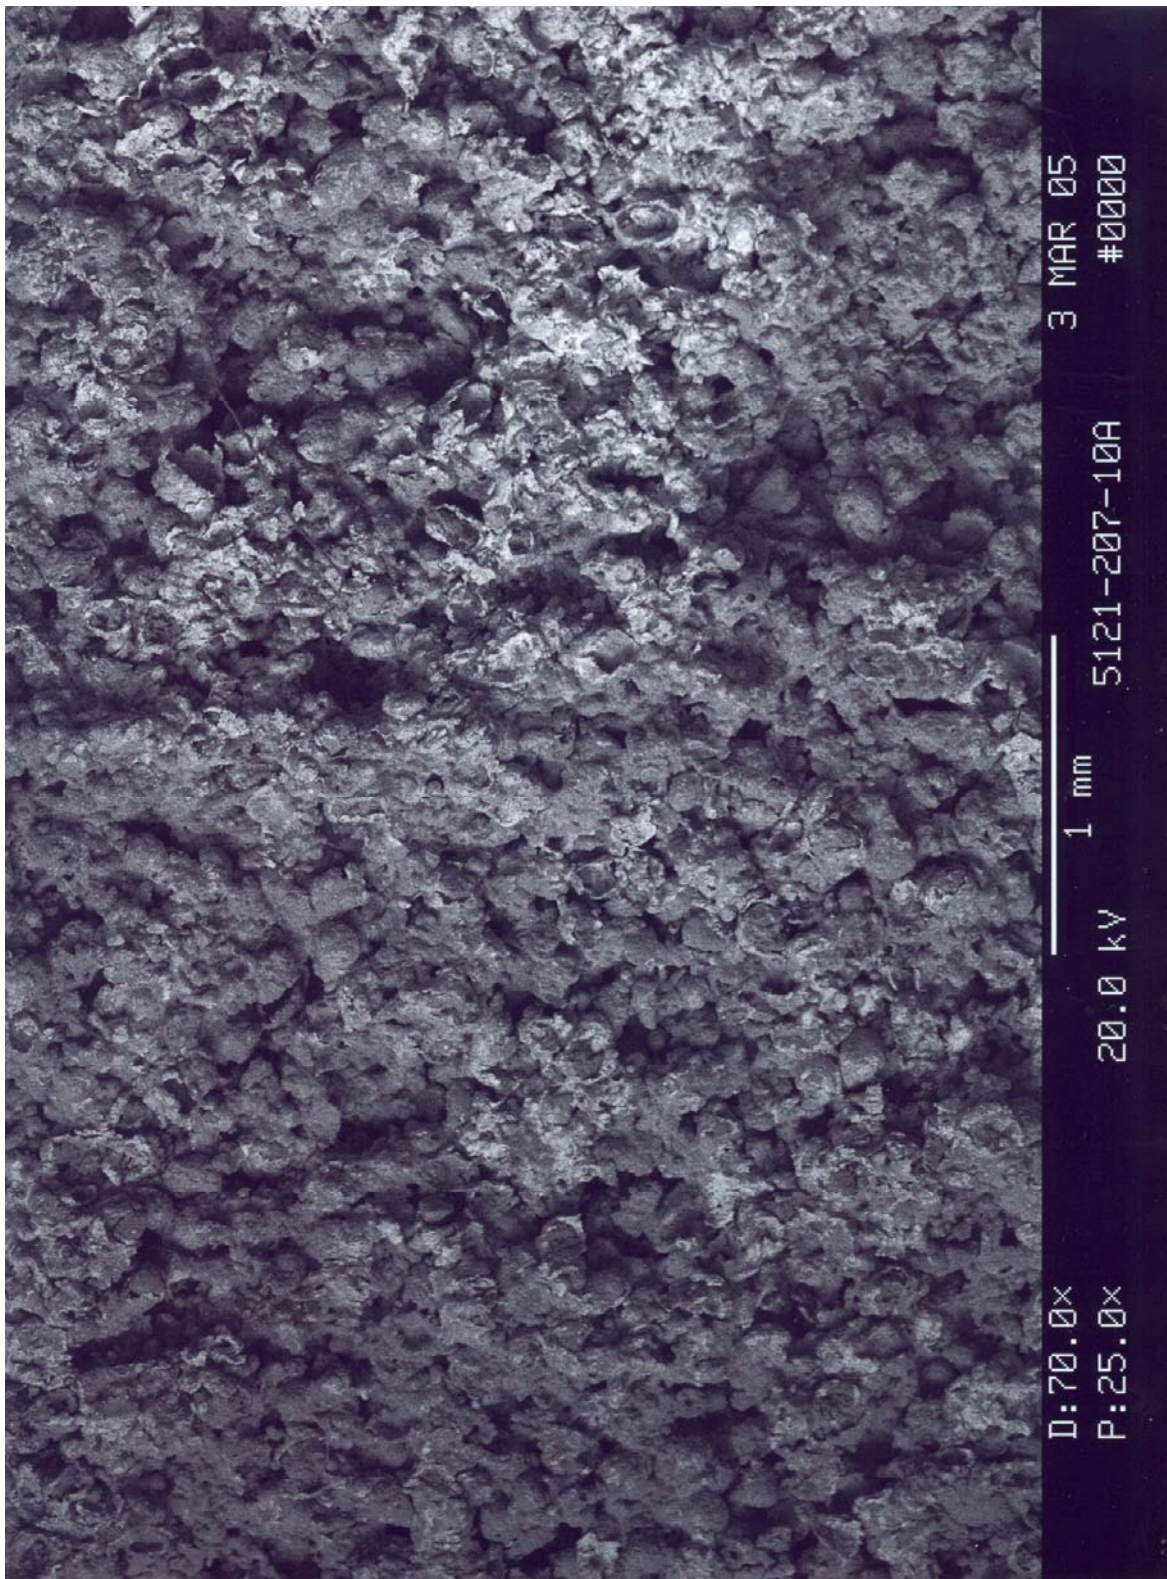
Figure 3a. SEM surface micrograph of area A, near forward edge of ring, showing high roughness and surface structure of LCA-314 particles, with NiCrAl skin eroded to expose Bentonite core, and more recent loss of areas exposing particles with no skin erosion. 42 X magnification.

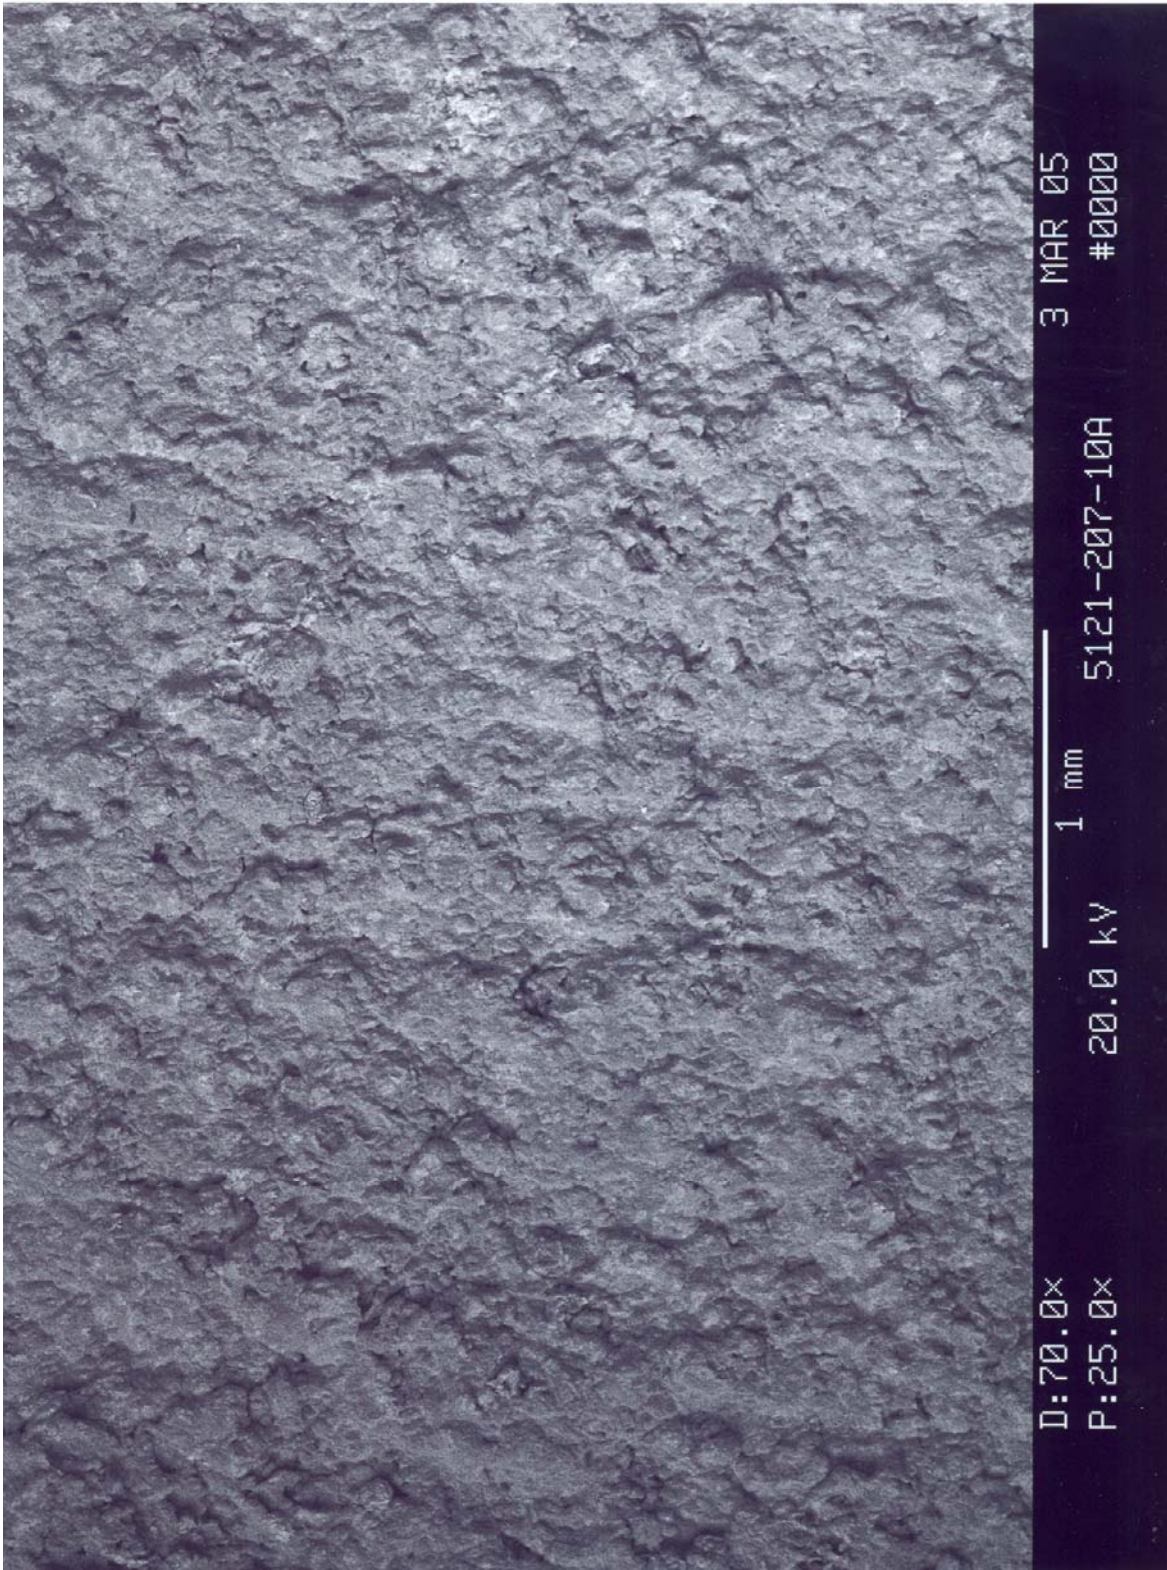
Figure 3b. SEM surface micrograph of area B, slightly rear of forward edge of ring, much like area A, showing further examples of NiCrAl skin erosion and peel-back, exposing Bentonite cores. 42 X magnification.

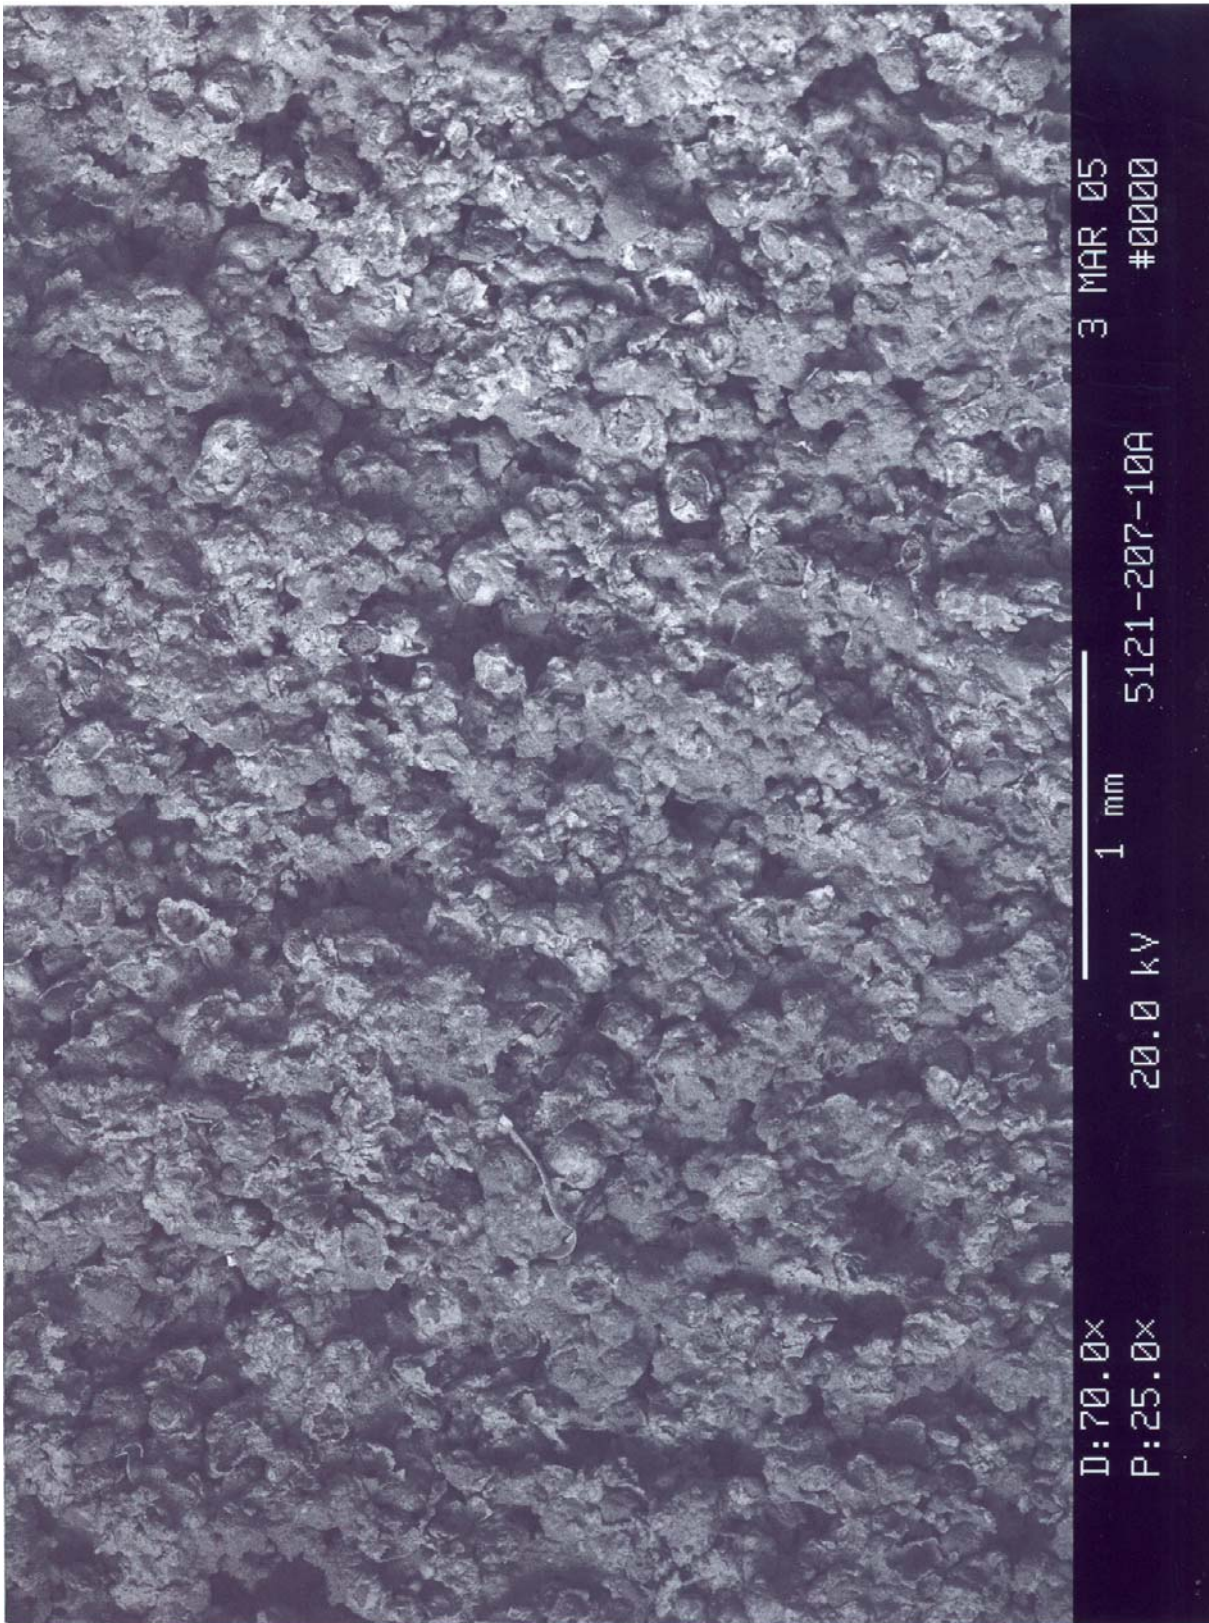
Figure 3c. SEM surface micrograph of area C, about mid-ring, showing relatively smooth, nodular surface, found by EDS to be mainly Ni-5Al bondcoat, but eroded to a smoother condition than as-coated. 42 X magnification.

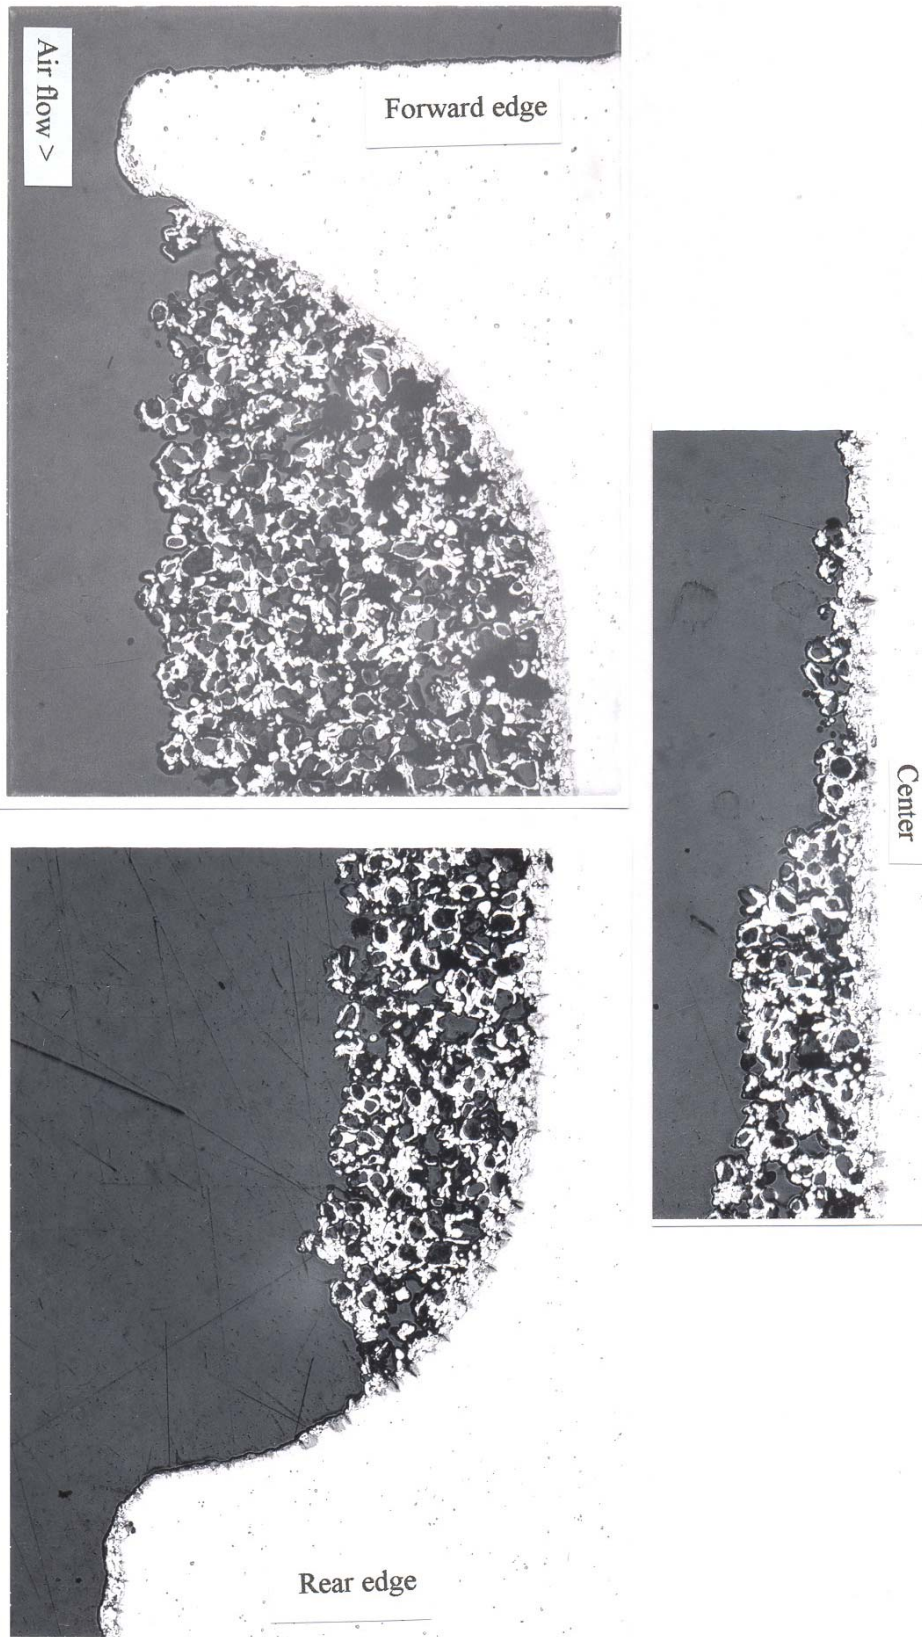
Figure 4. Macro photo of cross section slice of #51067 stage 6 ring with residual LCA-314 residing mainly on the forward edge (at top) and to the rear of center. The 314 is essentially gone in the center with only the 450 bondcoat remaining. EV 40155. 5126-207-10B. Approximately 6X magnification.

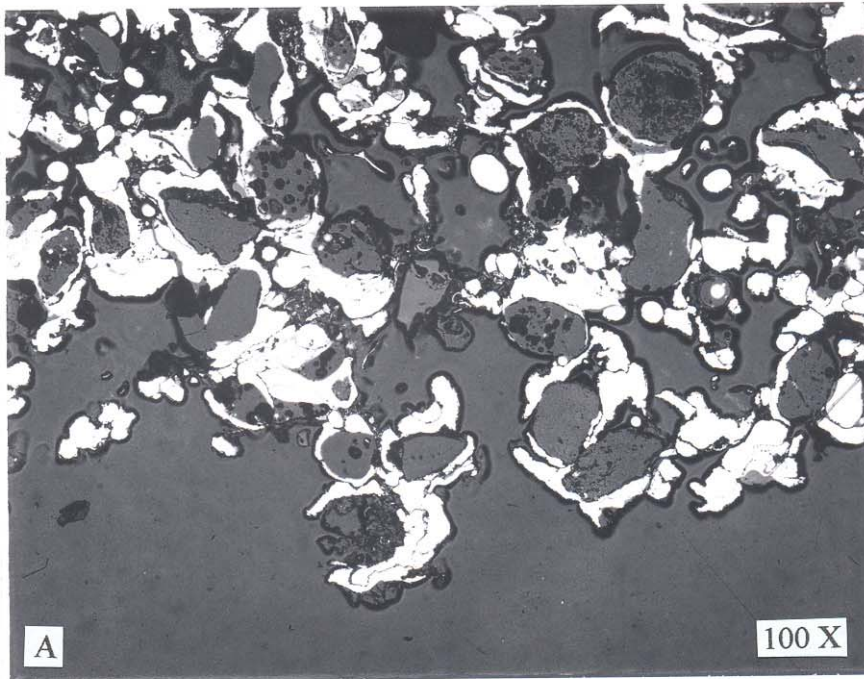
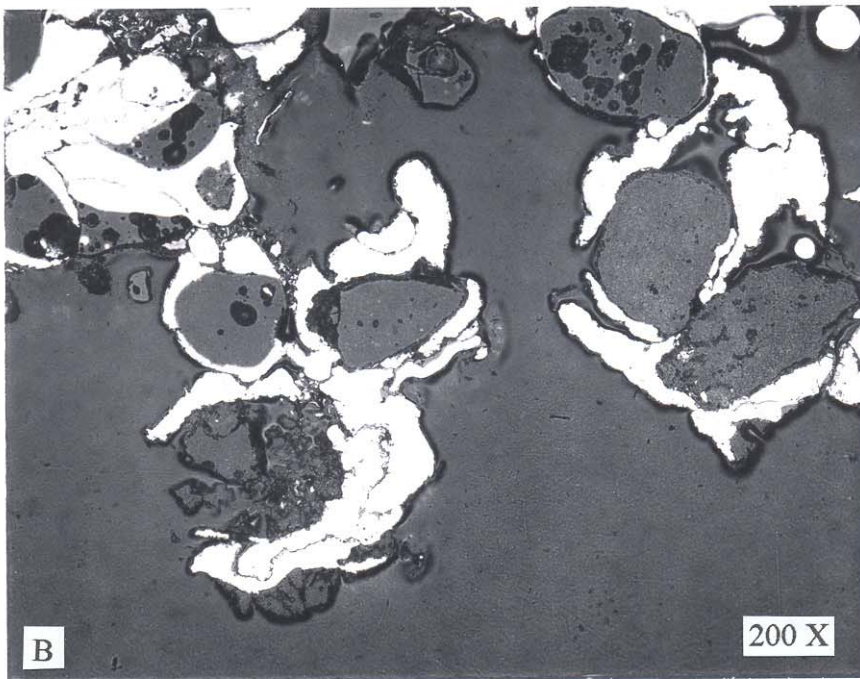
Figure 5. Microscopic cross sections of Fig. 4 sample to show detail of residual coating near forward, center and rear edge areas of the ring. Engine air flow from forward to rear as noted here. 23 X magnification.

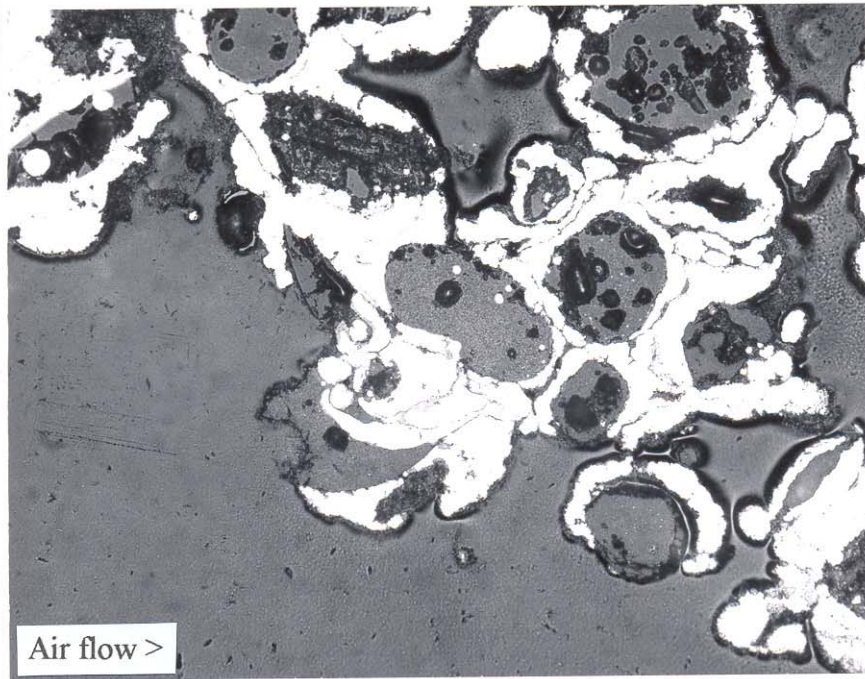
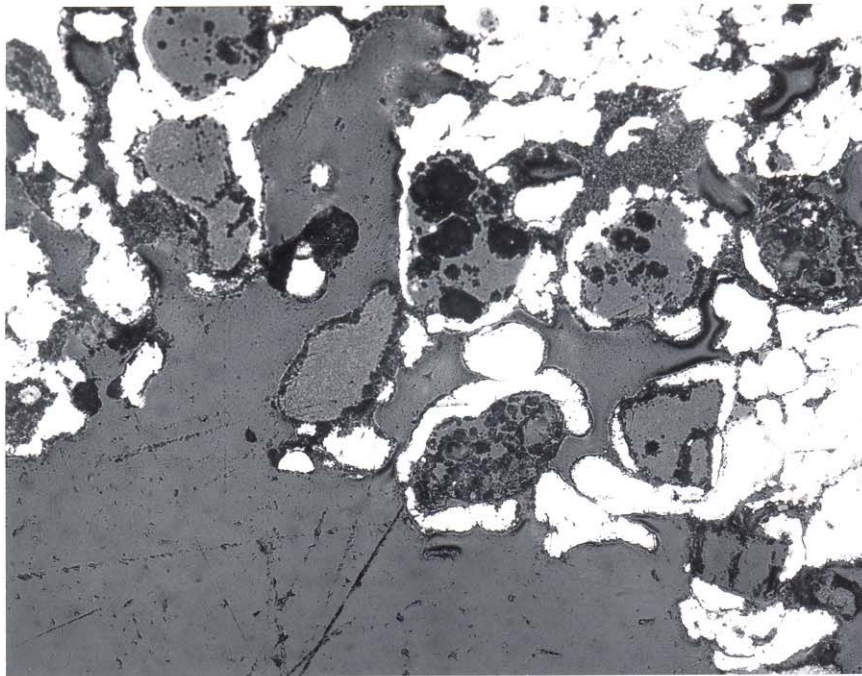
Figure 6. Cross section microstructure of residual LCA-314 coating of Fig. 5, but near forward edge of ring only. Engine air flow direction indicated. Showing erosion thinning of NiCrAl jacket layer predominately on side facing air flow, and subsequent erosion of Bentonite cores. 100 X (a) and 200 X (b) magnification.
