ATSB TRANSPORT SAFETY INVESTIGATION REPORT

Aviation Safety Incident Report – 200403110

**Engine failure - Melbourne Airport, Victoria
25-Aug-2004
Boeing Company 777-312
9V-SYB**

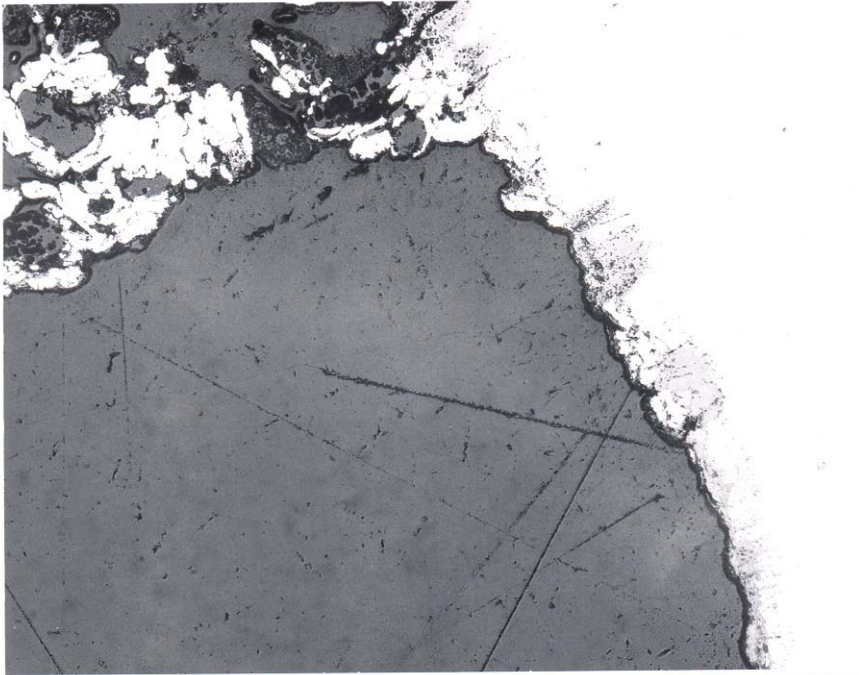
Figure 7. Cross section microstructure of residual LCA-314 near rear edge of ring, showing leading edge erosion of NiCrAl jacket and then the Bentonite core, deep porous zones devoid of all coating (now filled with epoxy), and heavily oxidized surfaces and boundaries of the NiCrAl phase. 200 X magnification.

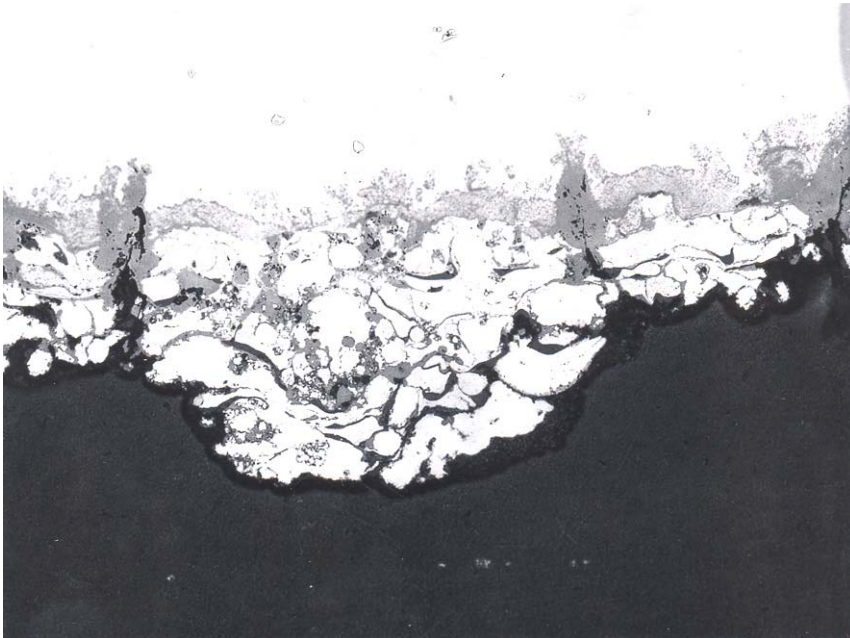
Figure 8. Cross section microstructure of residual LCA-314 coating at the rear edge of the ring, at the boundary where the coating is totally removed and only the bondcoat remains. 100 X magnification.

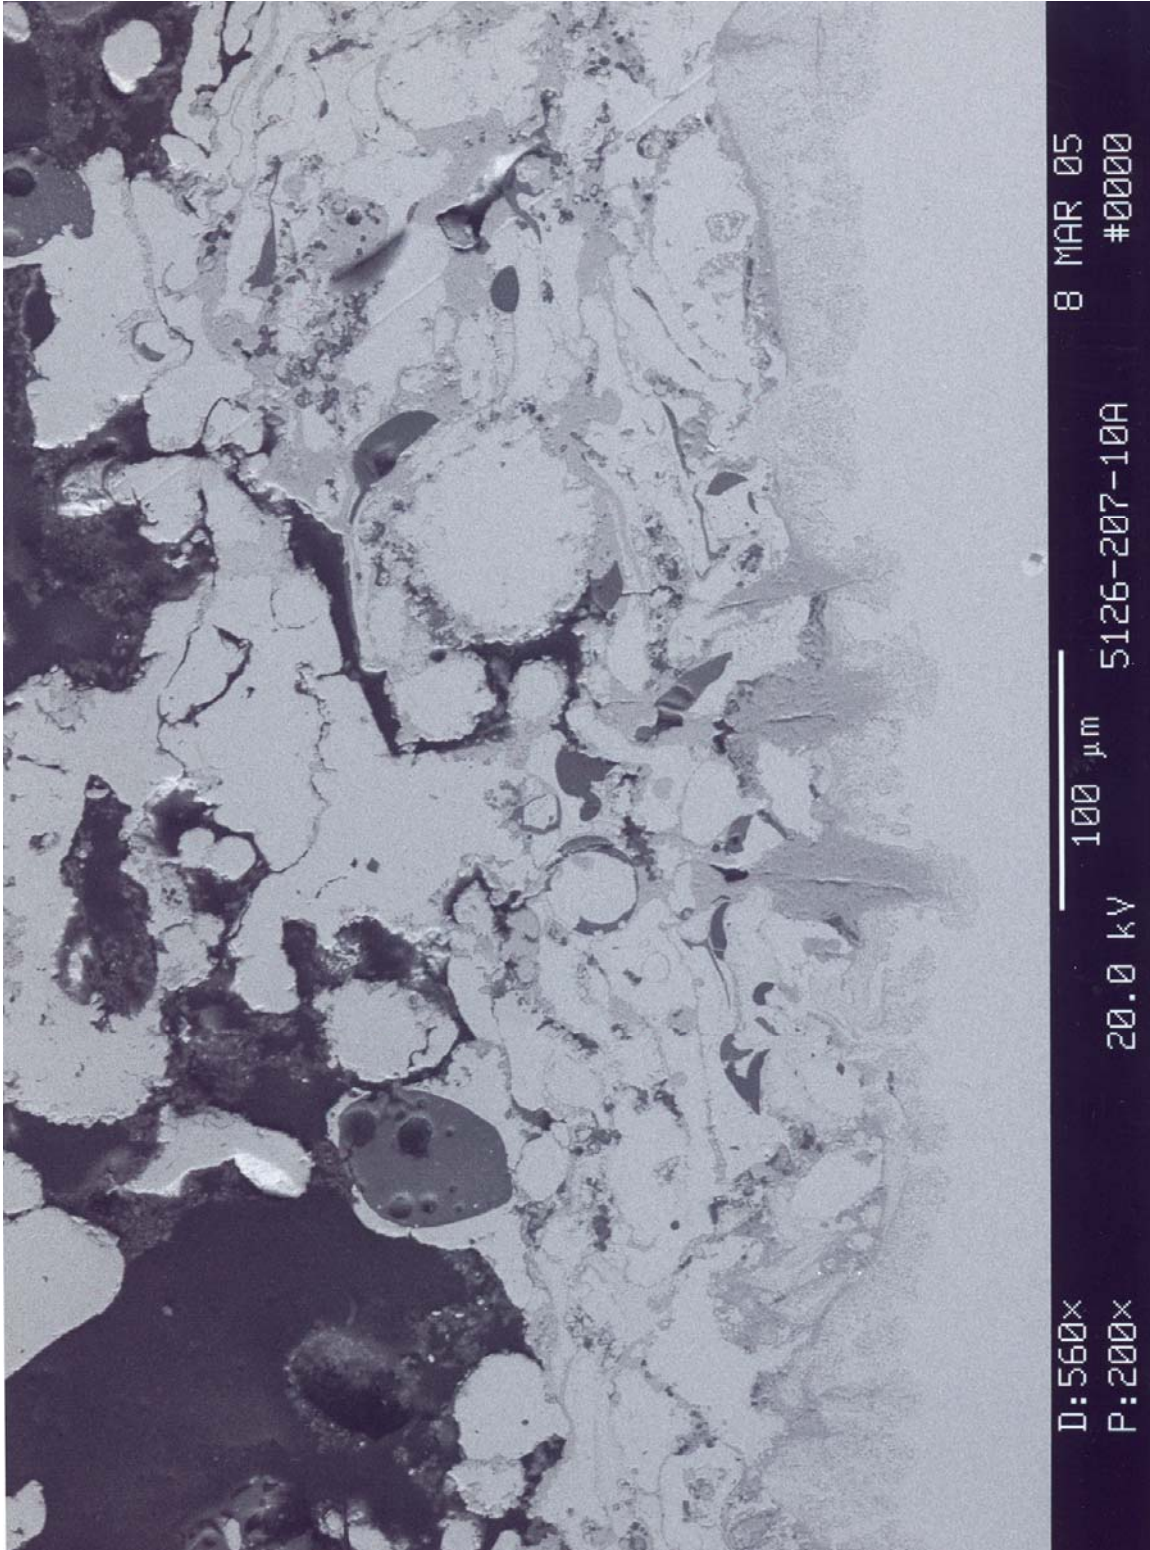
Figure 9. Cross section microstructure of residual 450 bondcoat near center of ring, showing complete loss of 314 layer, heavy internal oxidation of the 450 bondcoat and how the oxide layers between splats have allowed de-cohesion of the splats. IN 907 substrate also heavily oxidized. #51067 stage 6 ring. EV 40155. 5126-207-10B. 200 X magnification.

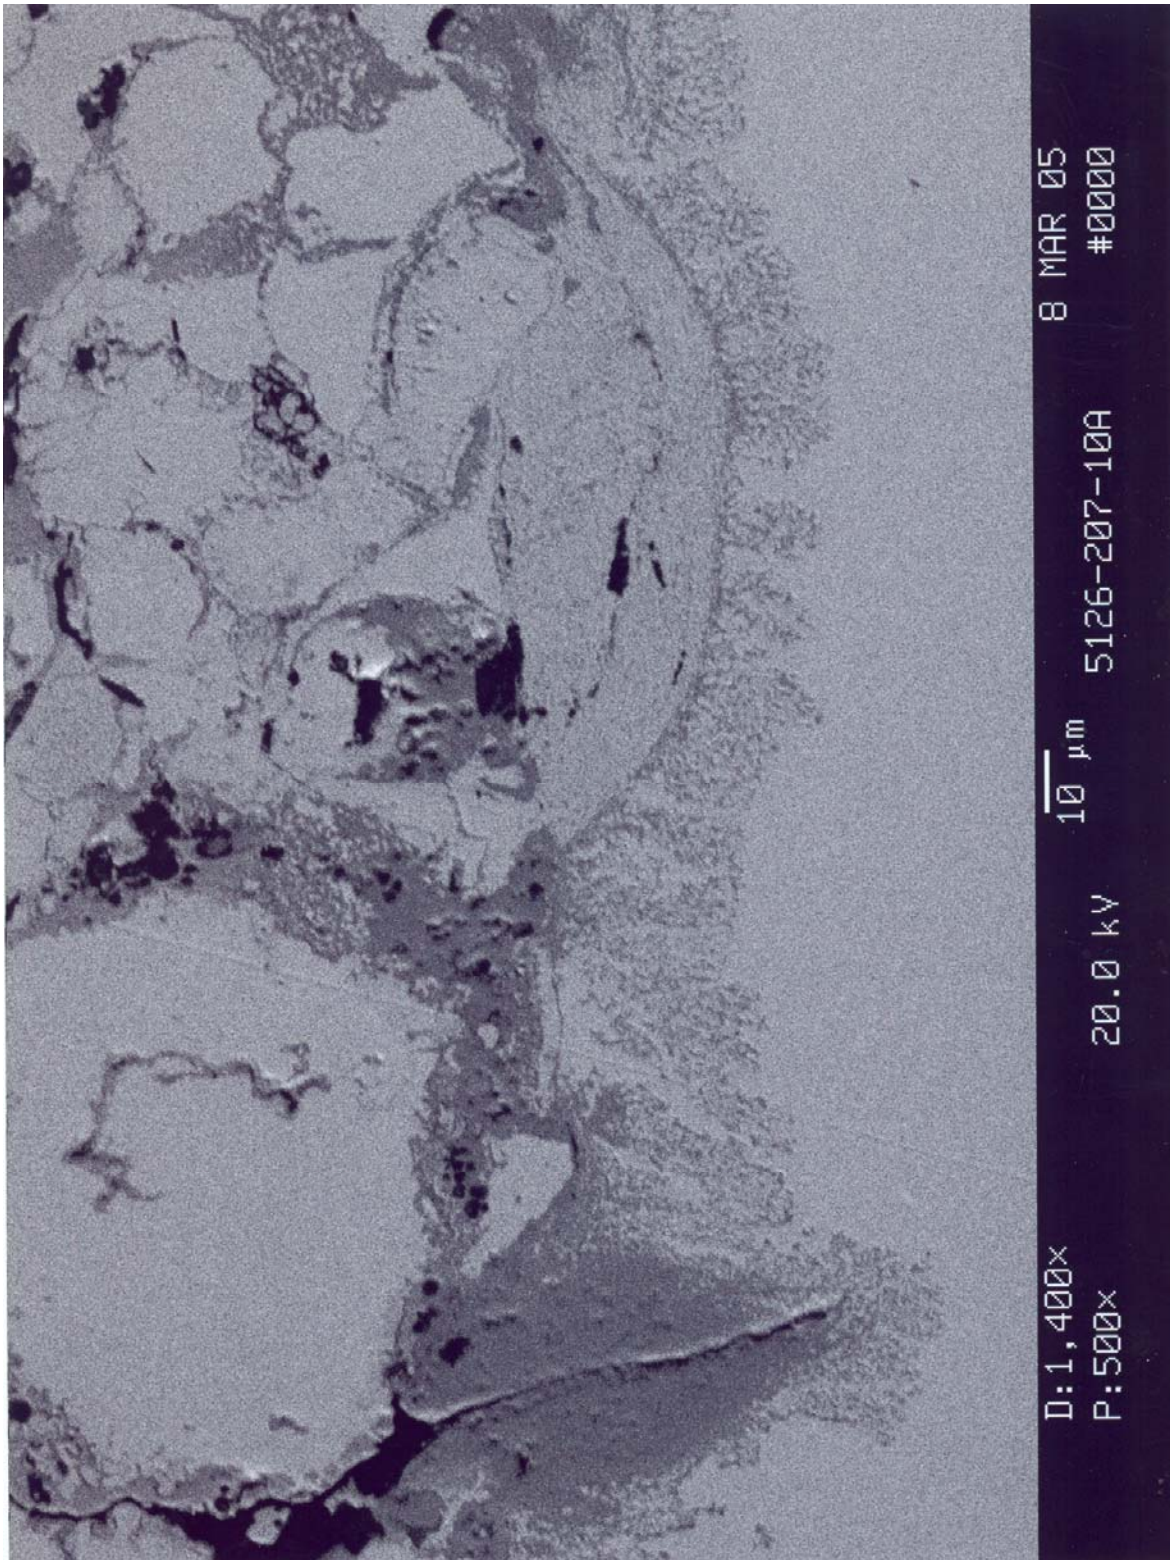
Figure 10a. SEM cross section microstructure of residual 450 bondcoat on IN 907 substrate, both heavily oxidized. Nickel oxide layers between 450 splats are allowing de-cohesion. #51067 stage 6 ring. 340 X magnification.

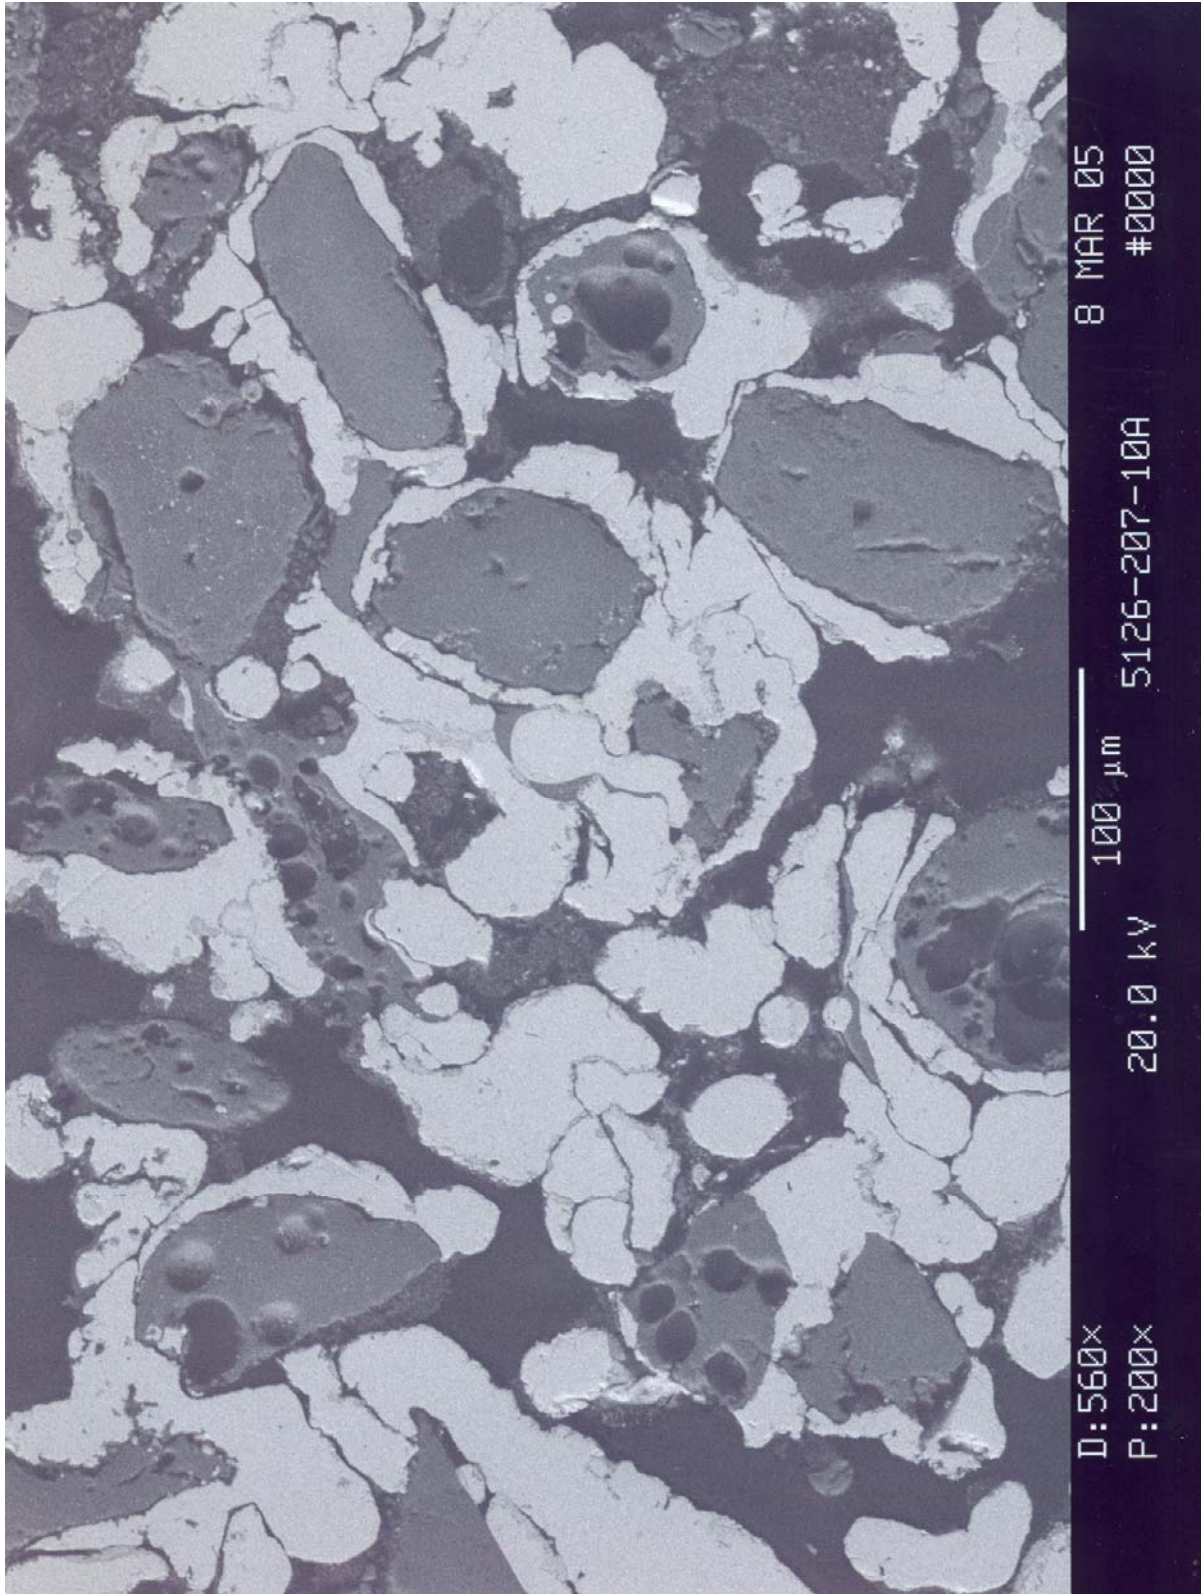
Figure 10b. SEM cross section microstructure showing detail of 450 bondcoat and IN 907 oxidation. Porosity and cracks formed in the inter-particle boundaries of 450 bondcoat. Large iron oxide particles penetrate IN 907, typically cracked, and layer of internal oxidation. 850 X magnification.

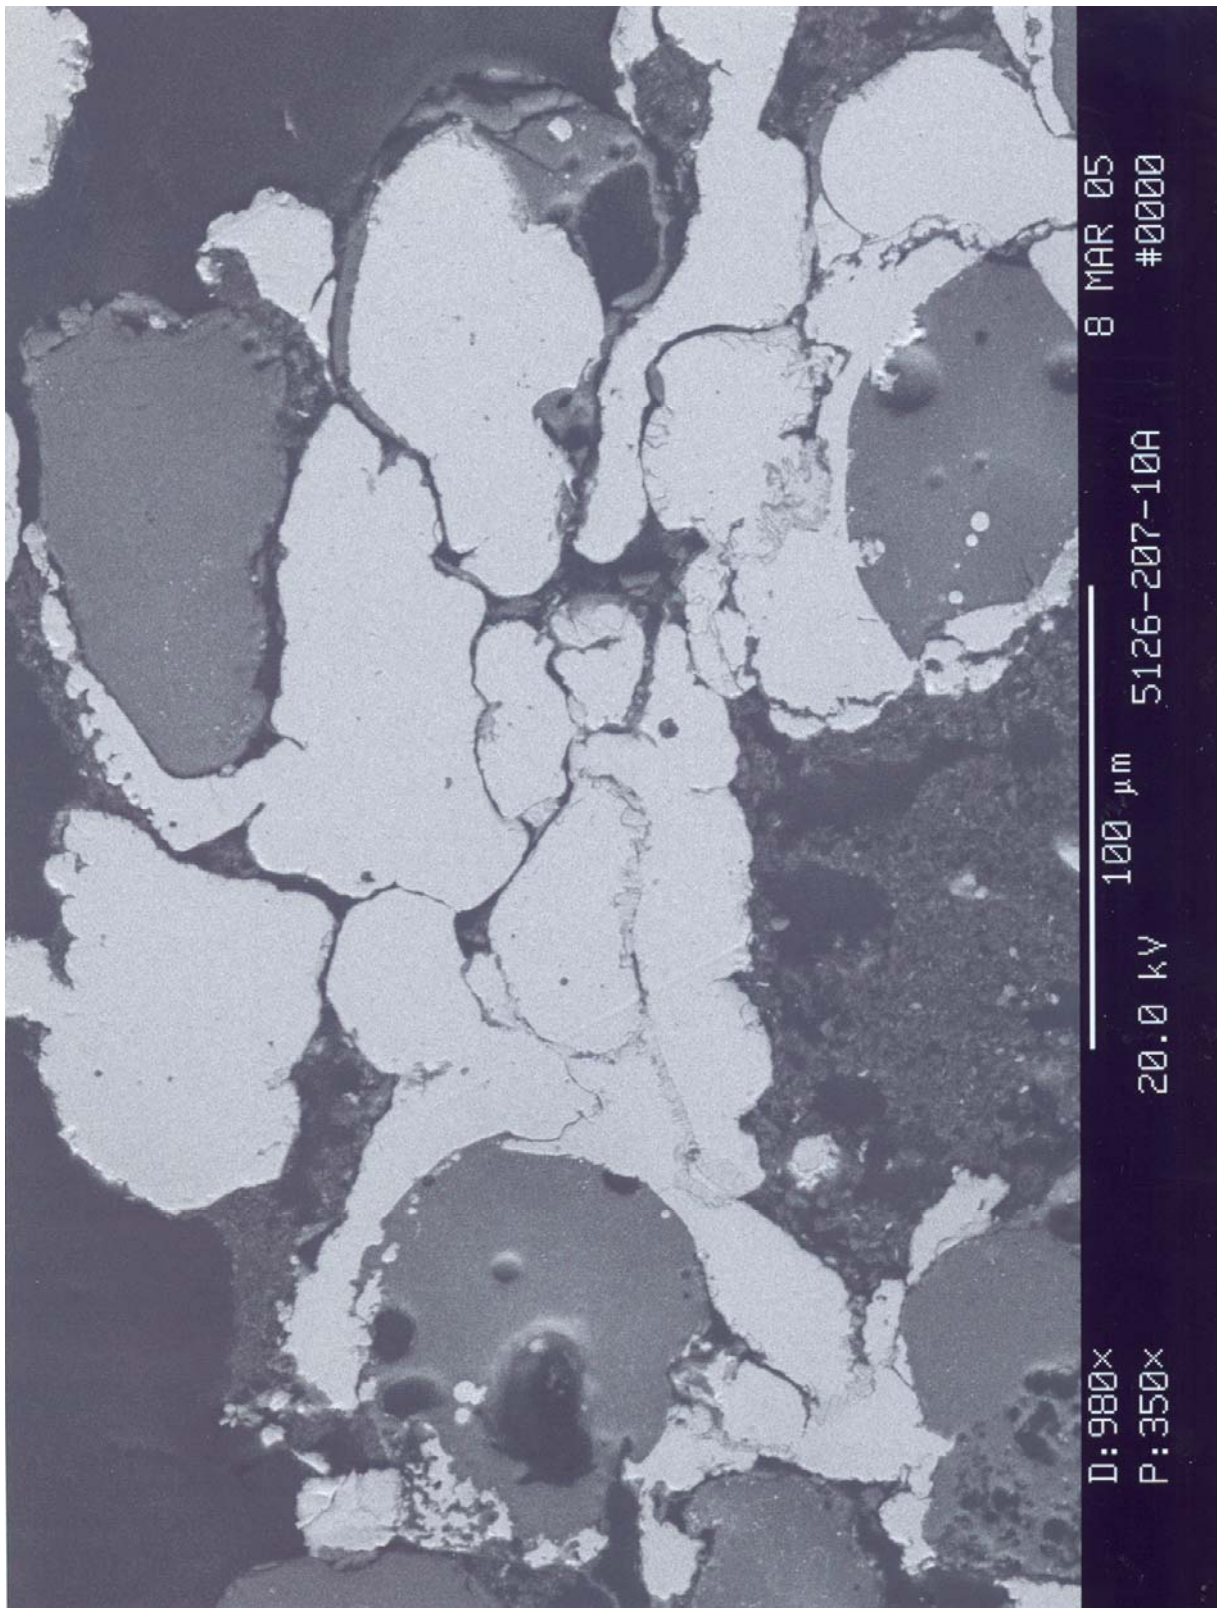
Figure 11a. SEM cross section microstructure of LCA-314 coating near upper surface, showing inter-particle oxide at NiCrAl splat boundaries. #51067 stage 6 ring. 340 X magnification.

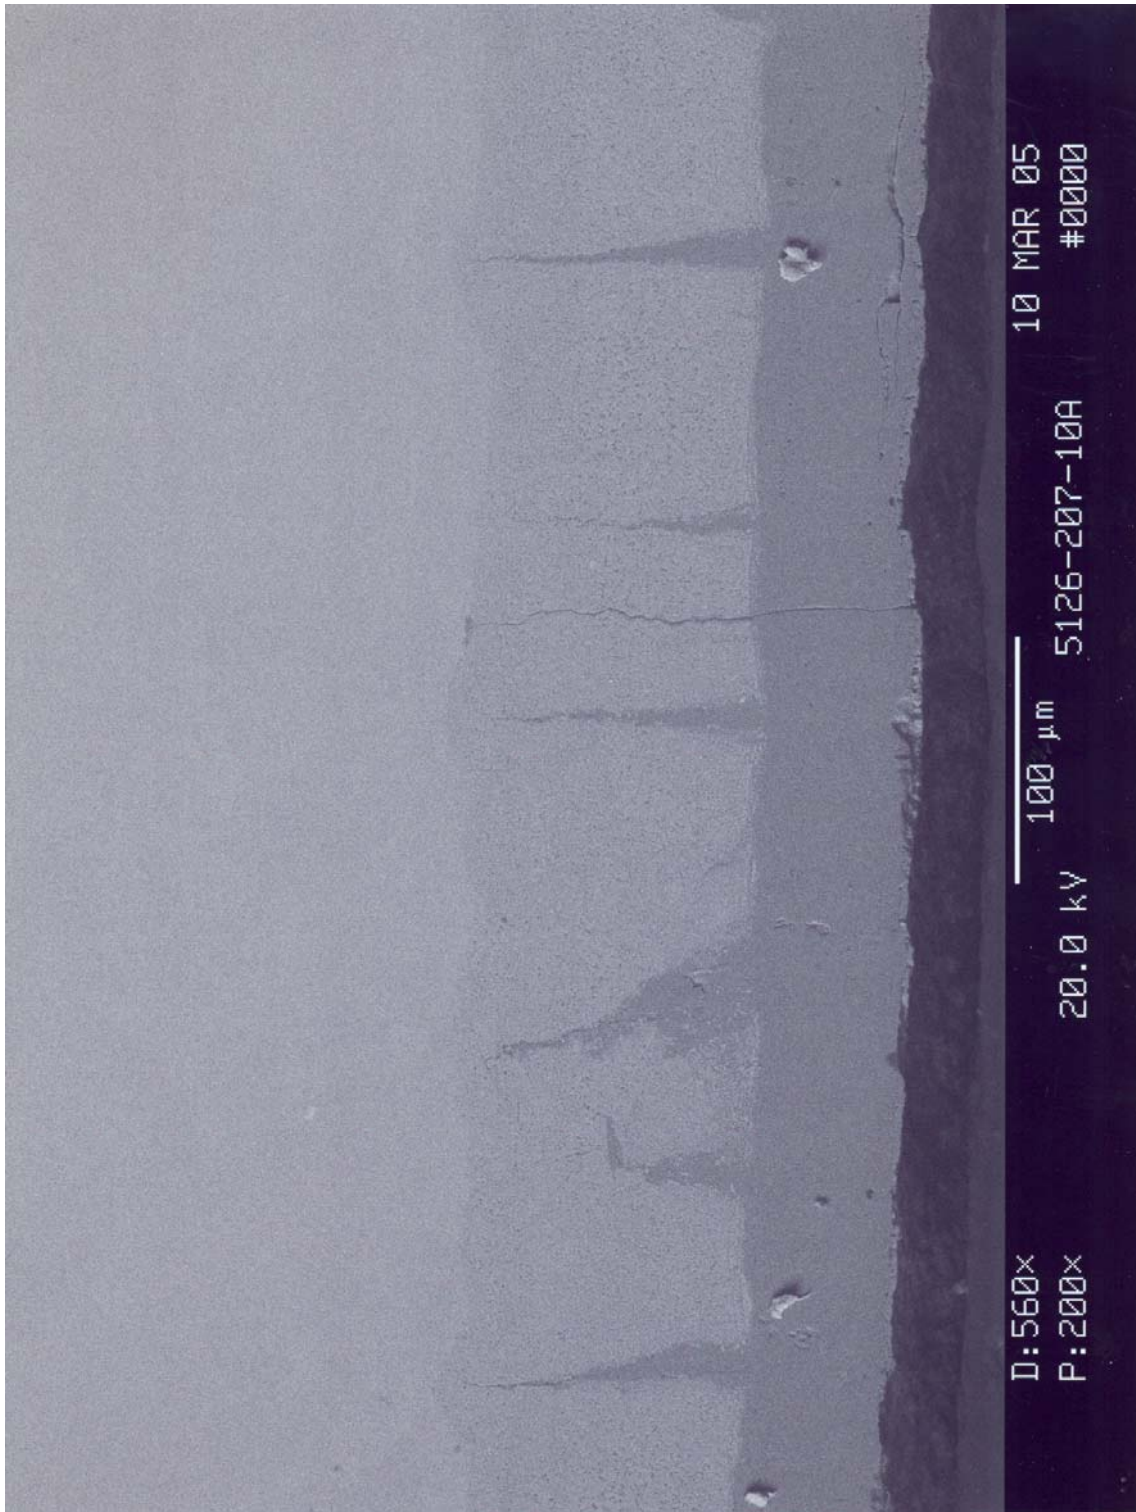
Figure 11b. SEM cross section microstructure of LCA-314 coating near upper surface, showing detail of inter-splat oxidation of NiCrAl and separation of between splats. 610 X magnification.

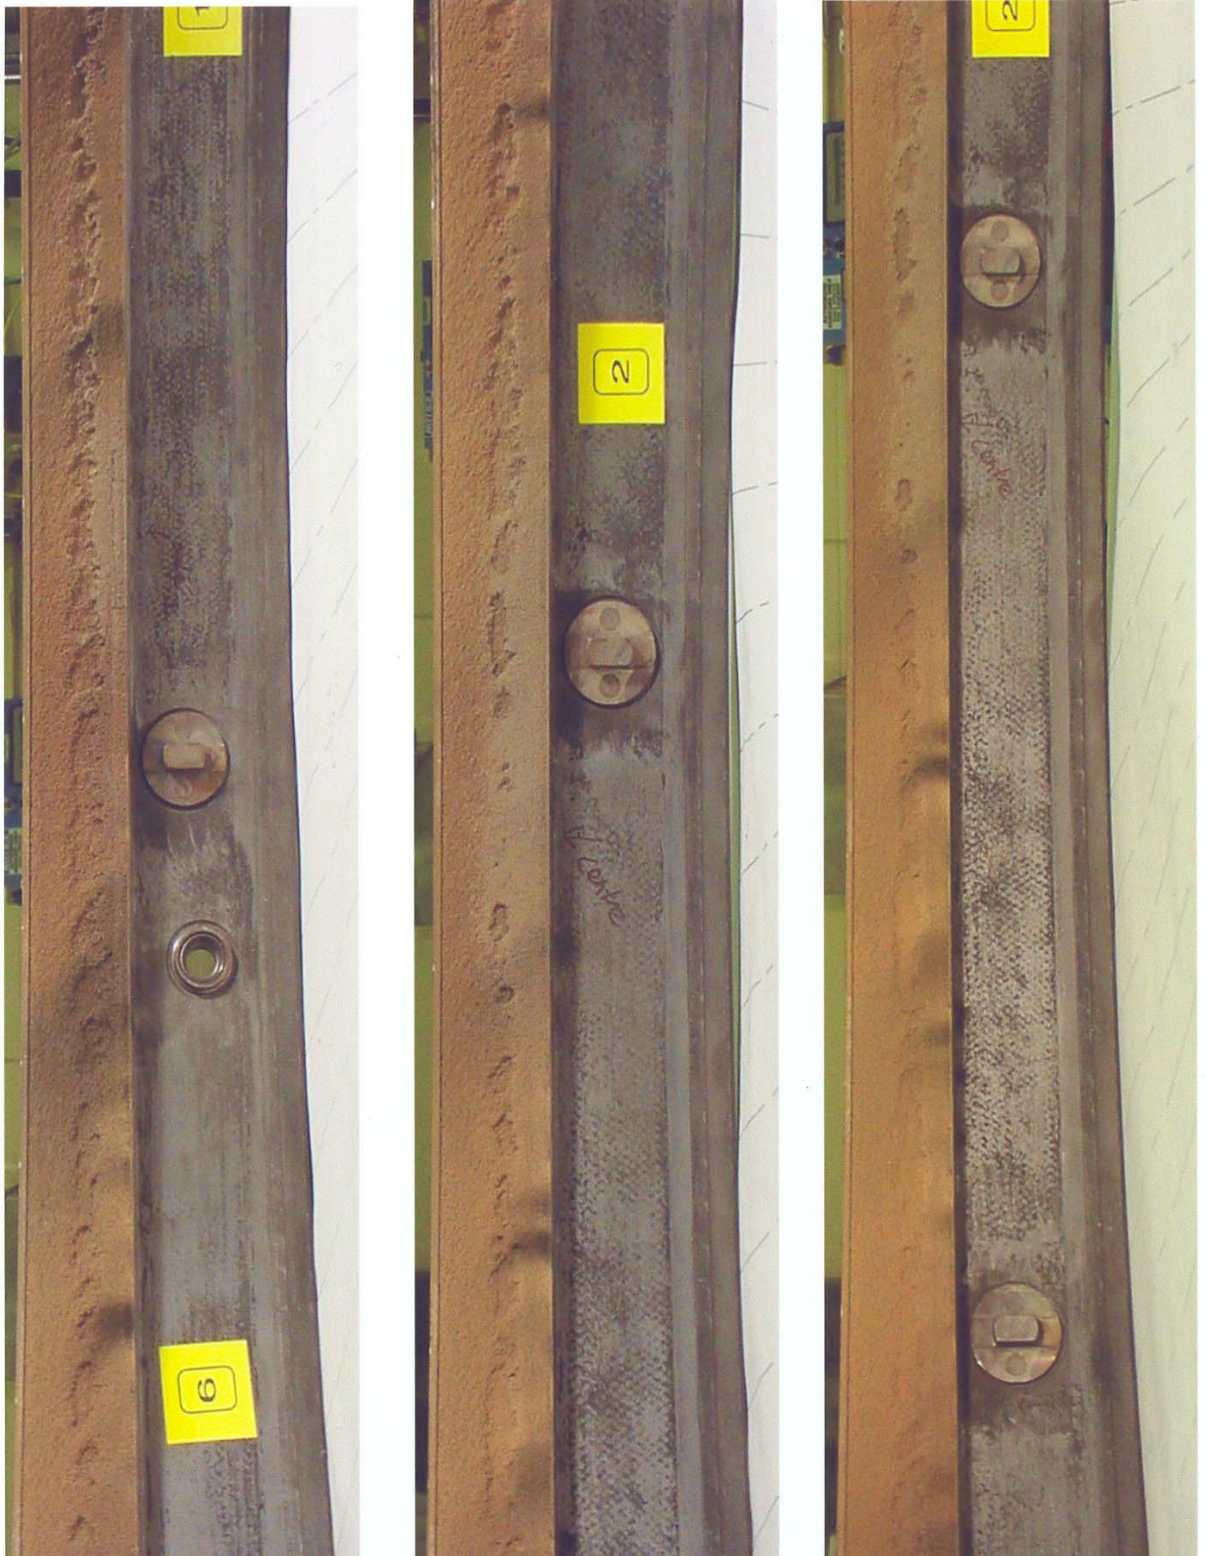
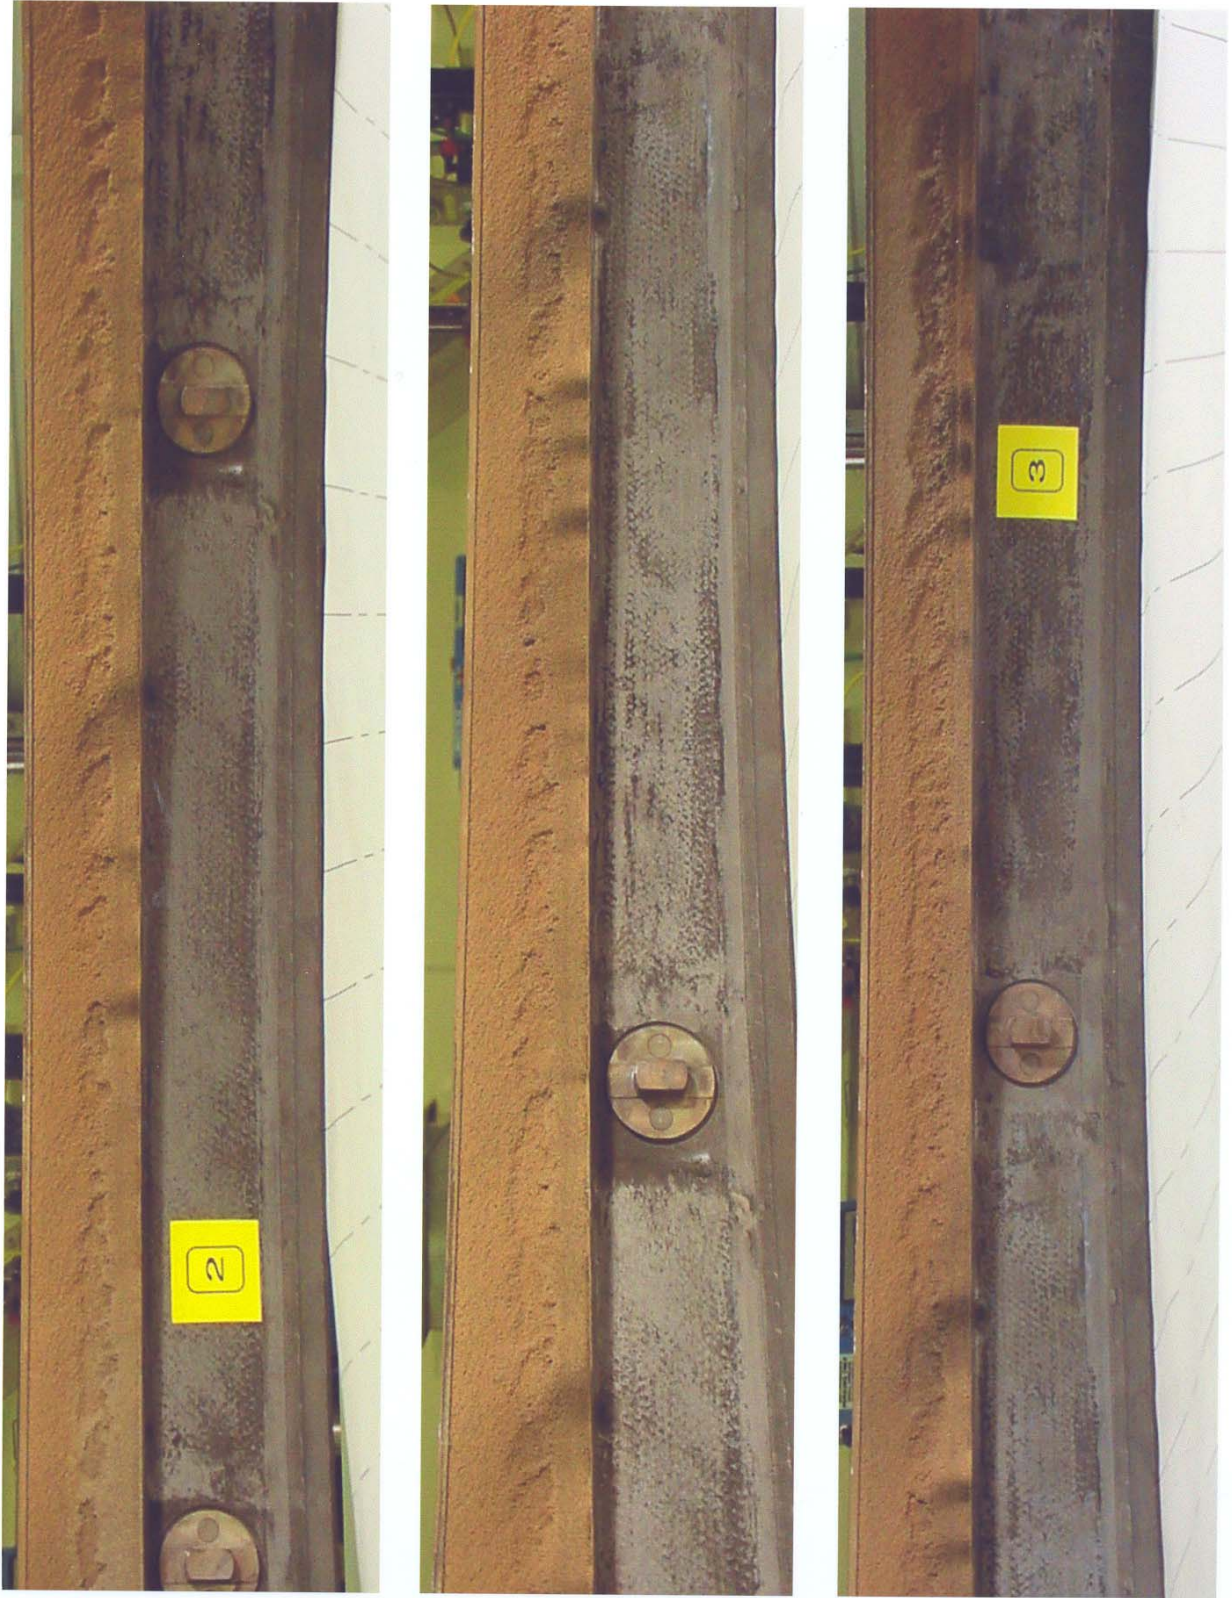
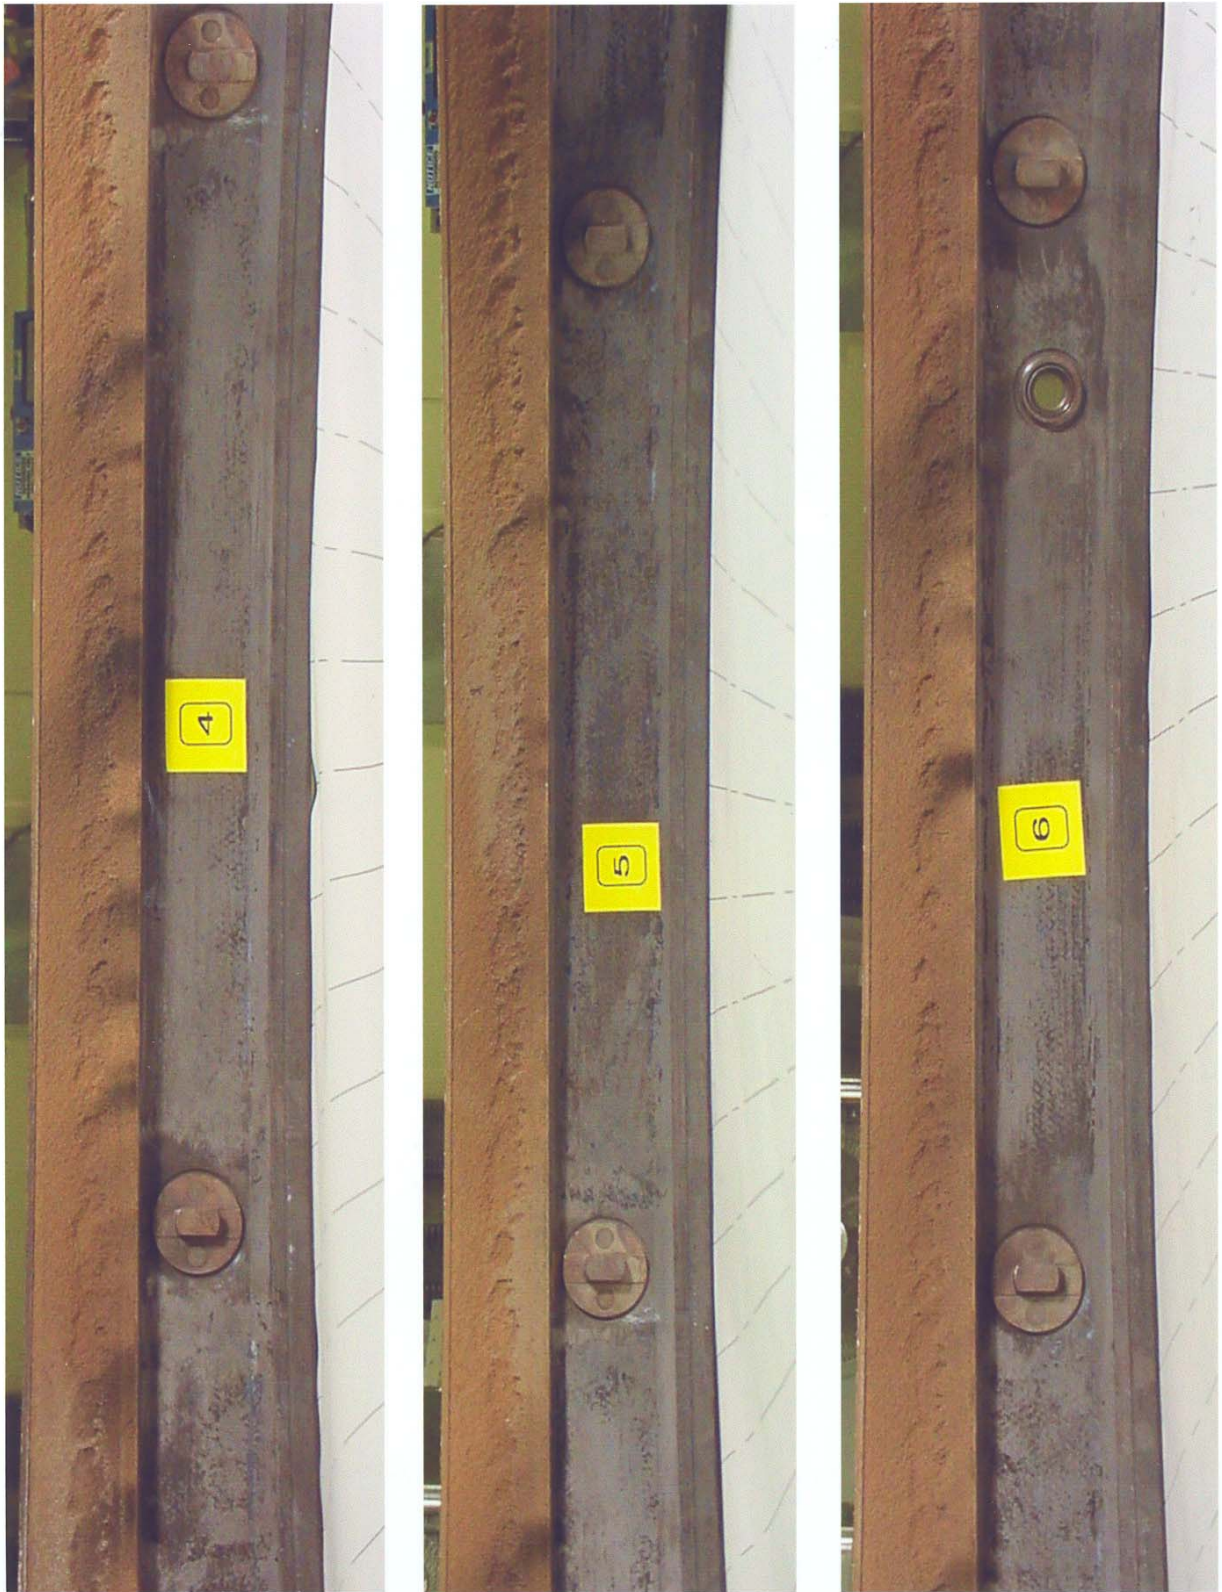
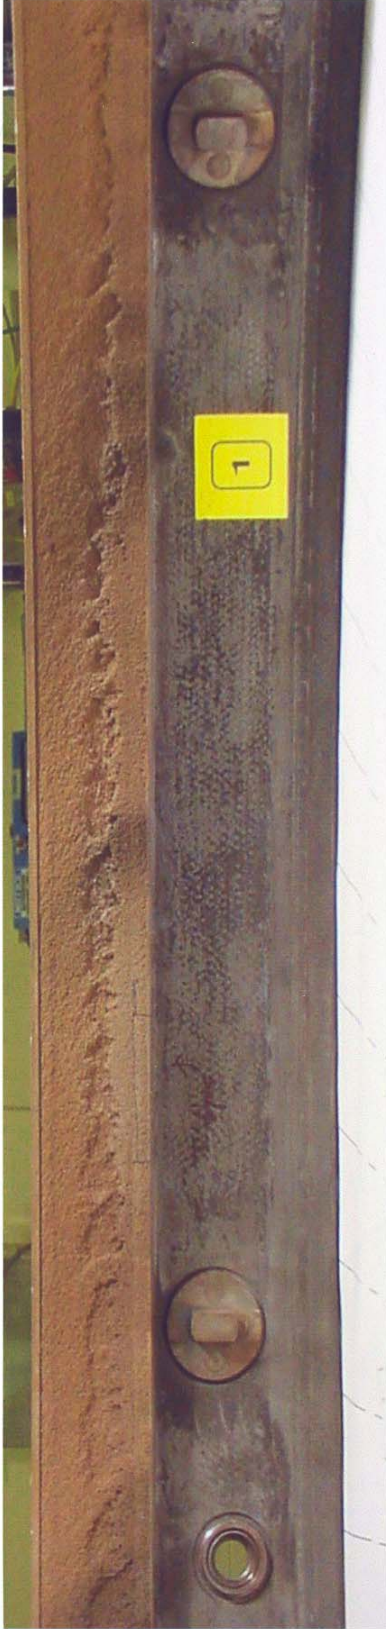
Figure 14. Photographic record of as-received #51363 stage 6 compressor ring with residual LCA-314 coating in upper track area. Whole ring is shown in overlapping views, with PST location numbers. "Pluck-out" of 314 and vivid brown surface coloration are both shown.

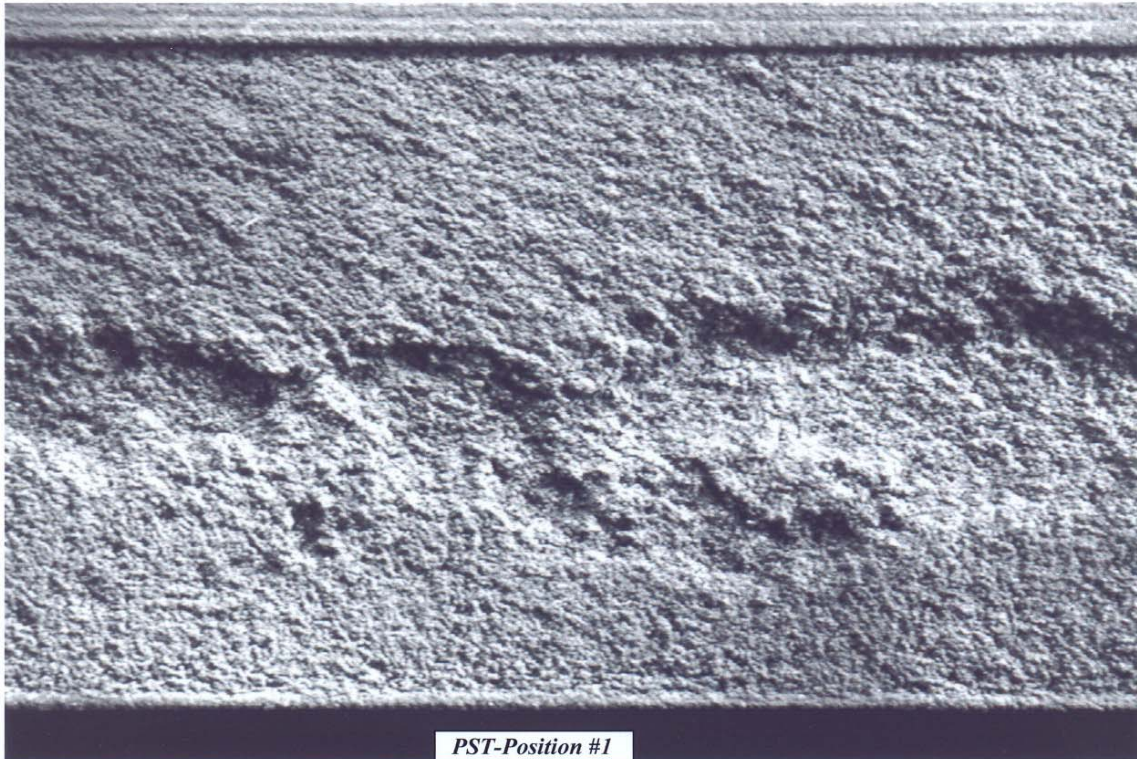
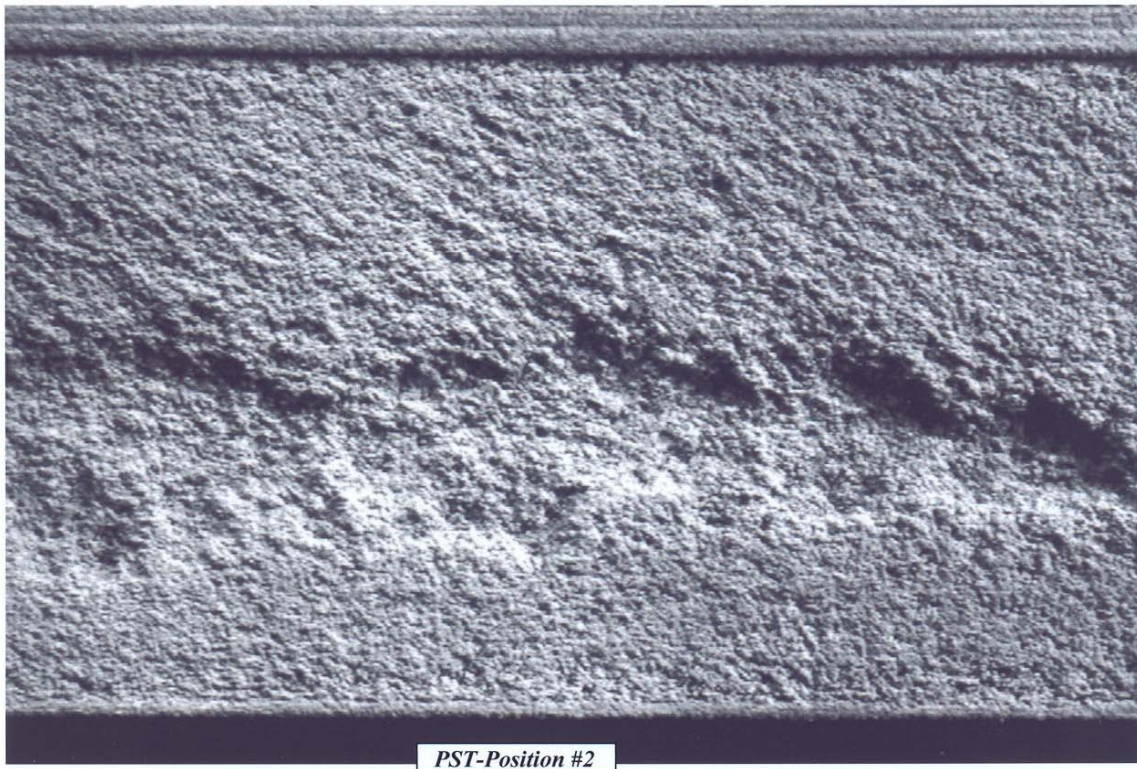
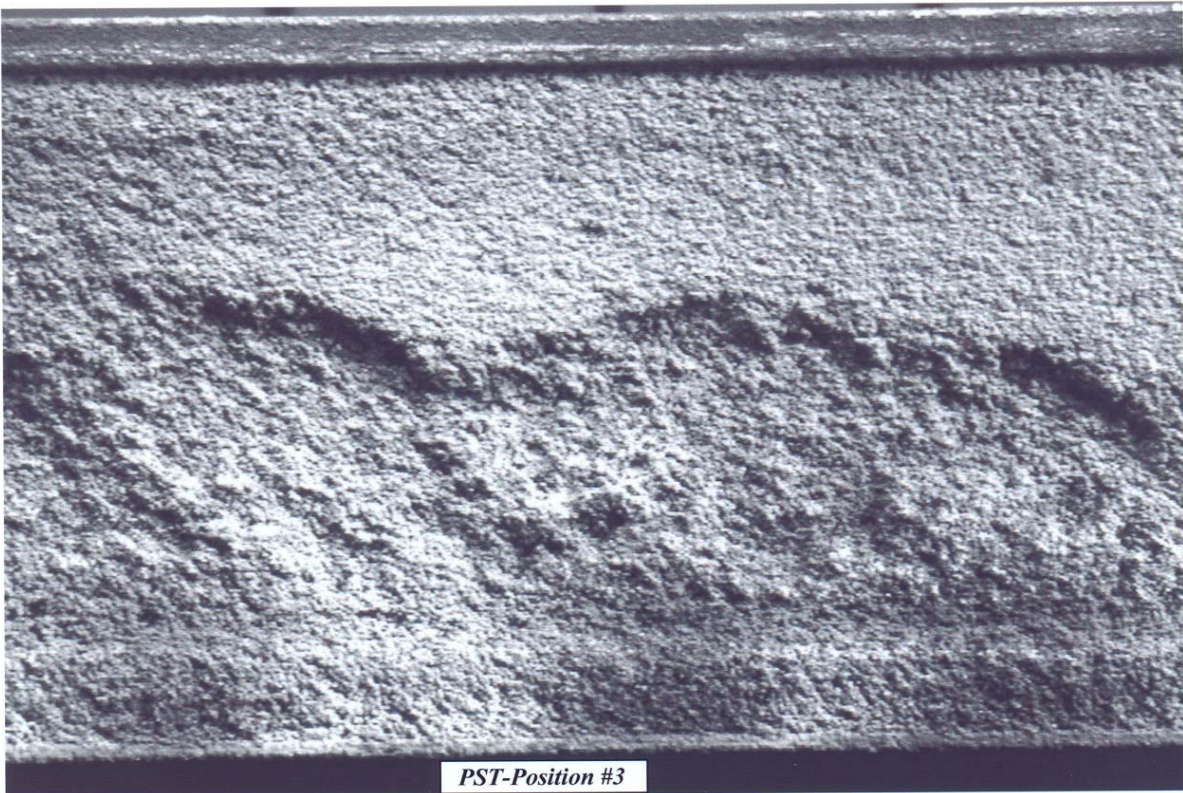
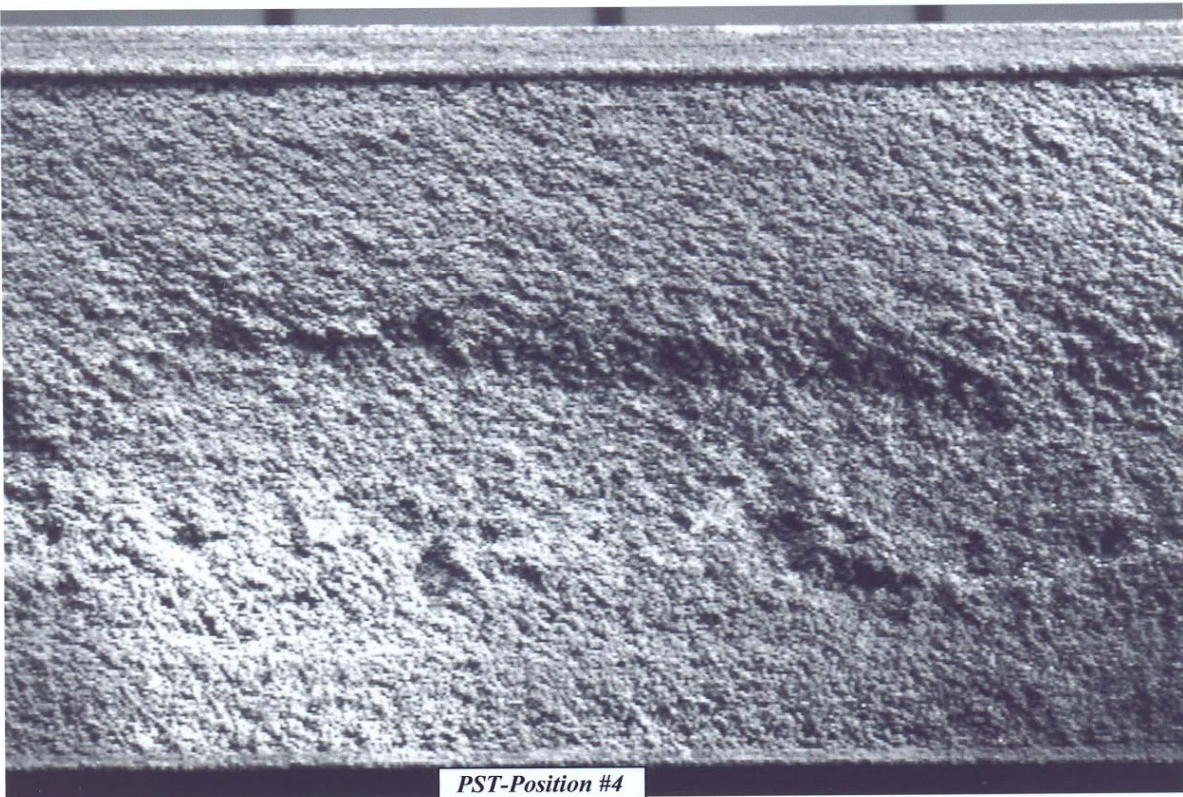
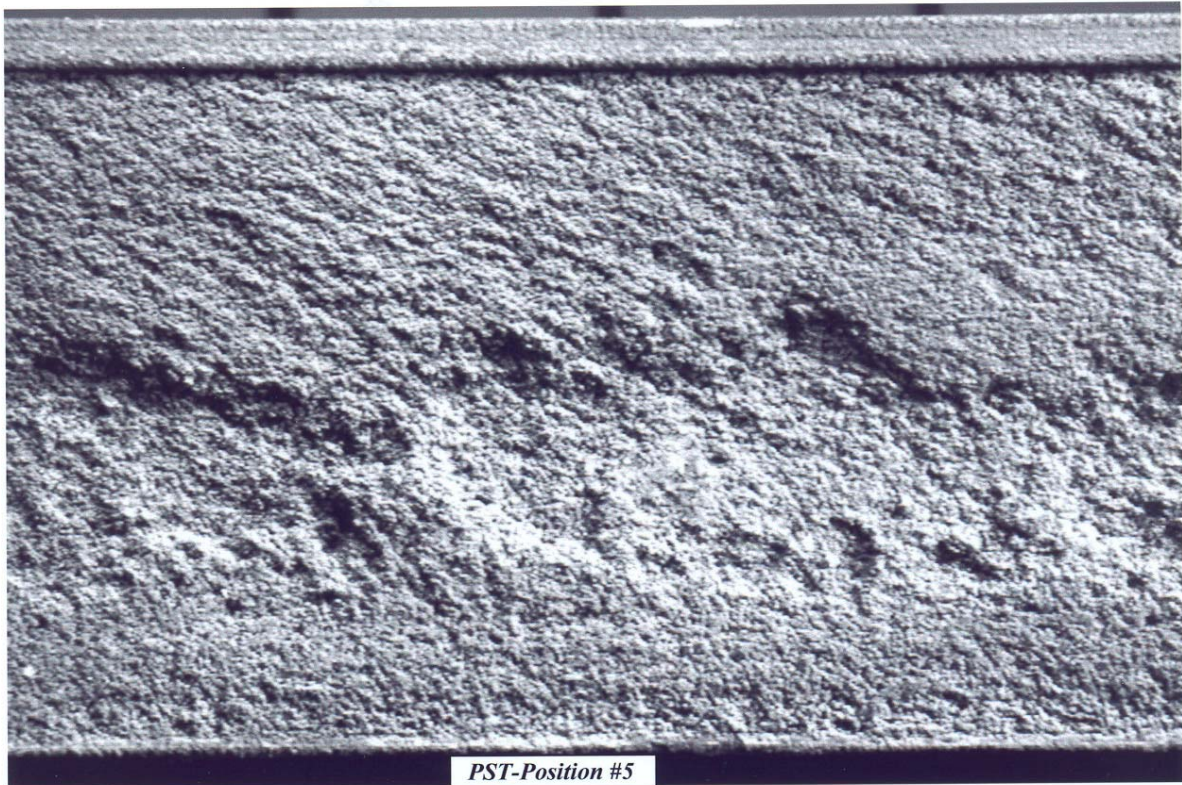
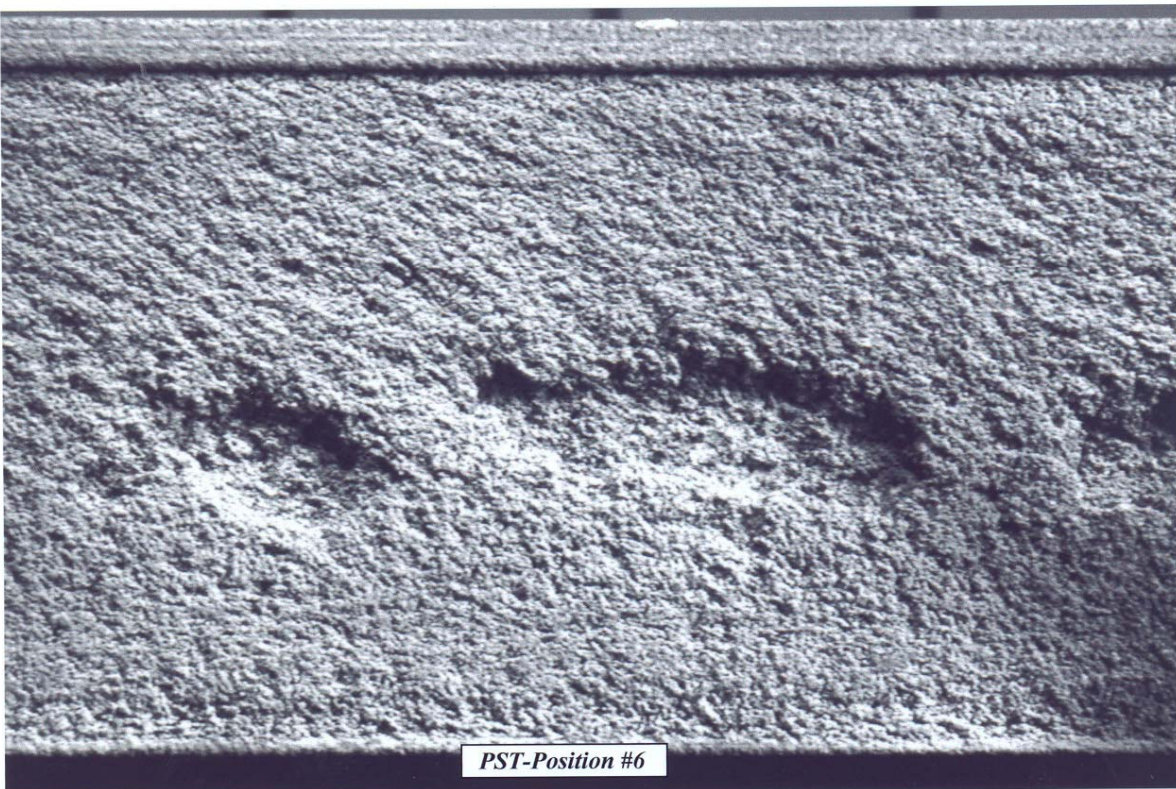
Figure 16. Macroscopic photos of the spall patches of LCA-314 coating on #51363 stage 6 ring. PST location numbers shown. Original size of top-to-bottom coated track is 1.1 inches.
