ATSB TRANSPORT SAFETY INVESTIGATION REPORT

Aviation Safety Incident Report – 200403110

**Engine failure - Melbourne Airport, Victoria
25-Aug-2004
Boeing Company 777-312
9V-SYB**

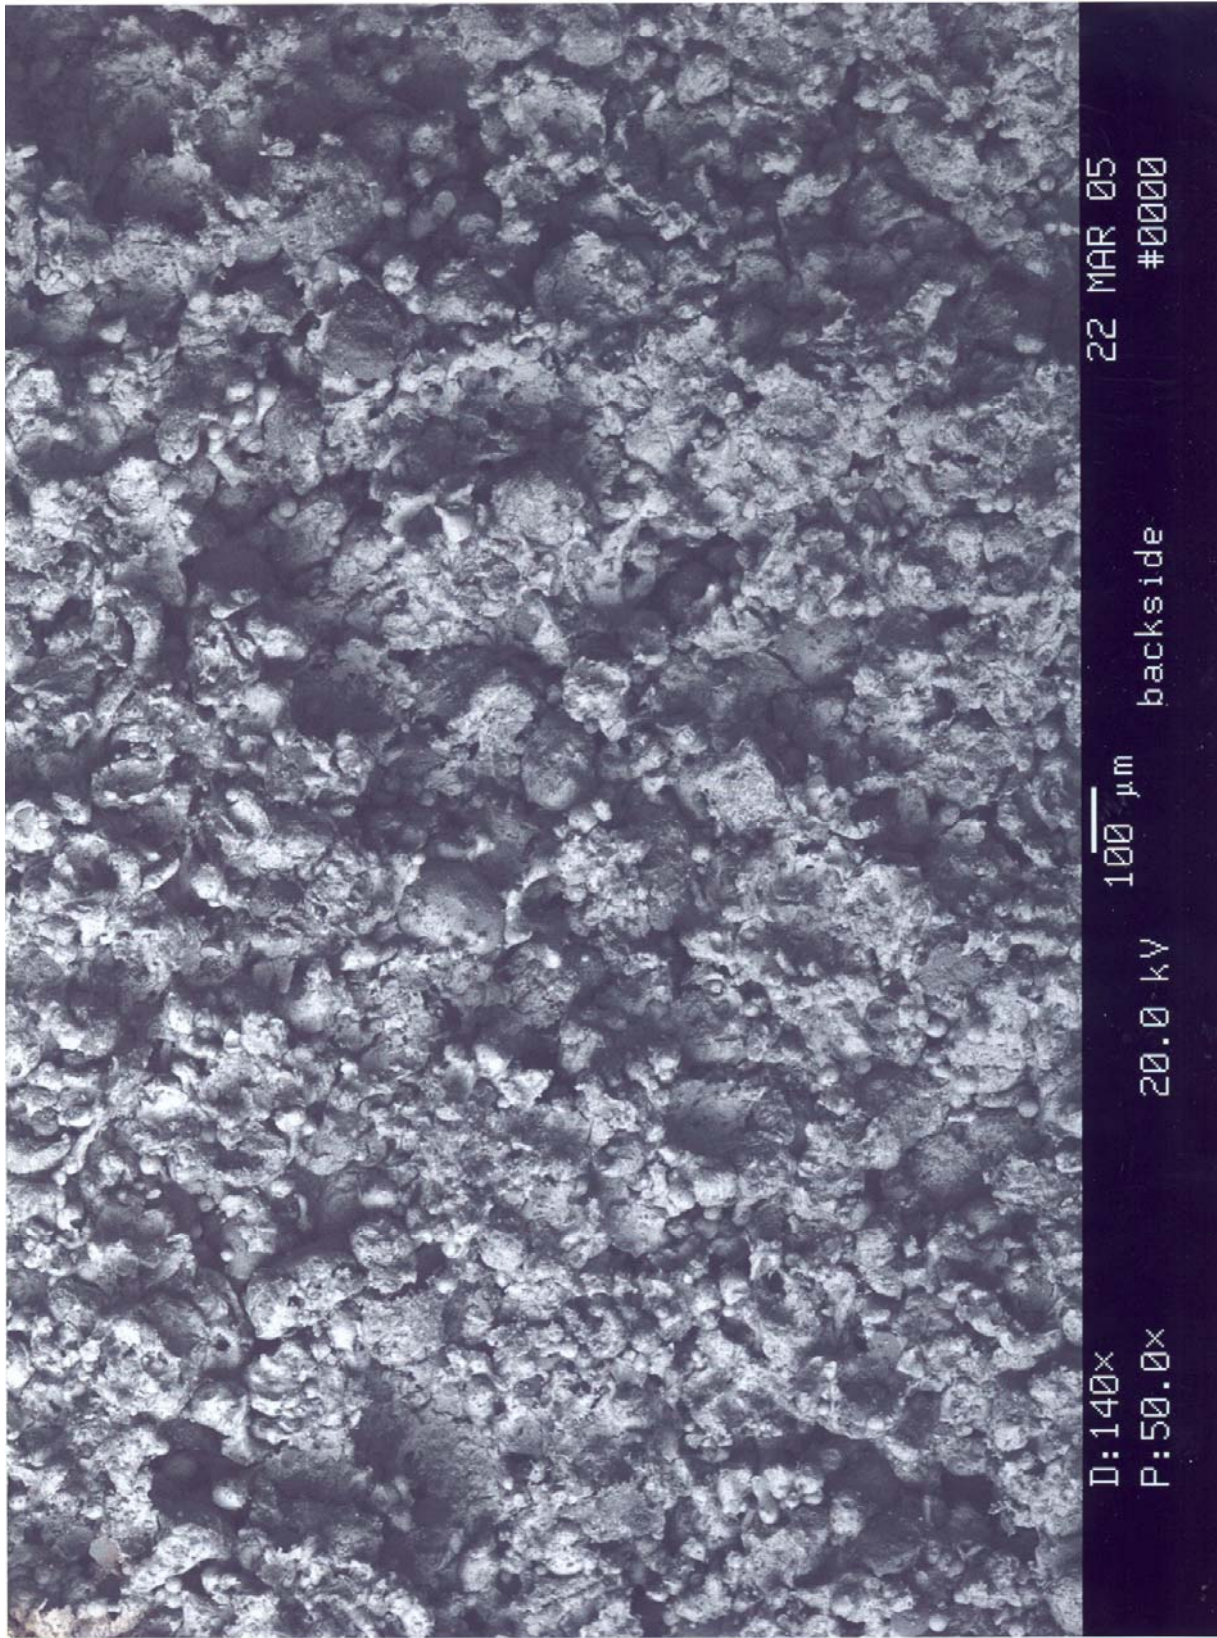
Figure 19a. SEM micrograph of backside of LCA-314 coating chip taken from #51363 stage 6 ring. 90 X magnification.

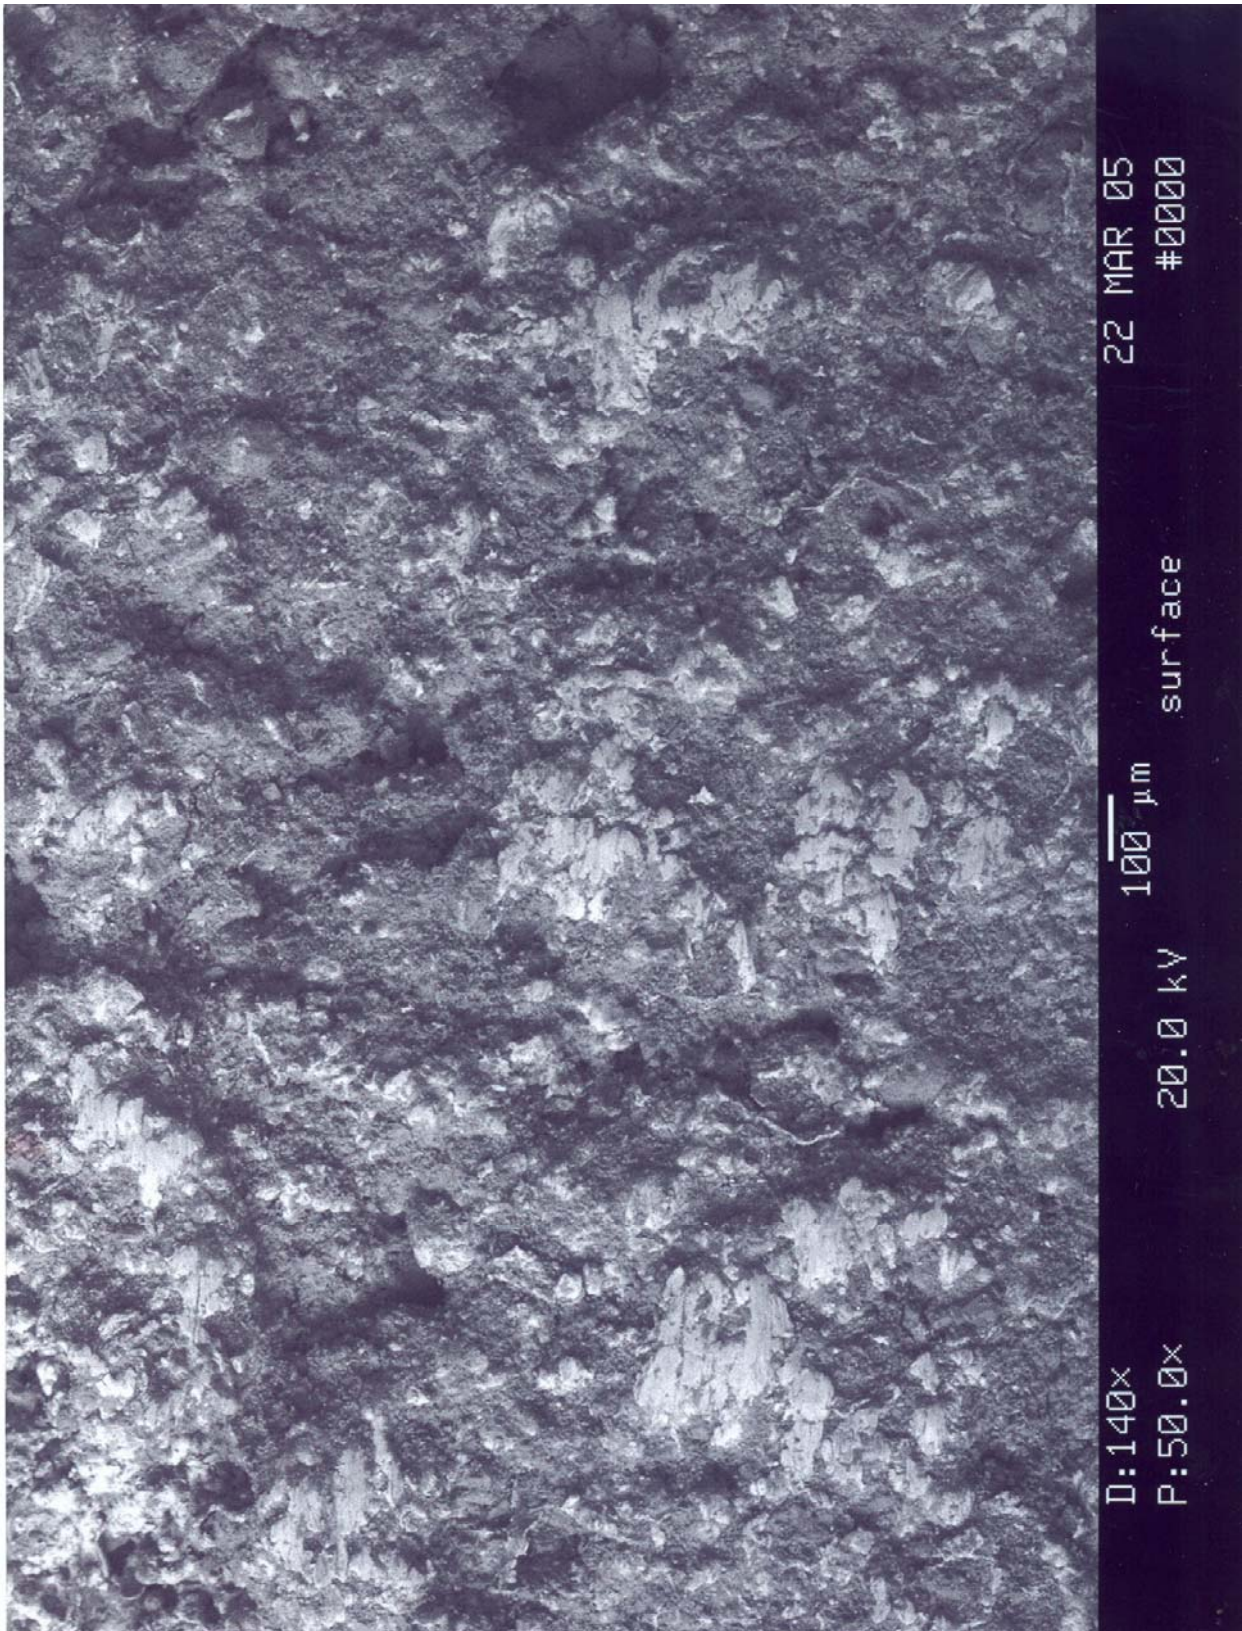
Figure 19b. SEM micrograph of front side of LCA-314 coating chip taken from #51363 stage 6 ring, showing fine-grained surface deposit on top of the 314 and small areas of light rub contact. Bright metallic smear of the rub areas suggest minimal oxidation after rub. 90 X magnification.

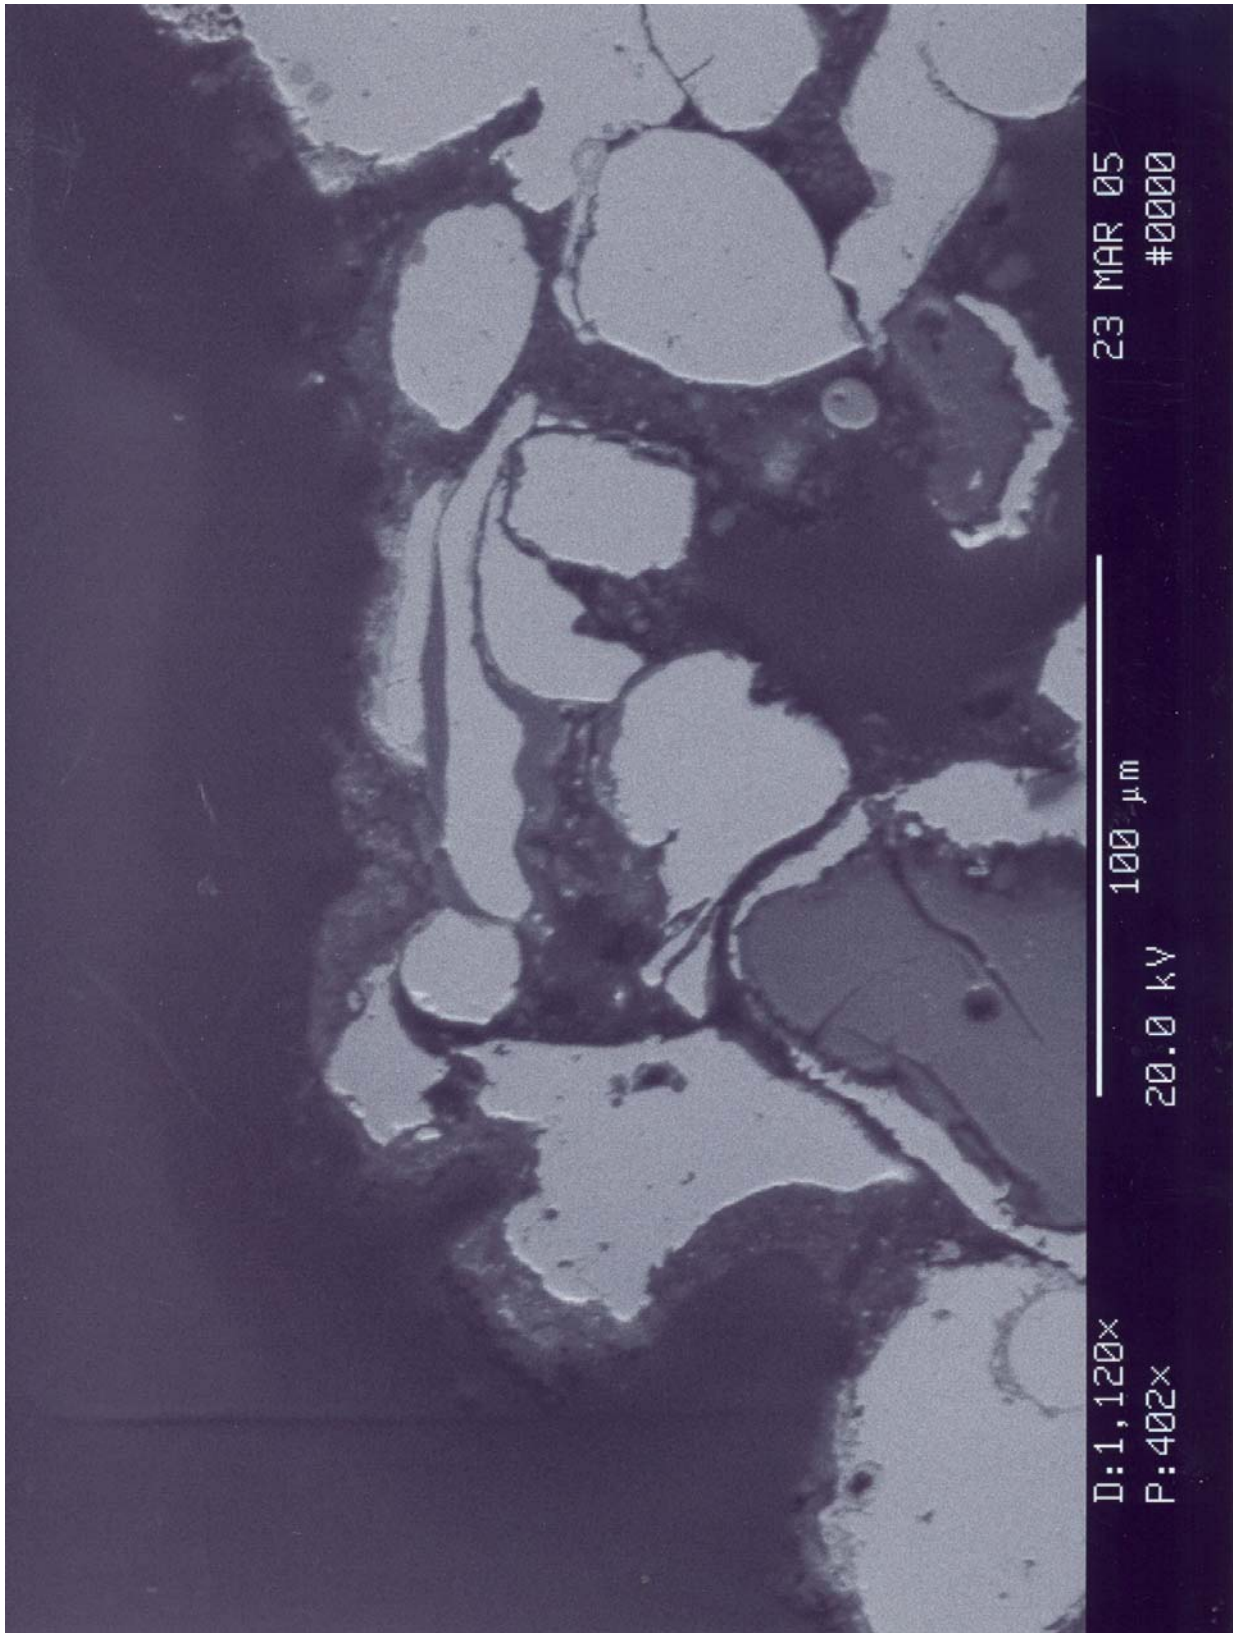
Figure 21a. SEM micrograph of polished cross section of LCA-314 coating chip taken from #51363 stage 6 ring, showing the normal 314 coating plus a fine-grained surface deposit that is also seen to penetrate into the 314 porosity. 715 X magnification.

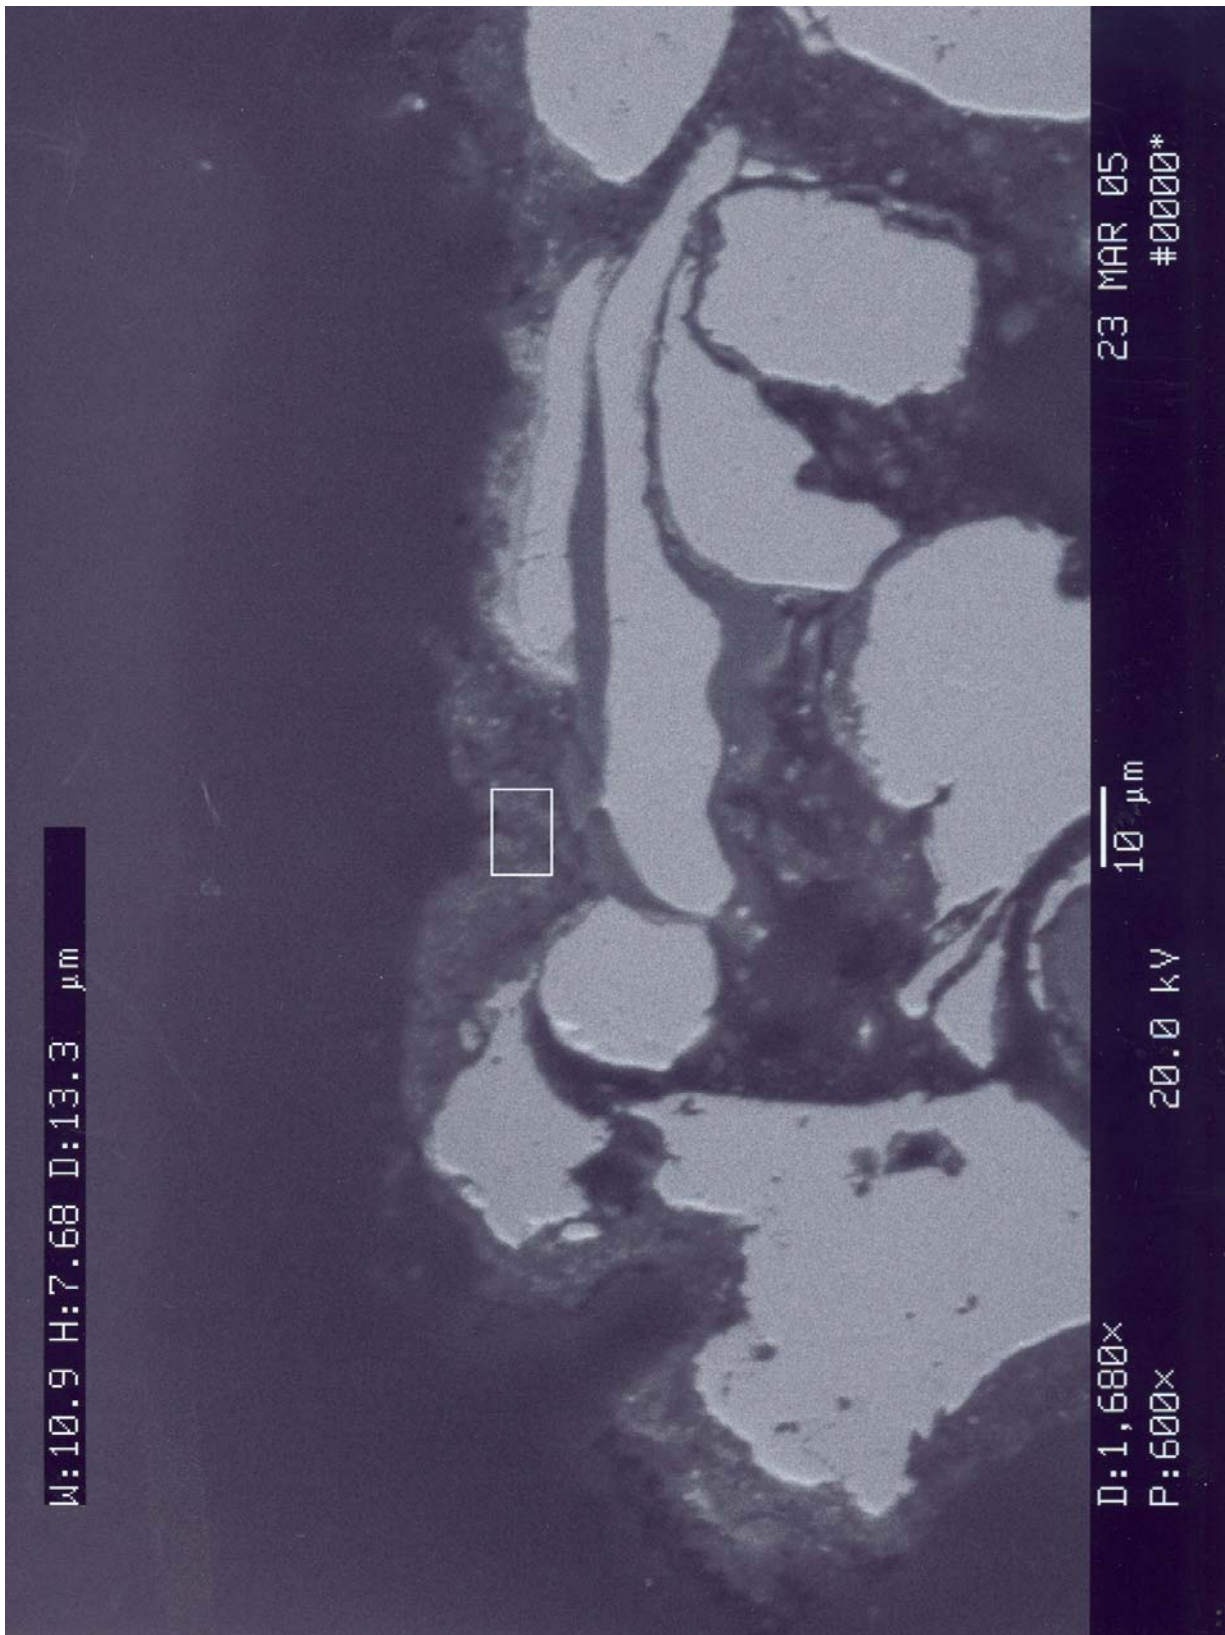
Figure 21b. SEM micrograph of LCA-314 coating for Fig 21a, at higher magnification showing area of EDS analysis within surface deposit layer in order to identify its composition. 1080 X magnification.
