ATSB TRANSPORT SAFETY INVESTIGATION REPORT

Technical Analysis Report No. 16/06
ATSB Investigation No. BO/200405511

**Independent Technical Review of
Gyrocopter Hub Bar Failures**

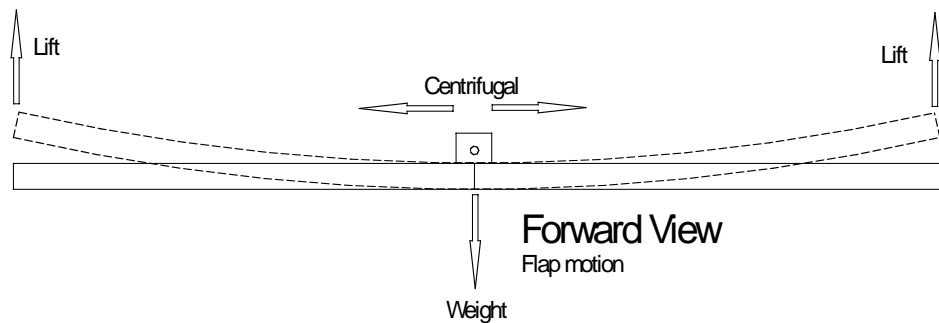
Figure 1: Hub bar ‘flap’ loads carried in steady flight

The function of the hub bar in a typical gyrocopter rotorcraft is to mechanically link the two rotor blades and provide for control of the aircraft via the movement of the rotor plane relative to the fuselage. In flight, the entire static weight of the rotorcraft and occupant/s is carried by the rotors and transferred through the hub bar and rotor head to the fuselage. Any flight manoeuvring will generate additional dynamic loads, as will landing and taxiing. A further source of loading arises from the spinning rotor, which produces a tensile stress along the bar axis in response to the centrifugal loads from the rotating blade masses. Drag and inertial loads acting on the individual advancing and retreating rotor blades may also induce bending in the rotor plane as the rotorcraft moves forward through the air. Figure 1 presents some of the basic loads sustained by the typical hub bar when in flight.

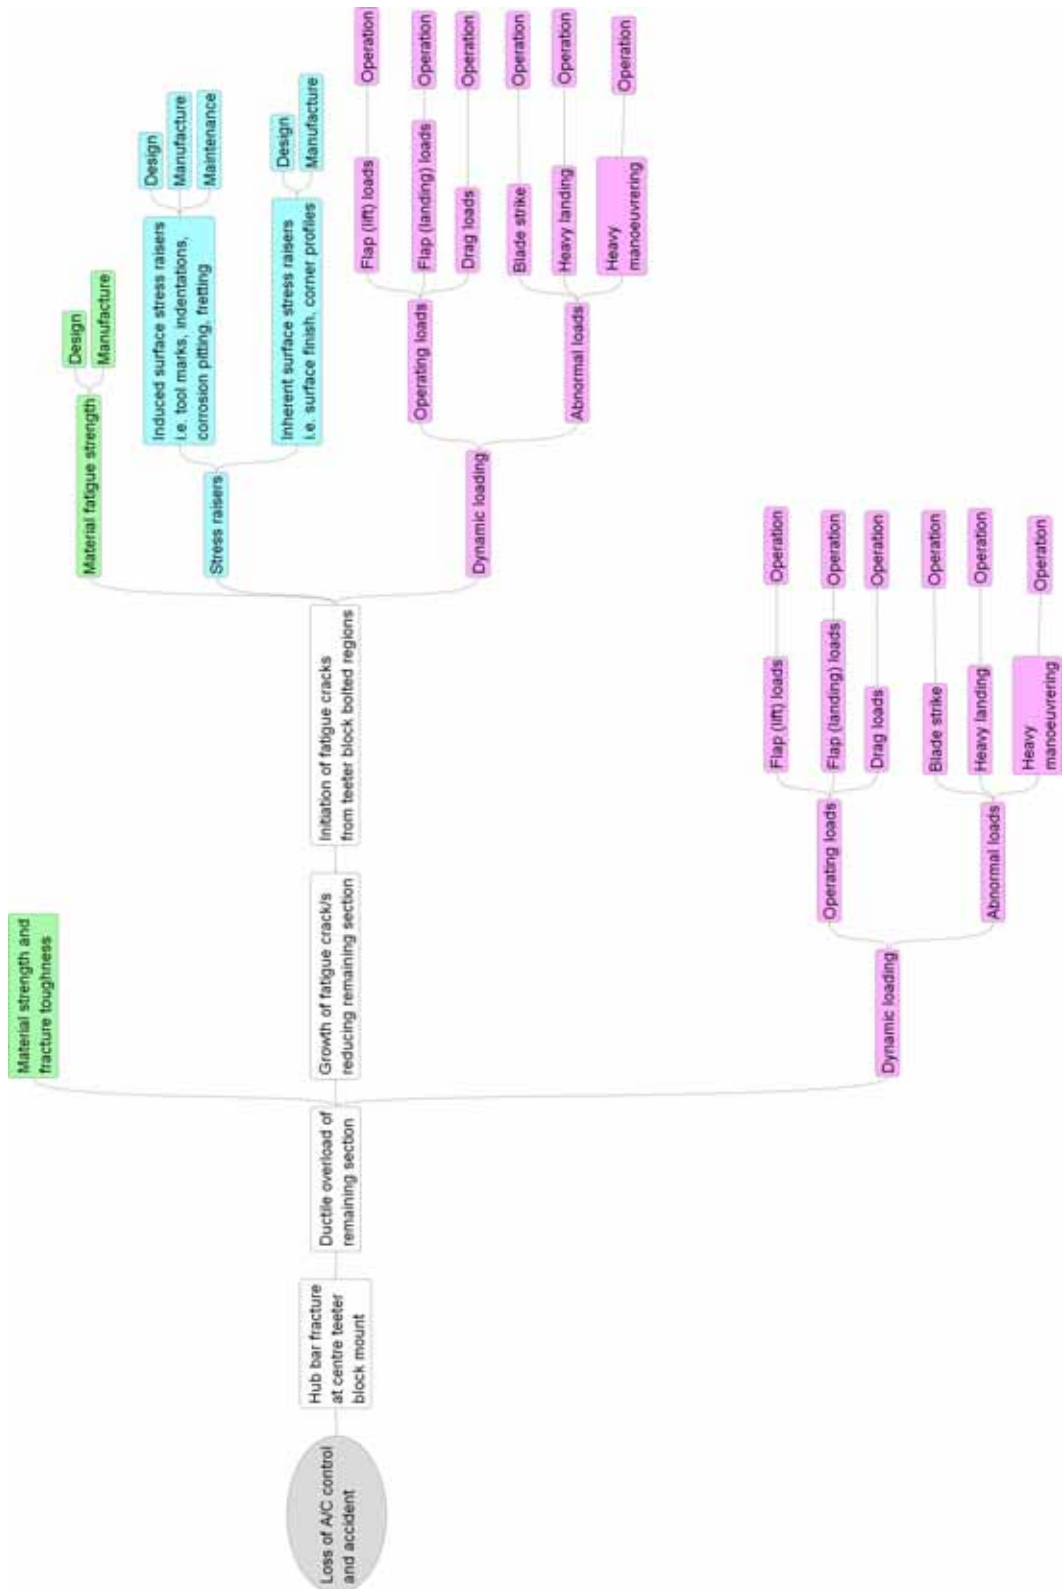
Appendix 1: Development of gyrocopter hub bar cracking, including possible contributory factors.

Appendix 1 presents a logic diagram examining the development of hub bar cracking. In all cases, the examinations referenced at [9] and [13] identified the presence of stress raising defects at the crack origins – features such as mechanical indentations produced by fastener clamping or surface fretting between the hub bar and fixtures.
