**ATSB TRANSPORT SAFETY INVESTIGATION REPORT**

Aviation Occurrence Report – 200501000

Final

**Loss of control  
7 km WSW of Tamworth Airport, NSW  
7 March 2005  
VH-FIN  
Cessna 310R**

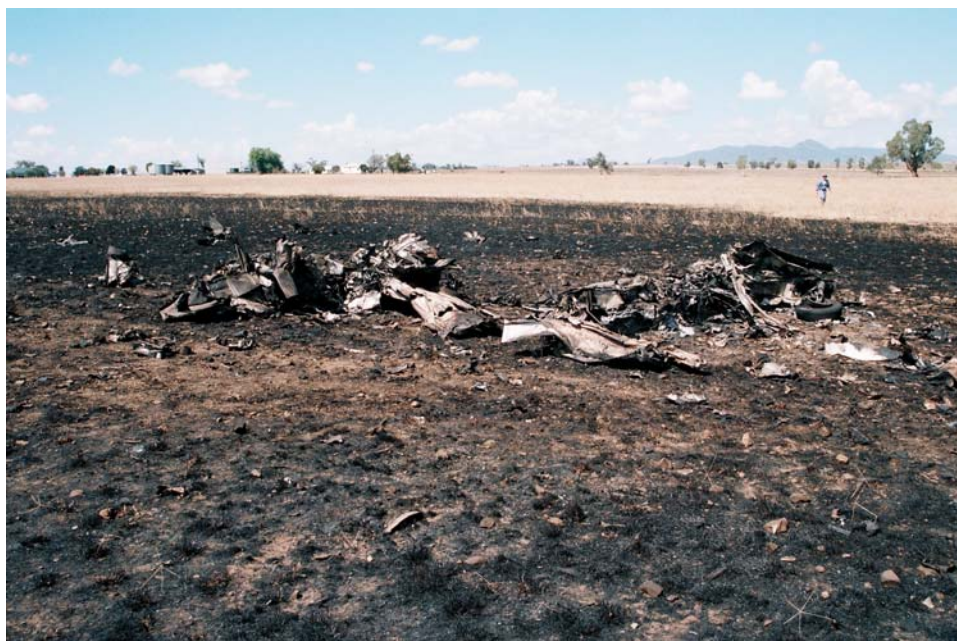
**Figure 2: Accident site**

Ground impact marks indicated that the aircraft struck the ground upright in a near wings level (slightly right wing low), nose-down attitude of between 35 and 40 degrees, on a heading of about 105 degrees magnetic (a downwind heading for runway 30R in nil wind conditions would have been about 121 degrees magnetic).

The wreckage trail covered a distance of approximately 217 m in length with a maximum width of 31 m. Small, high-density items such as instrument gyros were found at the end of the wreckage trail. The main section of the wreckage (Figure 5), consisting of the wings, fuselage and engine, was 23 to 29 m from the point of initial impact.

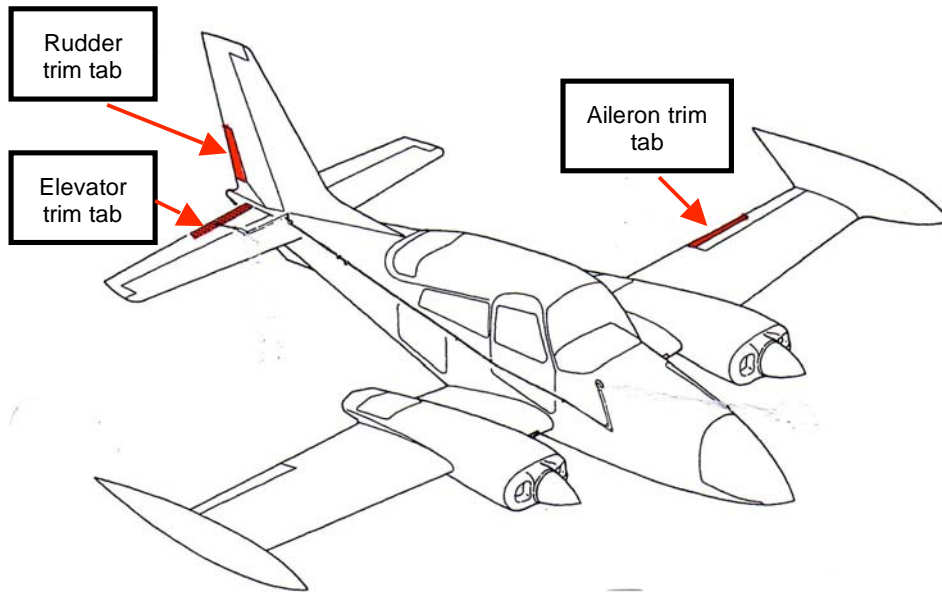
**Figure 3: Cessna 310R trim tab location**

All of the trim tabs were identified in the wreckage and were found attached to the parent control surfaces. All of the trim tab actuators were removed from the aircraft wreckage for detailed examination. Before the actuators were disassembled, each unit was x-rayed. There was evidence of positive thread engagement throughout and no indication of any abnormalities. The aileron trim tab actuator shaft was bent approximately 90 degrees, consistent with impact and break-up forces.

Each trim tab actuator's as-found extension was measured, translated into trim tab deflection and compared with the manufacturer's trim tab deflection limits. Those results were:

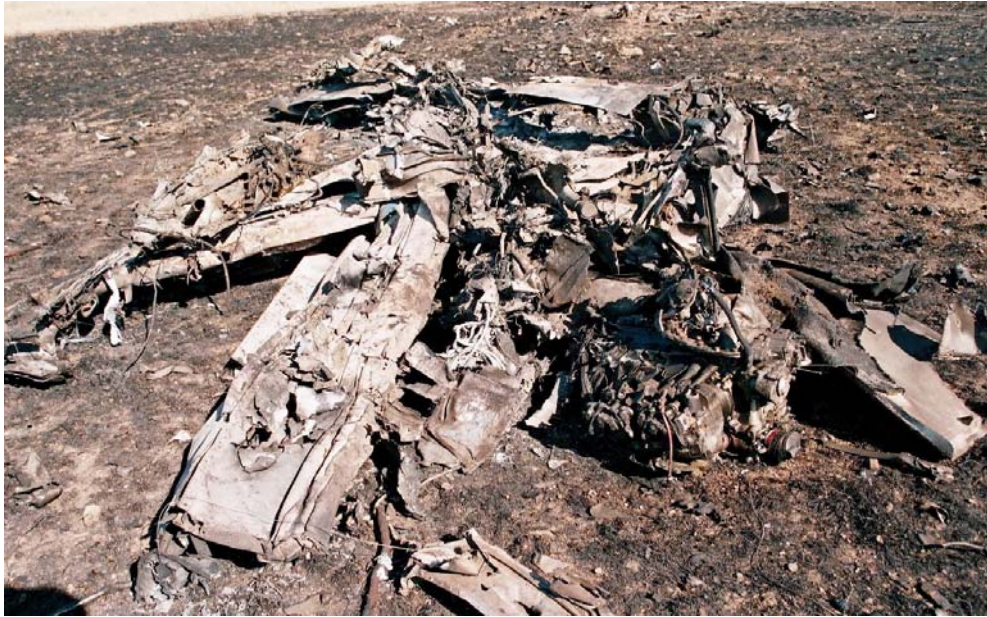
**Figure 5: Main wreckage**

The aircraft was destroyed by the impact forces and subsequent fire. The cockpit area, including all instrumentation, experienced high impact forces, resulting in extensive fragmentation damage.

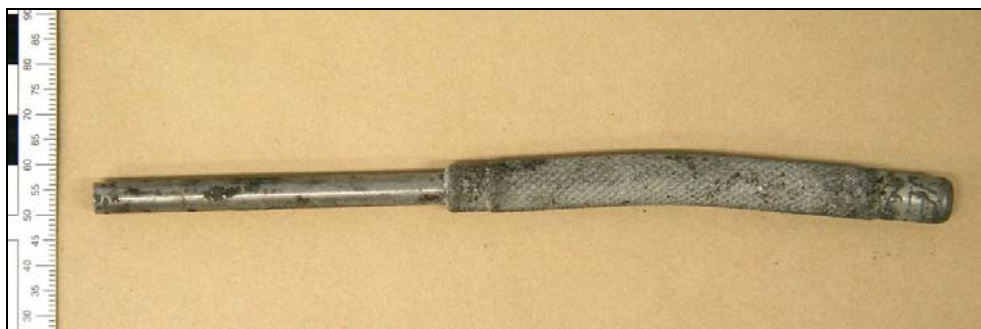
**Figure 6: Tool recovered on site**

During the on-site examination of the wreckage, investigators located a number of tools including a damaged hand tool (Figure 6) that would not normally be expected to be carried on the aircraft. The tool, known as a pin punch, was identified as belonging to an employee of the primary maintenance provider. That employee had not been involved in aircraft maintenance for the 6 months prior to the accident and the maintenance provider reported that the maintenance carried out before the flight did not include any tasks requiring use of such a tool. The investigation was unable to establish where the tool was located in the aircraft or when the tool was left in the aircraft.

Specialist examination of the bending damage to the punch handle found that the tool had impacted against, or been struck by, a wrought aluminium component or structure before or during the accident ground impact. There was no evidence that the punch had been trapped within, or had in any way interfered with the control systems of the aircraft – indeed, the absence of reciprocal loading points on the punch handle (support points opposite the impact point) was evidence against such an eventuality.

While not quantified in terms of a mechanical assessment of the control systems of the Cessna 310, it was nevertheless considered unlikely that a force of the magnitude calculated (280+ kg) could be developed and placed against the punch handle under the conventional movement of the flight controls by the pilot.

The location of the bent hand tool in the wreckage raised the possibility that it may have contributed to the flight control difficulty. Despite the tool being found in the wreckage, it was not possible to establish whether it was in an internal section of the aircraft that contained part of a primary flight control system or when it had been introduced.

The bending damage to the tool was found to be consistent with severe impact and breakup forces and there was no evidence that the tool had interfered pre-impact with a control system. Such evidence, however, may not have been detectable post-accident.

There was no work carried out during the maintenance activities preceding the flight that appeared to require use of such a tool. It is possible that the tool had been in the aircraft for some time and had not been detected during the recent periodic inspection. In any case, given the engineer checked the full and free movement of the flight controls prior to the flight, there was no evidence of any event or condition likely to precipitate ingress of the tool into a flight control mechanism before, during or after the takeoff.

1. There was no evidence that a bent hand tool found in the wreckage was implicated in the development of the accident.

Although the investigation considered that the tool found in the wreckage was not implicated in the accident, the presence of foreign objects in the internal parts of aircraft increases the risk of interference in flight control systems and other systems within aircraft. Aircraft maintainers need to be vigilant in the inspection of internal

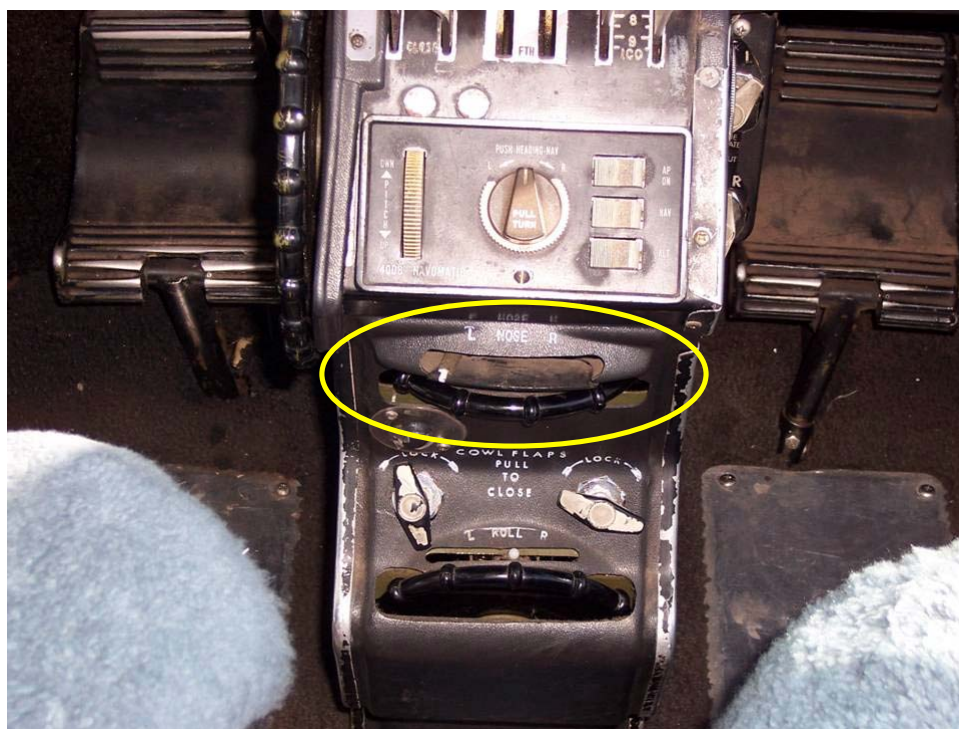
The rudder and aileron trim controls were located outside of the lower right quadrant of the pilot's visual field. That would have minimised the pilot's ability to detect the status of the rudder and aileron trim indicators which were located in the lower portion of the centre pedestal.

**Figure 7: Rudder trim wheel (circled) viewed from behind the pilot's seat**

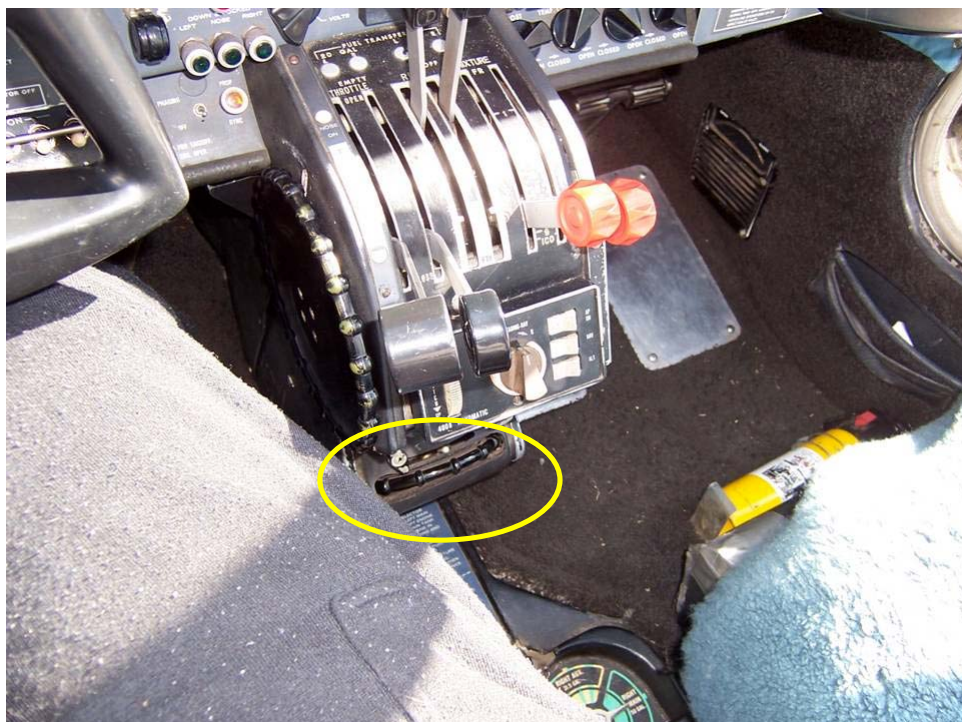
**Figure 8: Aileron trim wheel (circled) viewed from the pilot's seat**
