ATSB TRANSPORT SAFETY INVESTIGATION REPORT

Aviation Occurrence Report – 200501189

**In-Flight Engine Failure and Shut-Down
Boeing 717-200
148 km NNW Launceston TAS**

18 March 2005

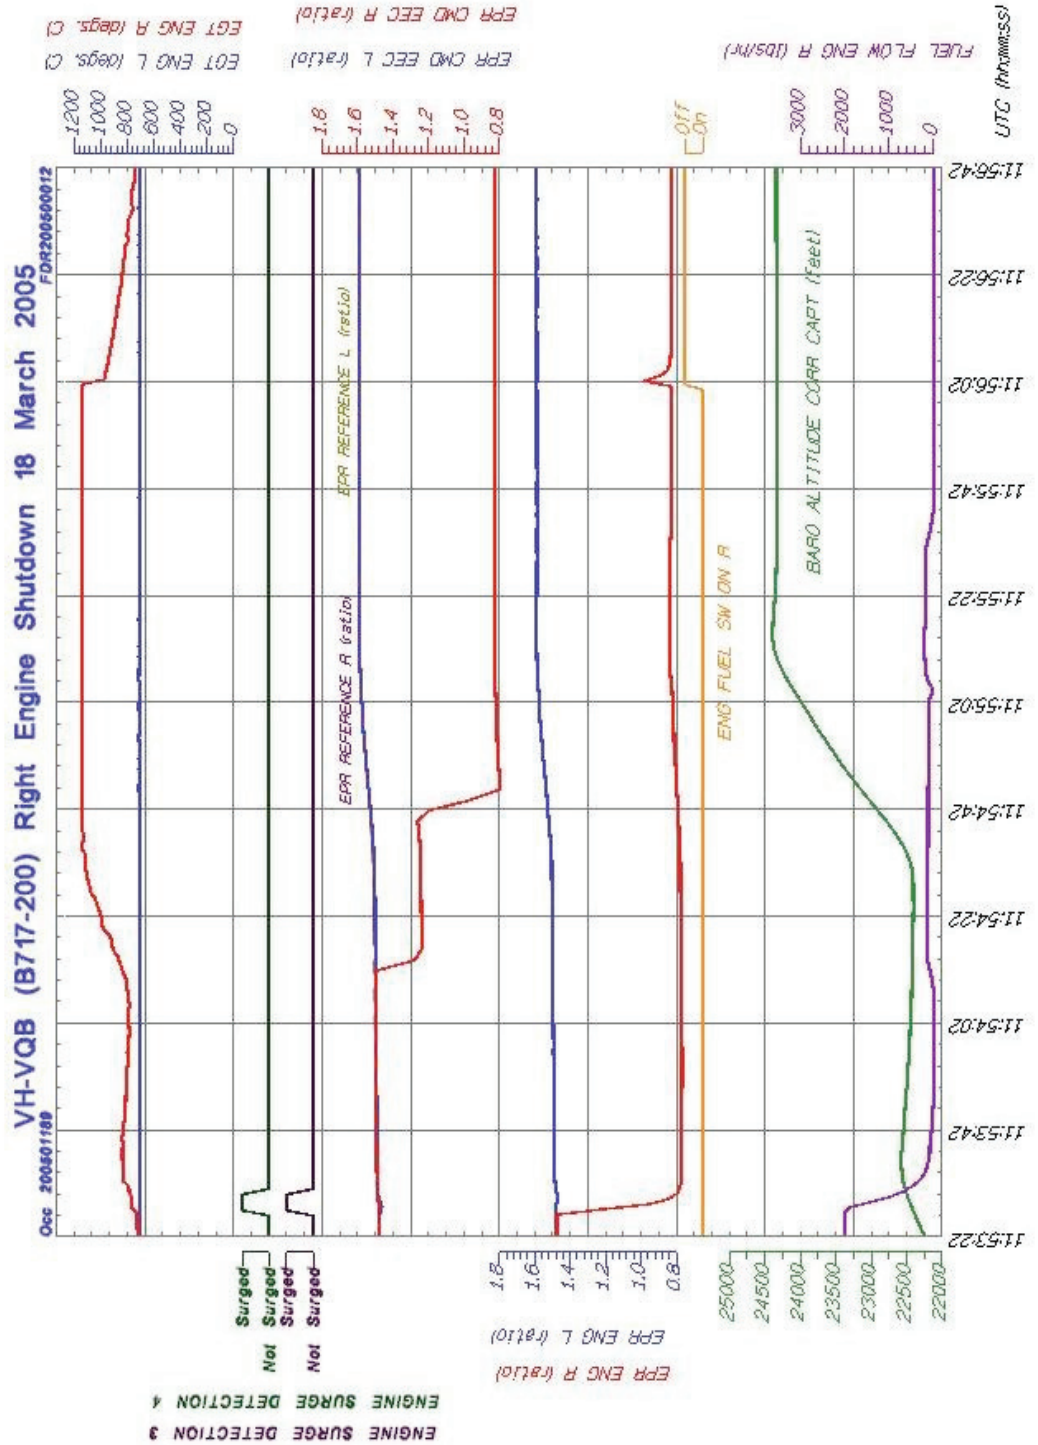
Examination of the FDR data revealed that about ten minutes after takeoff from Launceston airport and while climbing through 22,382 ft, the right engine of Boeing 717-200, VH-VQB indicated a 'surge' condition (figure 1). At this time, both the commanded and indicated engine pressure ratios (EPR) were 1.48, fuel flow was 2,000lbs/hr, N1 and N2 were 91-92% RPM, and exhaust gas temperature (EGT) was 706-724°C. Following the surge indication, the right EPR, fuel flow, N1, N2 and oil pressure decreased abruptly. At the same time, the right engine EGT began to increase.

The commanded EPR on the right engine was reduced to 1.24, 45 seconds after the surge condition, and to 0.8, 32 seconds later. The EGT continued to increase and passed through 1,141°C¹ about 73 seconds after the engine surge indication; remaining above that level for 82 seconds, until the selection of the right engine fuel switch to the OFF position.

Figure 1: incident_flight_2_zoom.plt – 200 second period during time of engine shutdown showing recorded values of barometric corrected altitude, engine EPR (actual, commanded and reference), engine EGT and right engine fuel flow/ fuel switch position.

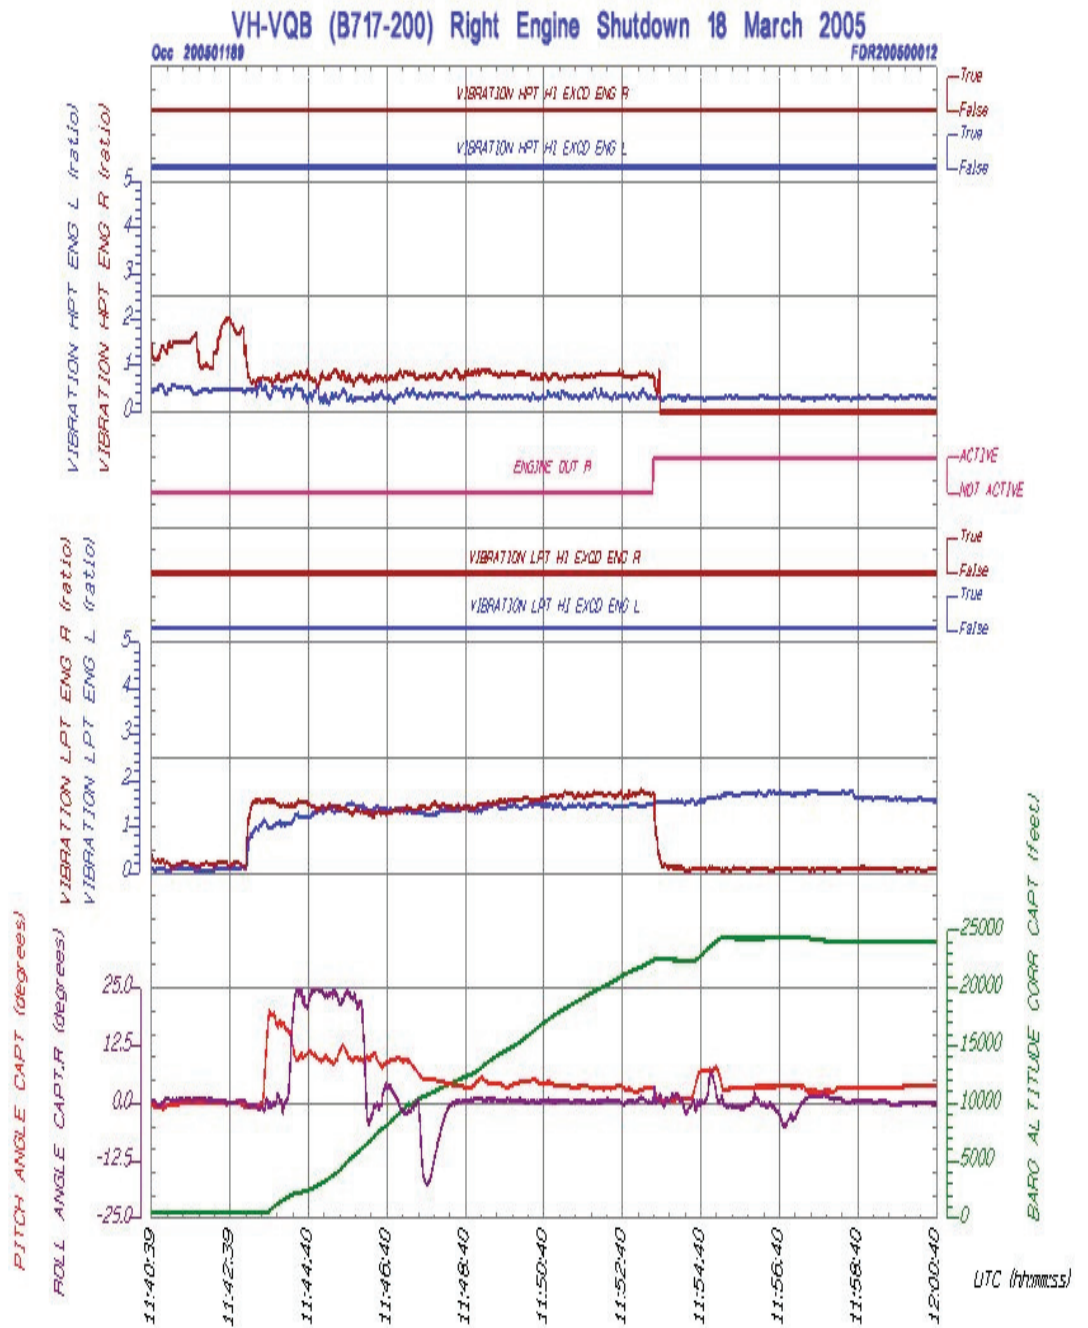
Data from the flight recorder showed that the right engine HPT vibration levels had been consistently higher than the left engine levels prior to the incident (figures 2 and 3) and during the previous six flights. This was particularly evident during the climb and descent phases of the flights (figure 3) and reached a peak three flights prior to the incident flight. The right engine vibration levels had not, however, reached a high enough value to generate a vibration level exceedance warning at any time during the flights from which data was available. Analysis by the manufacturer indicated that prior to and leading up to the failure, the vibration levels of both aircraft engines were within the bounds of normal operation, with the left engine presenting particularly low vibration levels.

Figure 2: *incident_flight_vibration.plt* – 20 minute period leading up to and including engine shutdown showing the recorded values of barometric corrected altitude, pitch angle, roll angle, engine out R, engine vibration levels (LPT and HPT) and engine vibration hi exceedance (LPT and HPT).

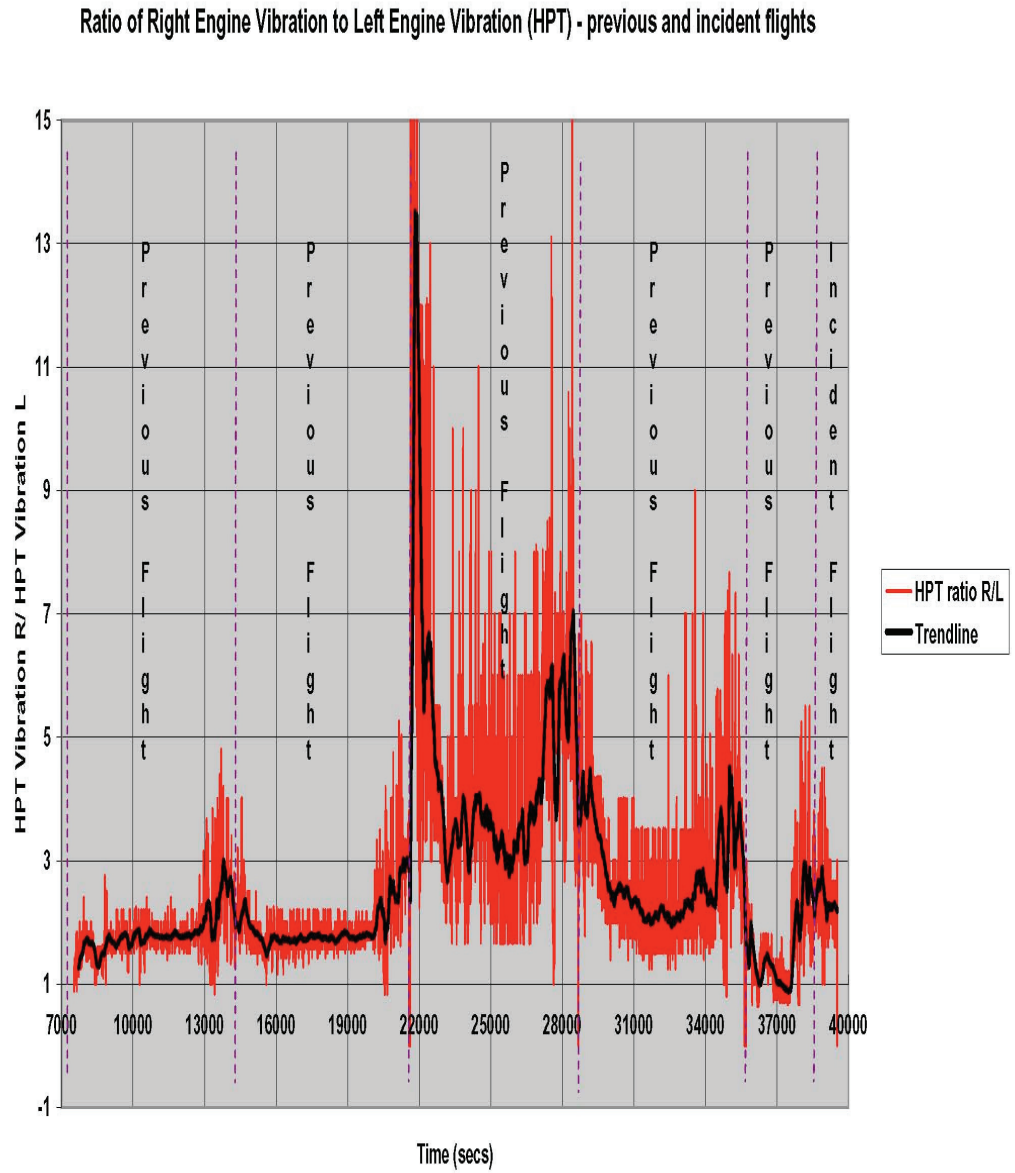
Figure 3: Ratio of right engine vibration to left engine vibration (LPT) previous and incident flights

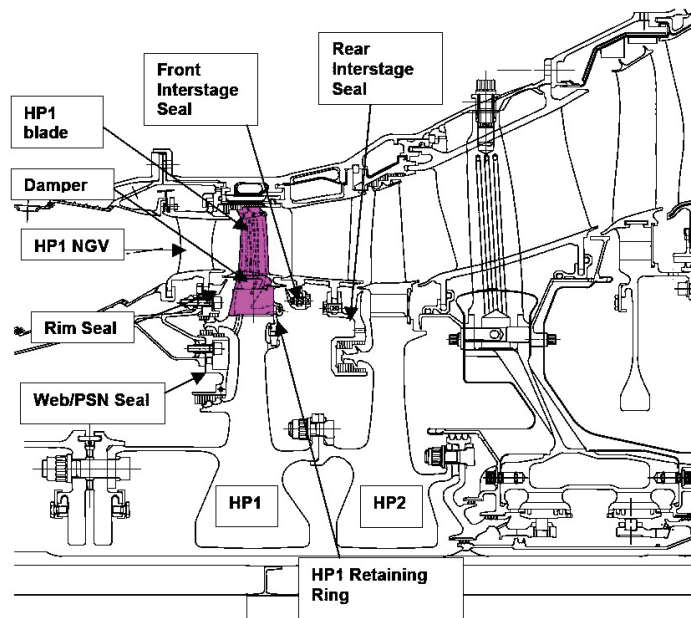
Disassembly of the engine high-pressure turbine module (figure 4) revealed the fracture and loss of all blades from the aerofoil root section around the HPT1 disk. Impact damage was confined to the trailing edges of the HPT1 NGV segments, with the leading edges showing no evidence of foreign hard-object ingress. The HPT2 blades presented similar impact and forced rupture damage, with the HPT NGV segments showing leading-edge impact and thermal damage. All exposed surfaces throughout the high-pressure turbine exhibited heavy surface oxidation and metallisation deposits.

Figure 4: BR715-A1-30 engine high-pressure turbine section⁴.

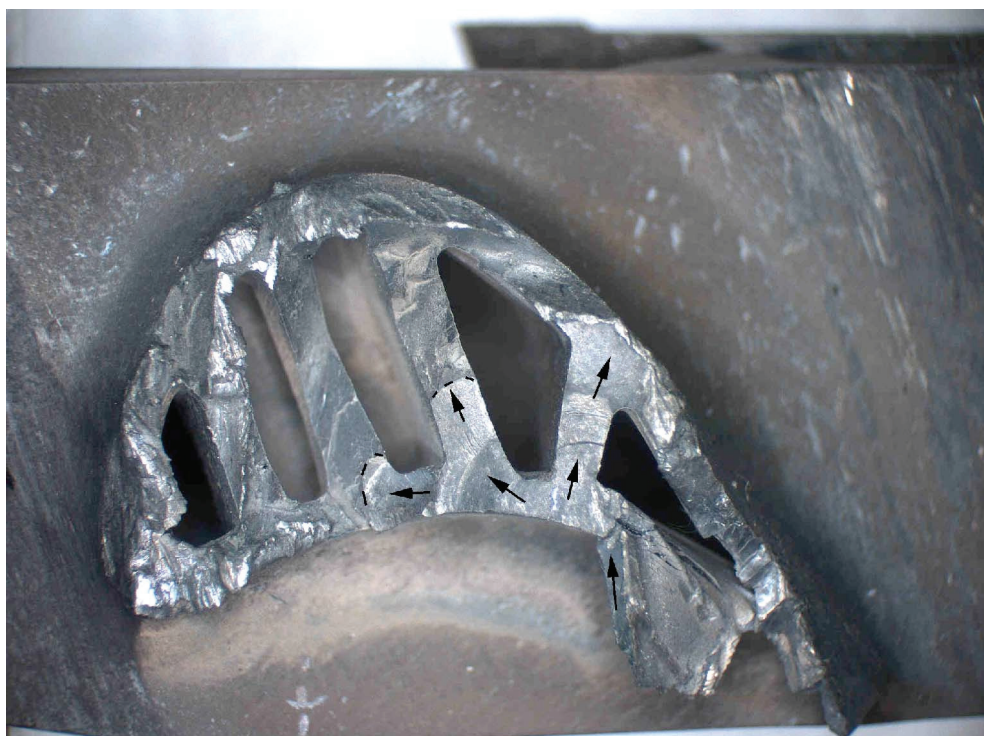
The characterisation of the HPT1 blade failures by the manufacturer's materials laboratory found one blade presenting clear evidence of transverse fatigue cracking above the aerofoil root transition, extending through approximately one-quarter of the blade cross section (figure 5). All other HPT1 blades showed the uneven fracture morphology typical of failure under impact overload conditions. Although damaged, the region of fatigue cracking appeared to have an origin towards the blade trailing edge cooling holes, with the subsequent propagation morphology being typical of crack growth under resonant vibratory conditions (High Cycle Fatigue, HCF). Impact and mechanical damage prevented any further characterisation of the origin region.

Figure 5: Fractured HPT1 blade with annotations showing the growth of fatigue cracking.

As a possible failure mechanism, the engine manufacturer proposed that a portion of an eroded HPT stage-1 NGV vane may have released and damaged the trailing edge of an HPT blade, which subsequently cracked under HCF conditions stemming from NGV deterioration and the stress-raising effects of the trailing edge damage.

Failure of the HPT stage-1 blade was attributed to the initiation and growth of high-cycle fatigue cracking transversely through the blade lower aerofoil section. Damage to the trailing edge region precluded the characterisation of the fatigue origin and prevented the establishment of the manner in which the cracking initiated.

- Monitoring of the P30 engine parameter and requiring a borescope inspection of the HPT1 NGV assembly once the parameter decreases below 96.5 percent of initial values. A reduction in the P30 parameter provides an indicator of degradation and metal-loss within the NGV assembly.
- Changes to the maintenance requirements for the hot-section of the engine during routine or unplanned workshop visits, requiring the replacement of degraded HPT1 NGV segments that would otherwise have been repaired and returned to service.
- Design action to improve the robustness of the HPT1 NGV assembly and the functionality of the HPT blade dampers. Service bulletins SB-BR700-101579 and SB-BR700-101546 have been released to implement changes to the blade and NGV configuration aimed at reducing the potential for premature NGV degradation and enhancing blade vibration damper reliability.
