ATSB TRANSPORT SAFETY INVESTIGATION REPORT

Aviation Occurrence Report – 200501912

Tower Shaft Failures on PWC Engines

PW100 Series Engines

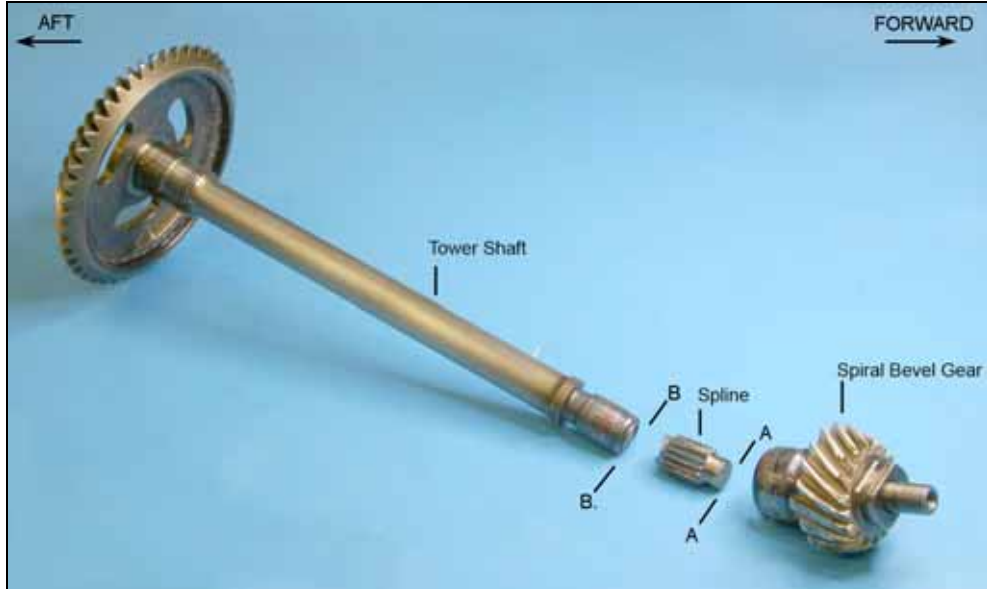
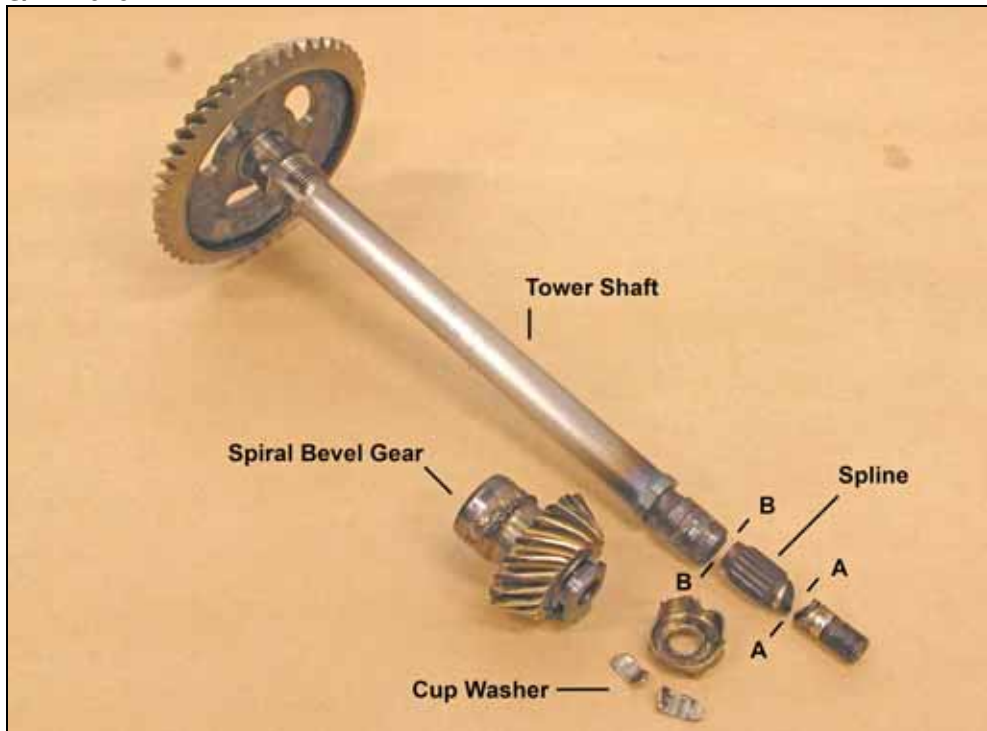
Other damage to the tower shafts included circumferential abrasion from metal-to-metal contact adjacent to the mid-section fracture at location B-B of figure 3. Discolouration, commonly referred to as 'heat tint', was also observed in the abraded region of both shafts, which indicated that the shafts had experienced localised high temperature distress at that location. The shaft from engine S/N 120257 displayed significantly more discolouration than shaft from S/N 115622.

Figure 3: Photographs of the failed tower shafts from engines S/N 115622 (VH-XUD) and S/N 120257 (VH-TQW). Both shafts fractured at two locations (labelled A-A and B-B) allowing separation of the spiral bevel gear and mid-shaft spline gear.

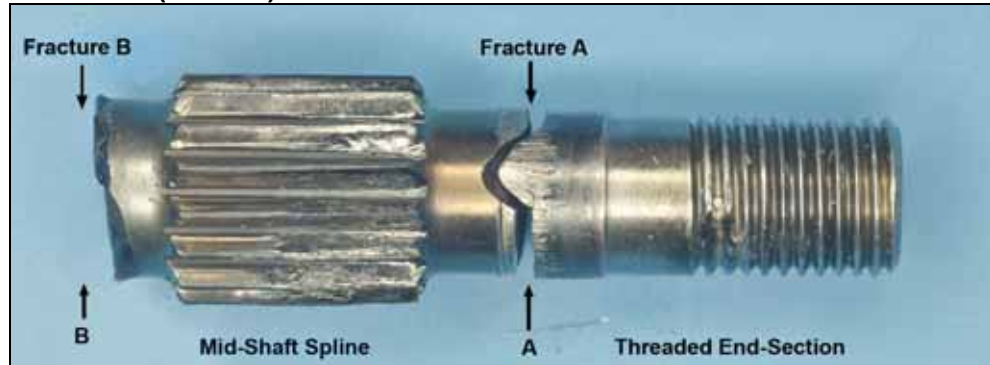
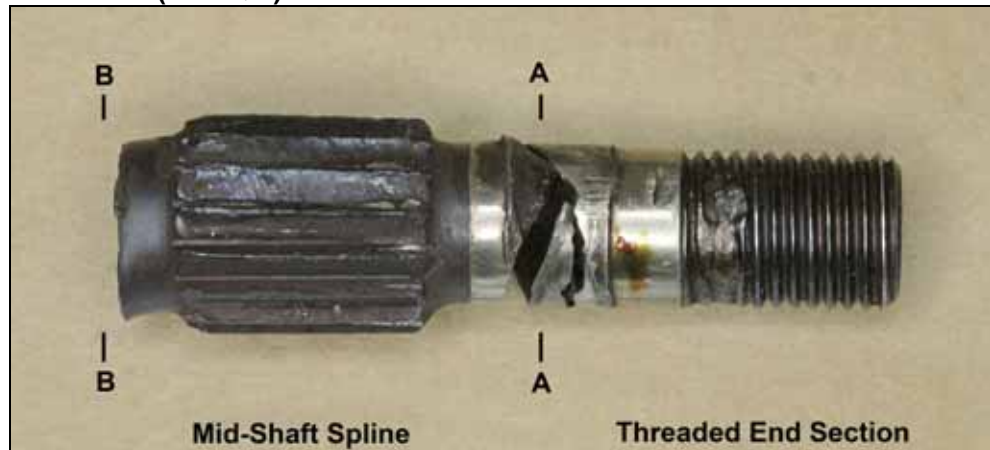
Figure 4: General view of the liberated mid-shaft spline gear and threaded end section of the tower shaft showing the location of both fractures.

Close examination of the mid-shaft splines and the threaded end-section from each shaft, showed clear and severe galling¹⁰ on the seating diameter close to fracture location A-A, see figure 4 and figure 5. The galling damage was aligned longitudinally with the shaft axis with many well defined scores observed, which was consistent with being produced during the pressing of the spiral bevel gear onto the shaft.

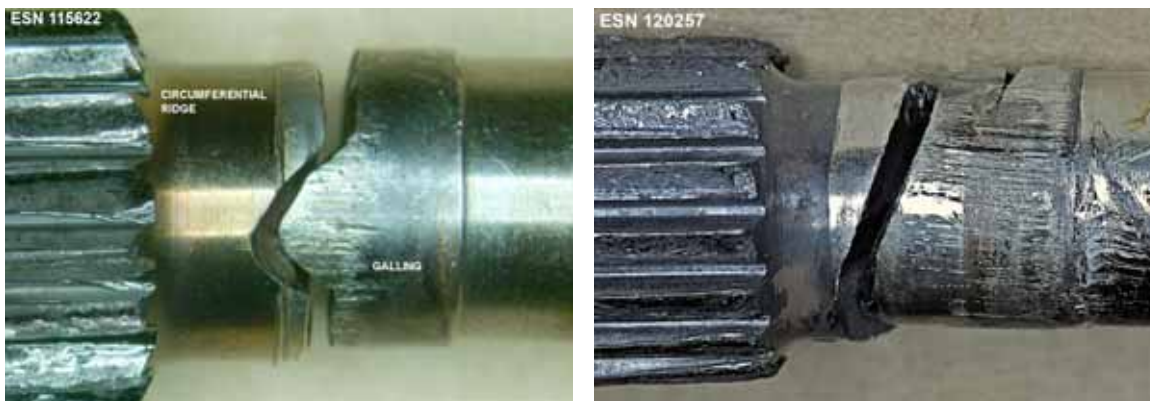
Figure 5: Close-up of fracture A-A showing the identical nature of the damage to the seating diameters of tower shafts from engine S/N 115622 (VH-XUD) and S/N 120257 (V/H TQW).

The fractures identified in both tower shafts at location A-A were the result of fatigue cracking that was directly attributed to galling damage that had been created during hydraulic assembly of the spiral bevel gears onto each tower shaft. During that process, the interference fit between the contacting surfaces of the tower shaft and spiral bevel gear resulted in scoring, material pick-up and localised deformation. These stress raisers increased the potential for crack initiation. Once the cracking had initiated, peak stresses within the overall engine load spectrum drove the crack growth to the point of failure.

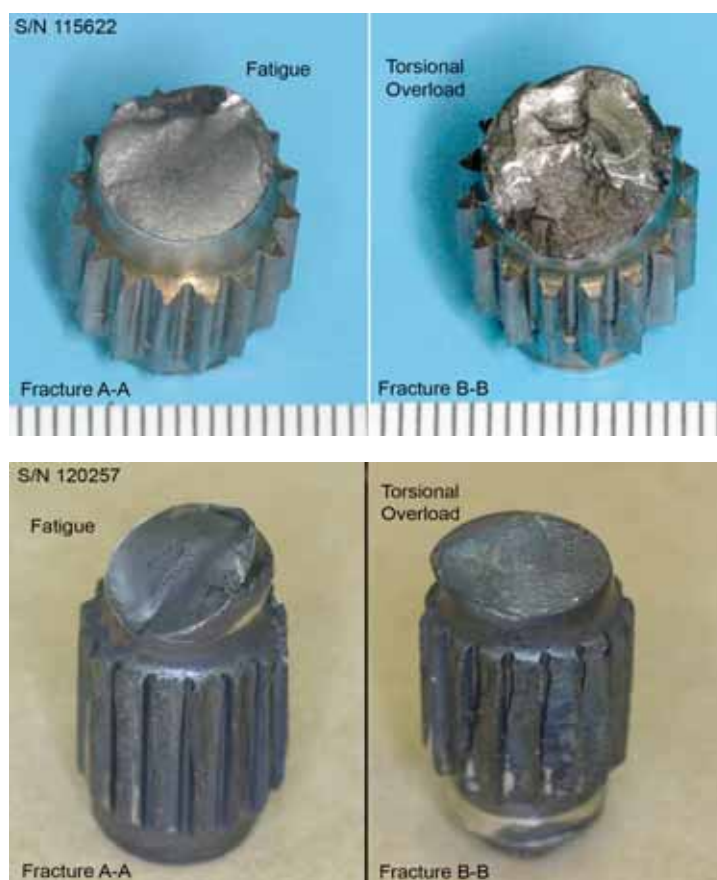
Other damage to the mid-shaft splines included accelerated wear of the spline teeth whereby the profile of each gear tooth had deteriorated into a sharpened edge. Thread damage was also observed near the runout region of each shaft stub where the profile of the rear threads had been flattened.

Figure 6: Opposing views of the fractured mid-shaft spline gear from engine S/N 115622 (VH-XUD) and engine S/N 120257 (VH-TQW).

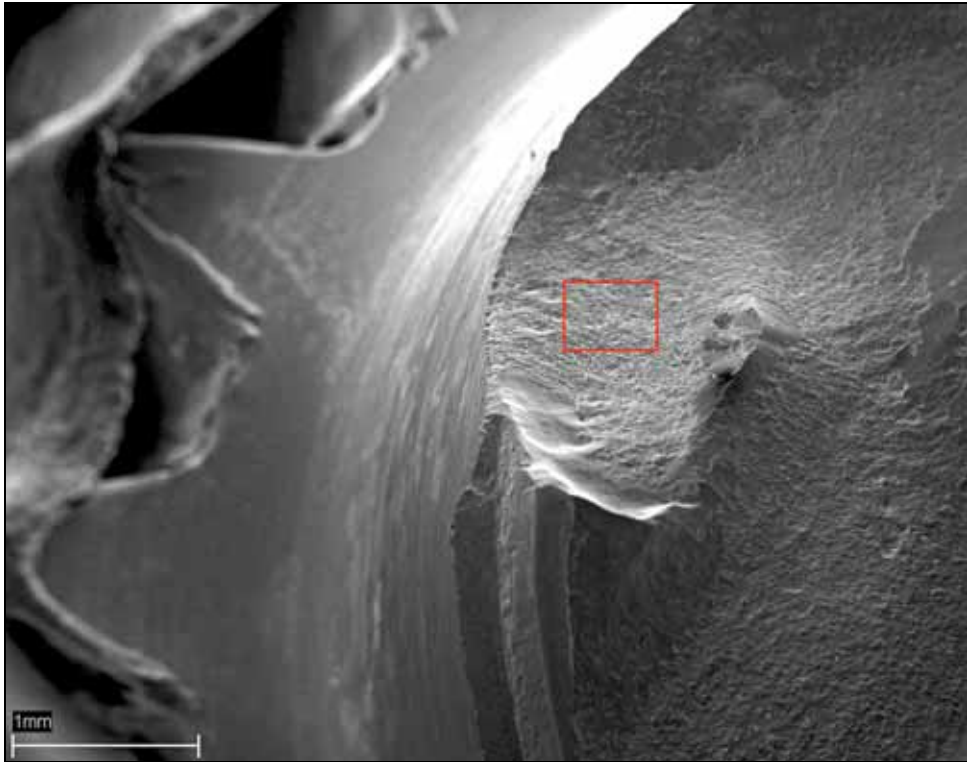
When the fractures at location A-A were examined at high magnification using the scanning electron microscope (SEM), it was revealed that the surfaces were flat and transgranular consistent with a fatigue crack growth mechanism. It was found that the fatigue cracking had initiated from within the galled region, see figures 6 – 8.

Figure 7: Low magnification SEM image of the tower shaft fracture surface A-A from engine S/N 115622 (VH-XUD). See also figure 8.

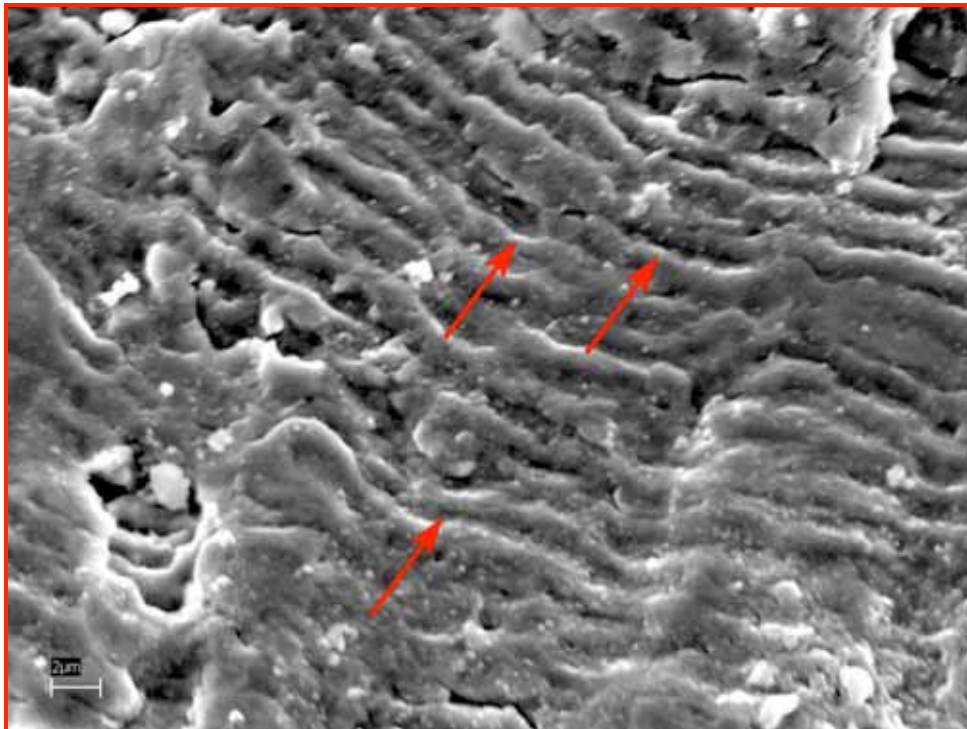
Figure 8: High magnification image of fracture A-A showing finely spaced fatigue striations (arrowed).

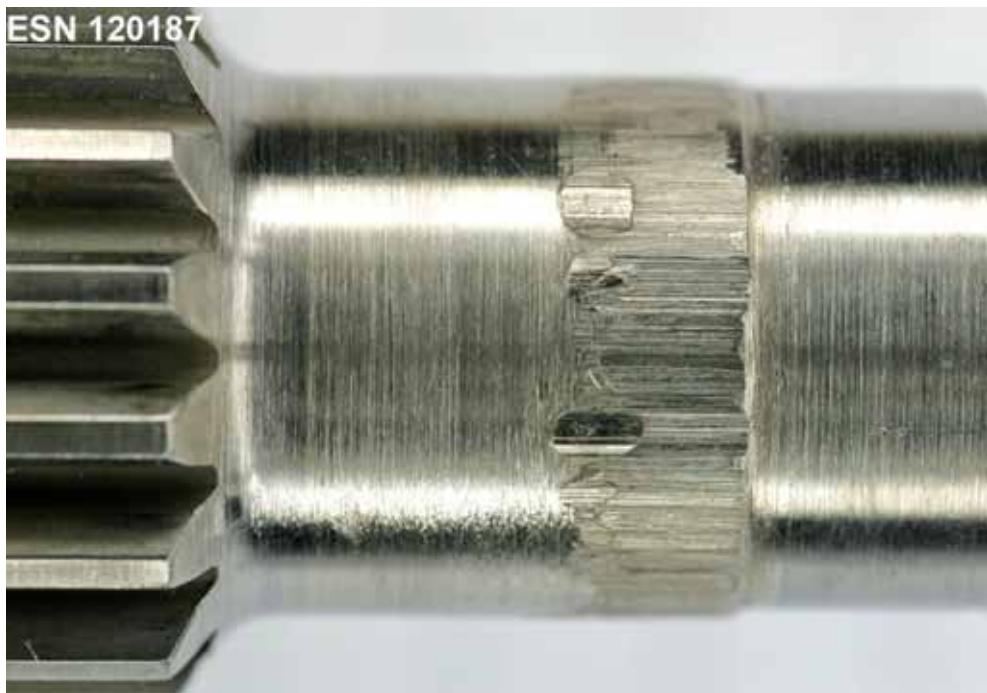
When the tower shaft from engine S/N 120187 was examined, clear and distinct galling damage was observed on the shaft surface where the assembled spiral bevel gear had been normally seated. The direction of the damage was evident through the scoring and indicated that it had occurred during hydraulic pressing of the spiral bevel gear onto the shaft, see figure 9. No evidence of cracking was found at that location.

Figure 9: Surface damage was produced during assembly of the spiral bevel gear onto the tower shaft from engine S/N 120187.

The galling damage found on the tower shaft that had been fitted to engine S/N 120187 was shown to have been produced during the assembly process. That damage was identical in physical nature and orientation to the damage that had precipitated fatigue cracking in the other two shafts. When the shaft was initially removed from 120187 it was intact and still serviceable but had sustained damage to the interfering contact surfaces. Close inspection of the affected area showed an axial alignment to the damage indicating that it had been produced during an overhaul period when the bevel gear was pressed onto the tower shaft.

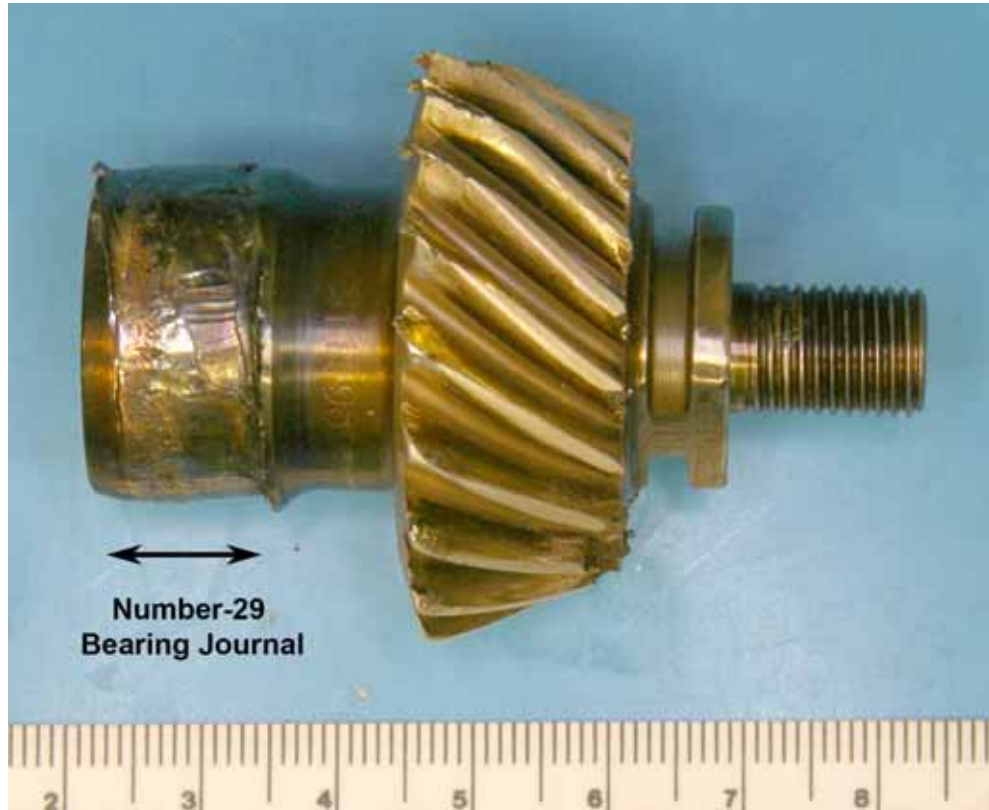
Initial examination of the spiral bevel gear from both engines revealed substantial damage to most surfaces. Portions of the gear teeth were missing, cracked or scored. Other damage included brinelling¹¹, overheating and misalignment damage to the number-29 bearing journal surfaces, see figure 10.

Figure 10: Photograph of the spiral bevel gear (P/N 3111969-01) from engine S/N 115622 (VH-XUD). Severe damage to the journal surface (labelled) and gear teeth had occurred. The threaded stub of the tower shaft can be seen protruding from the forward face of the gear.

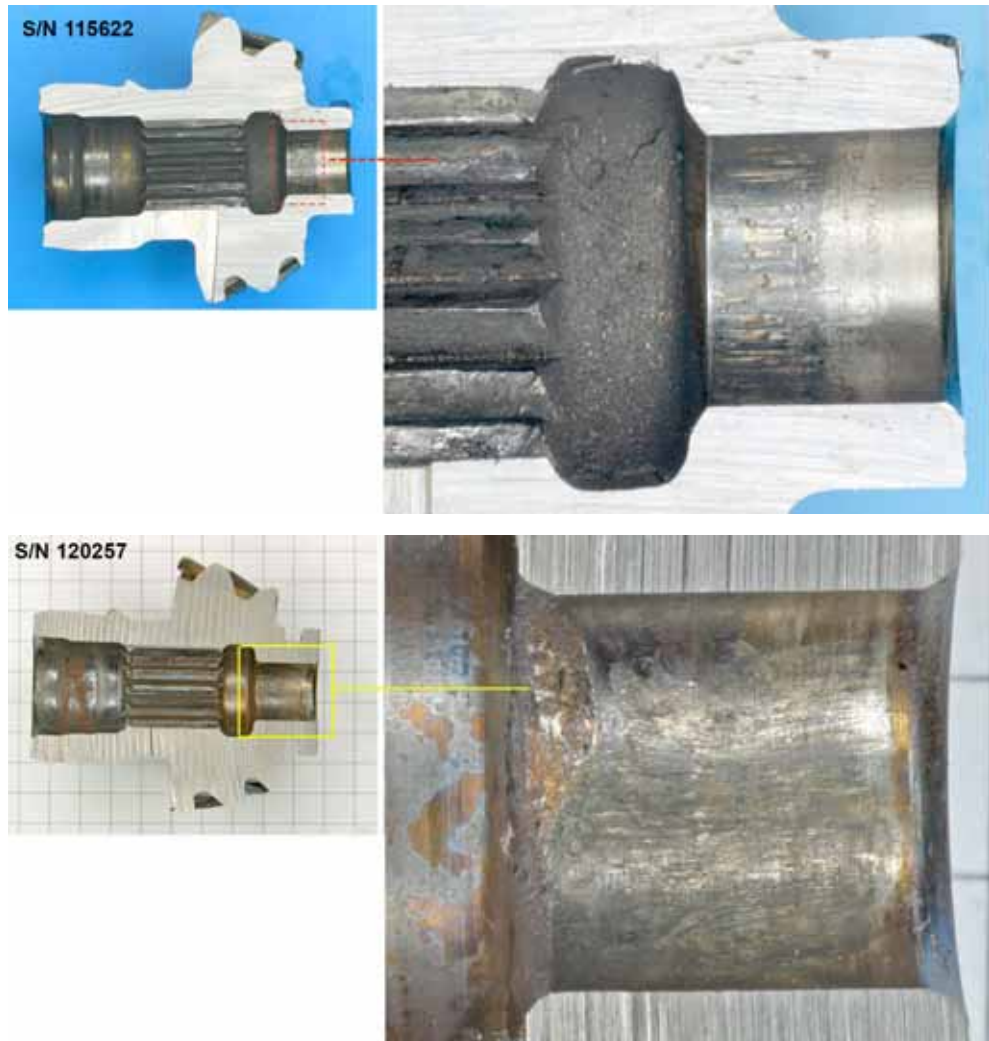
Destructive sectioning was performed in order to examine the internal seating surface of each spiral bevel gear. Once sectioned, longitudinal scores from galling were observed on the inner surfaces. These scores matched the galling damage seen on the seating diameter of the tower shaft stubs. Figure 11 shows a cross-section through the spiral bevel gears from each engine highlighting the damage.

Figure 11: Close-up of the internal seating diameter from the spiral bevel gear of both engines (S/N 115622 and 120257). Axial aligned scores can be seen.

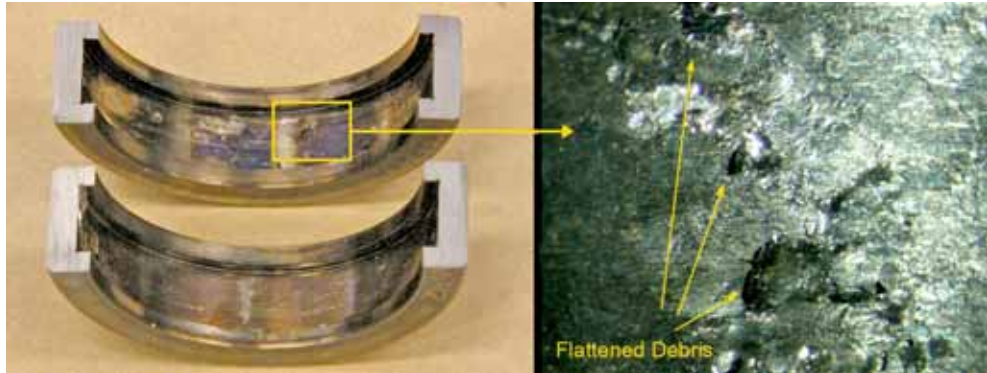
Sectioning of the bearings revealed the presence of more metallic flakes on the rolling surfaces, which were consistent with the external contamination. No evidence was found to indicate the contaminating debris had been produced by raceway spalling or any other such failure mechanism. The cage and cage pockets were intact with no obvious indications of failure or damage. Two rollers were missing from the bearing removed from engine S/N 120257. Both bearings displayed chipping and wear of their cylindrical rollers.

Figure 12: Photographs of the number-29 bearing from engine S/N 120257 after sectioning. Flakes of flattened contamination can be seen on the raceway surfaces (labelled).

Seizure of the number-29 bearing was a secondary event in the engine failure sequence. It was shown that the bearing seizure in each engine occurred when the rolling elements became contaminated due to the migration of tooth material from the spiral bevel gear. The analysis indicated that migration of the tooth material only occurred after the tower shaft fractured at location A-A.

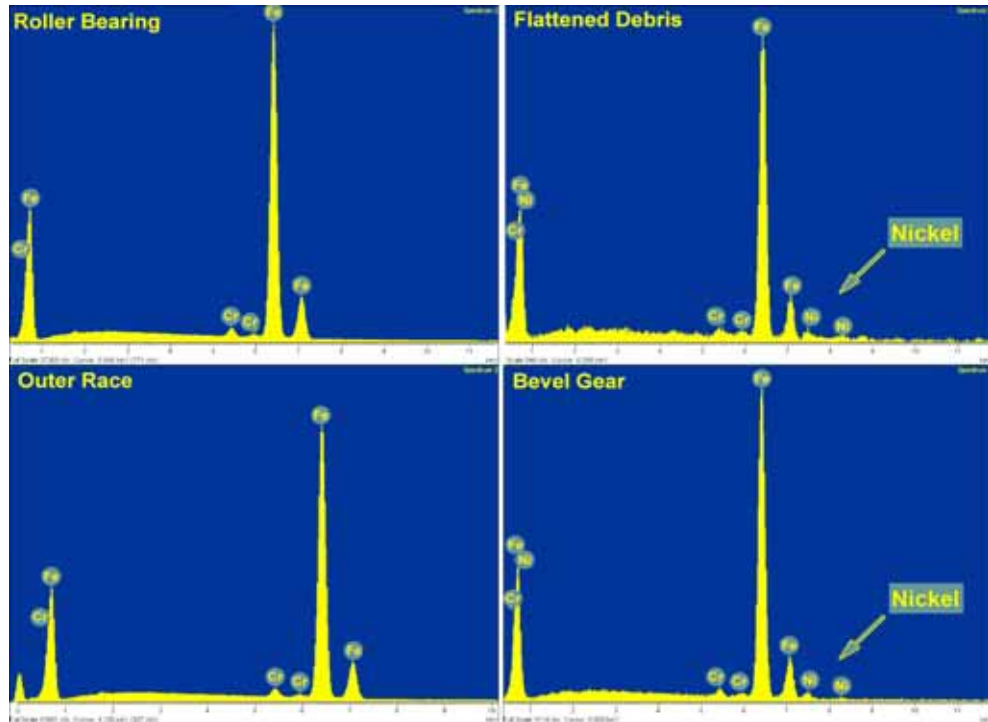
Chemical analysis of the spiral bevel gear revealed a composition of iron, chromium and nickel. The alloy composition of contaminant debris that had seized the number-29 was found to be closely match that of the spiral bevel gear, see table 3 and figure 13 for detail.

Figure 13: Comparison of EDS chemical spectra between various tower shaft components.

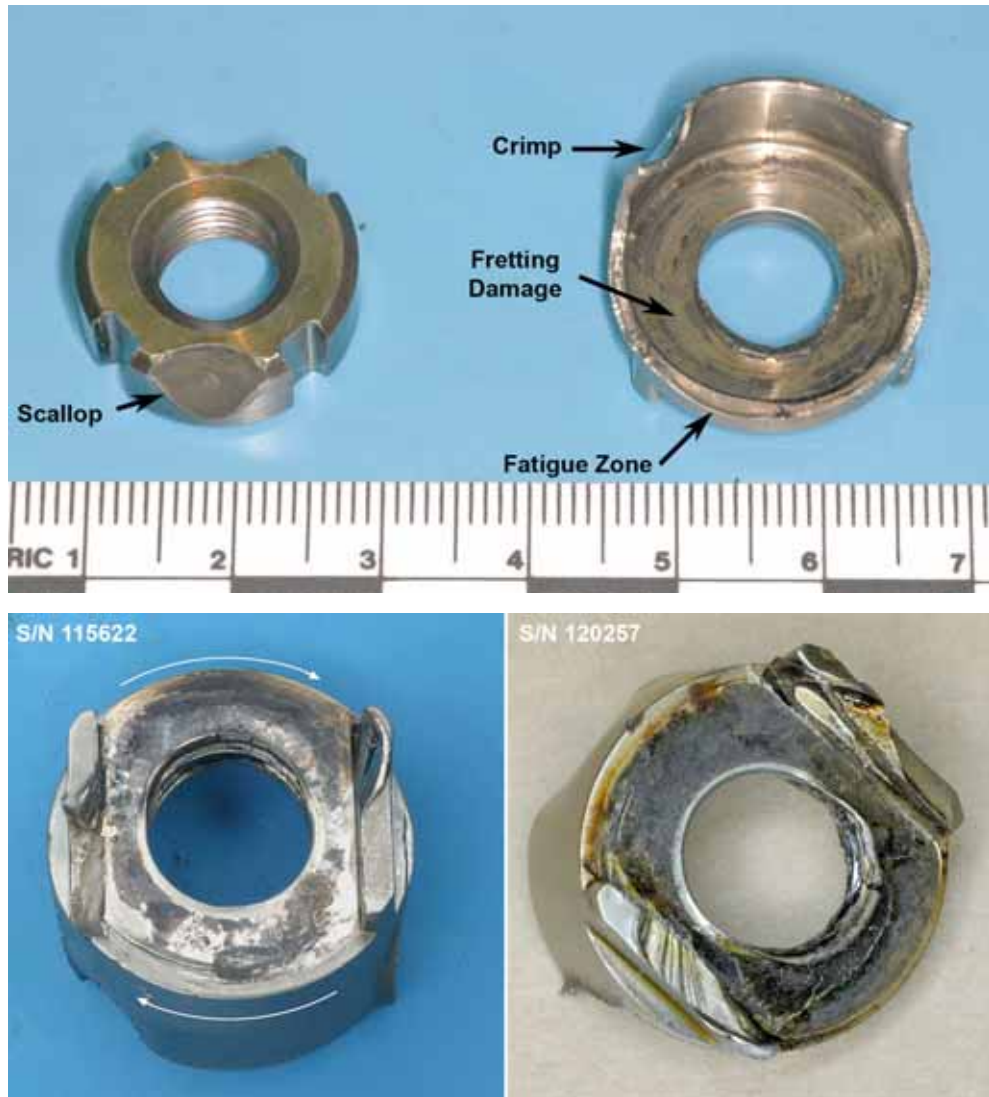
The cup washers displayed fatigue cracking and had fractured circumferentially through the sidewalls. Overload fracture of the underside tabs and distortion to the inner holes had also occurred. Both the upper and lower surfaces of the washers showed evidence of fretting¹², see figure 14.

Figure 14: Top view showing the lock nut and damaged cup washer from engine S/N 115622. Identical features were observed on engine S/N 120257. Underside damage shown in lower view.

At some stage during the primary failure sequence (post location A-A failure), preload of the lock nut and cup washer was lost. That loss allowed relative movement between the cup washer and lock nut, which resulted in fretting and

subsequent fatigue cracking of the cup washer sides. Failure of the cup washer sides allowed the lock nut to unwind and migrate within the tower shaft housing.
