**ATSB TRANSPORT SAFETY INVESTIGATION REPORT**

Technical Analysis – 200502231

**Inflight Engine Failure  
13 km WSW Young, NSW  
Piper PA31P-350 – Chieftain, VH-IGW  
Lycoming TIO-540-V2AD, s/n L8484-61A  
18 May 2005**

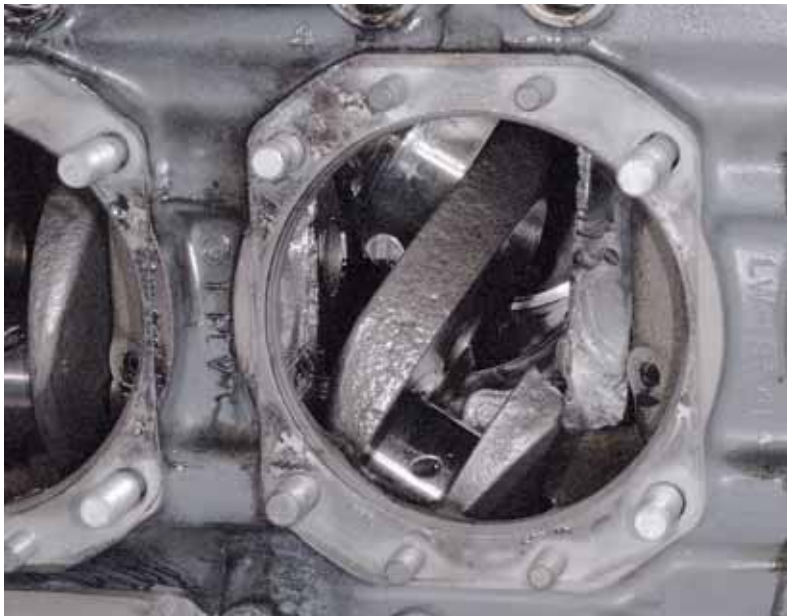
Initial examination of the Lycoming TIO-540-V2AD engine revealed that the crankshaft had fractured in two places allowing the section containing the No.3 and No.4 connecting rod journals<sup>1</sup> (the section between the two intermediate main bearings) to become displaced, see figure 1.

**Figure 1: The fractured section of the crankshaft in the position found during initial engine examination**

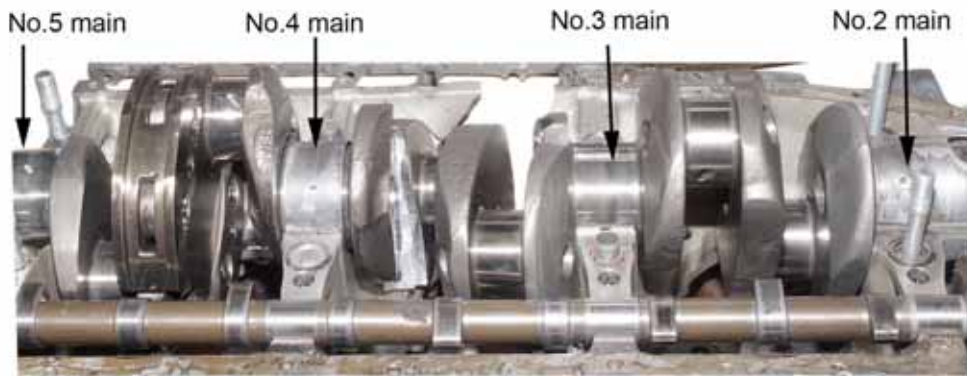
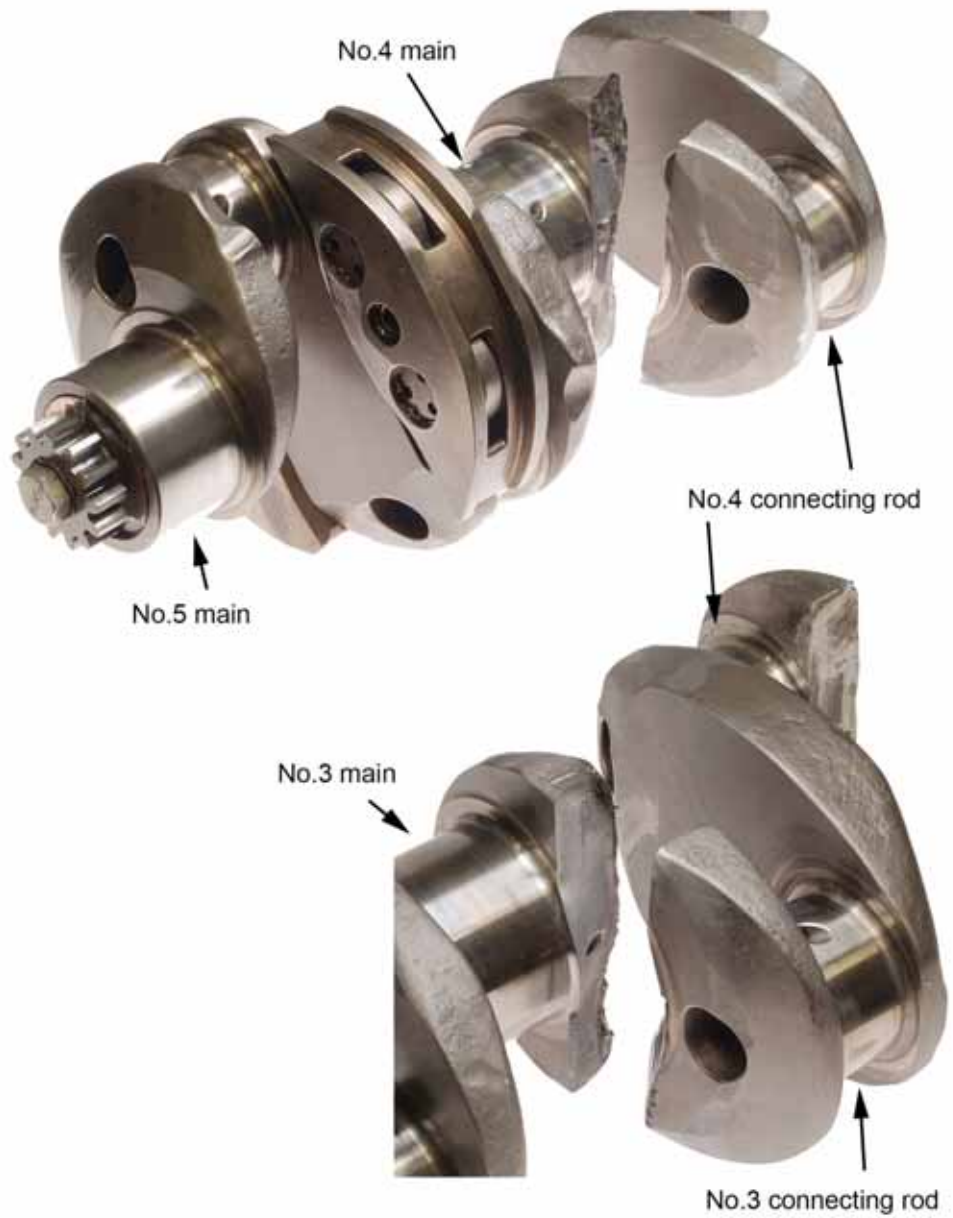
Examination of the engine revealed that the crankshaft had fractured in two locations: through the web between the No.4 main bearing journal and the No.4 connecting rod journal; and through the web between the No.3 main bearing journal and No.3 connecting rod journal, see figure 2.

**Figure 2: The location of both fractures and their orientation with respect to the crankshaft webs**

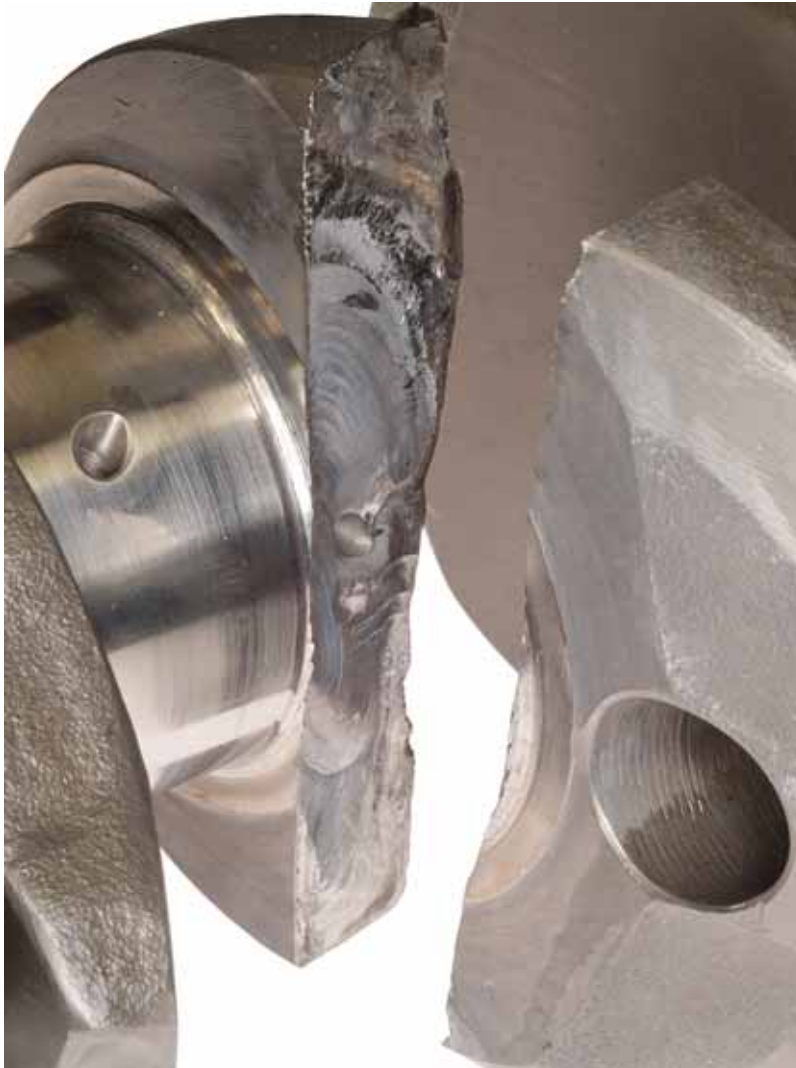
The fracture of the web between the No.4 main and No.4 connecting rod journals occurred as a result of fatigue crack initiation and growth, see figure 3. The fatigue fracture surface features present on the fracture surface indicated that crack growth had occurred over a period of approximately 50 engine start/stop cycles.

**Figure 3: Crankshaft Web Fracture, No.4 main/No.4 connecting rod**

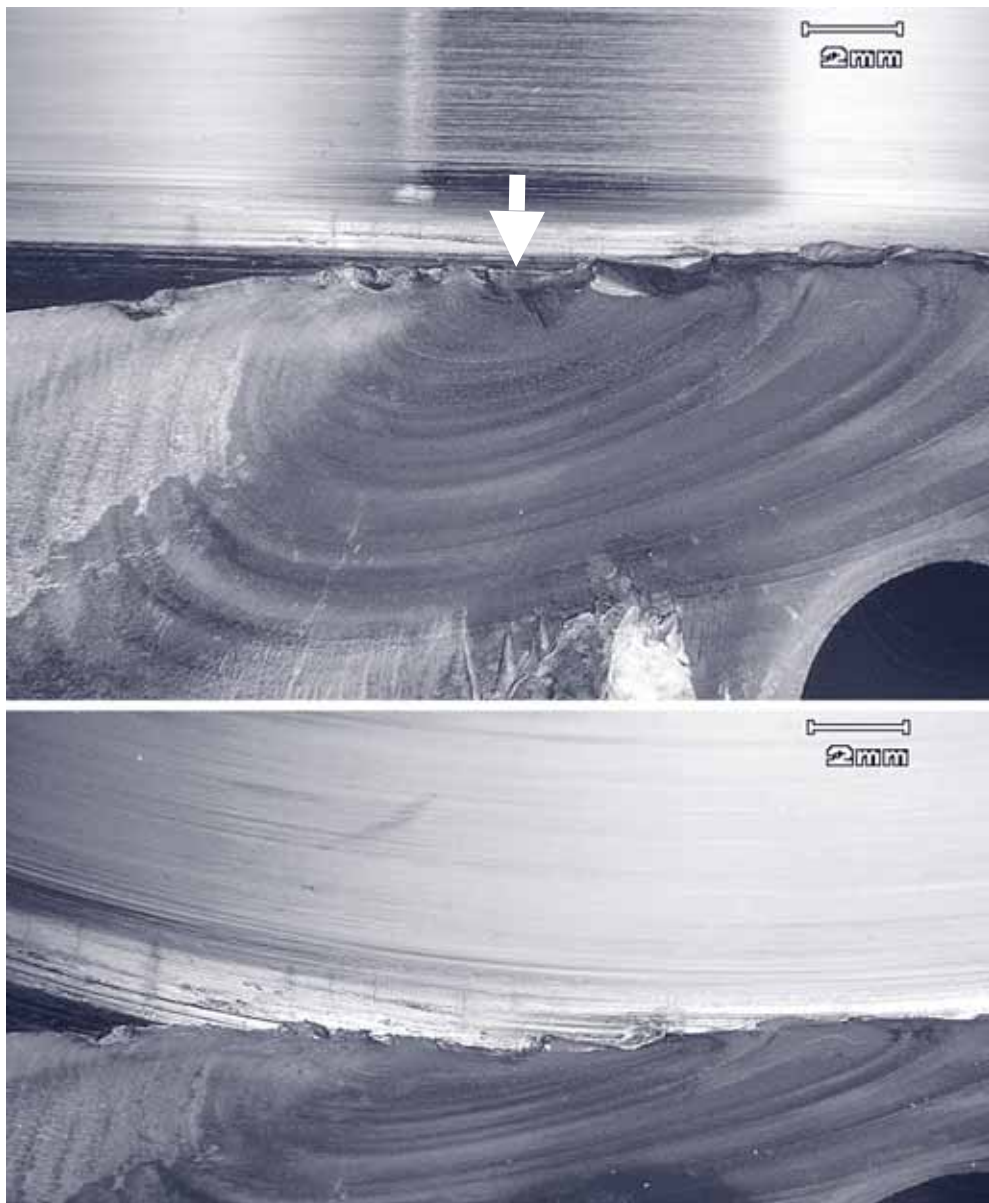
Fatigue cracking in the fillet radius of the No.4 main bearing journal initiated from damage created by rubbing contact between the No.4 main bearing insert and the fillet radius, see figure 4. The axial movement of the No.4 main bearing insert forward in its housing, during engine operation, allowed the bearing insert to come into contact with the rotating crankshaft main bearing journal fillet radius, see figure 5. The contact between the bearing insert edge and the journal fillet radius was sufficient to damage the fillet surface by scoring and localised heating. Localised thermal expansion of the hardened surface of the fillet, from localised heating, results in the formation of a series of short axially-oriented cracks.

**Figure 4: The site of fatigue crack initiation, No.4 main bearing journal fillet**

The location of the fatigue crack initiation is indicated by the arrow. Circumferential scoring and a series of short axially-oriented cracks in the journal fillet are evident

It is evident that fatigue cracking in the No.4 main/No. 4 connecting rod crankshaft web initiated as a result of damage created in the fillet of the No.4 main bearing journal. This damage comprised circumferential scoring created through contact between the No.4 main bearing insert and the crankshaft during engine operation. It is also evident that the nature of contact between the journal fillet and bearing insert, was sufficient to create a series of short axially-oriented cracks through the localised heating of the hardened surface of the journal fillet.

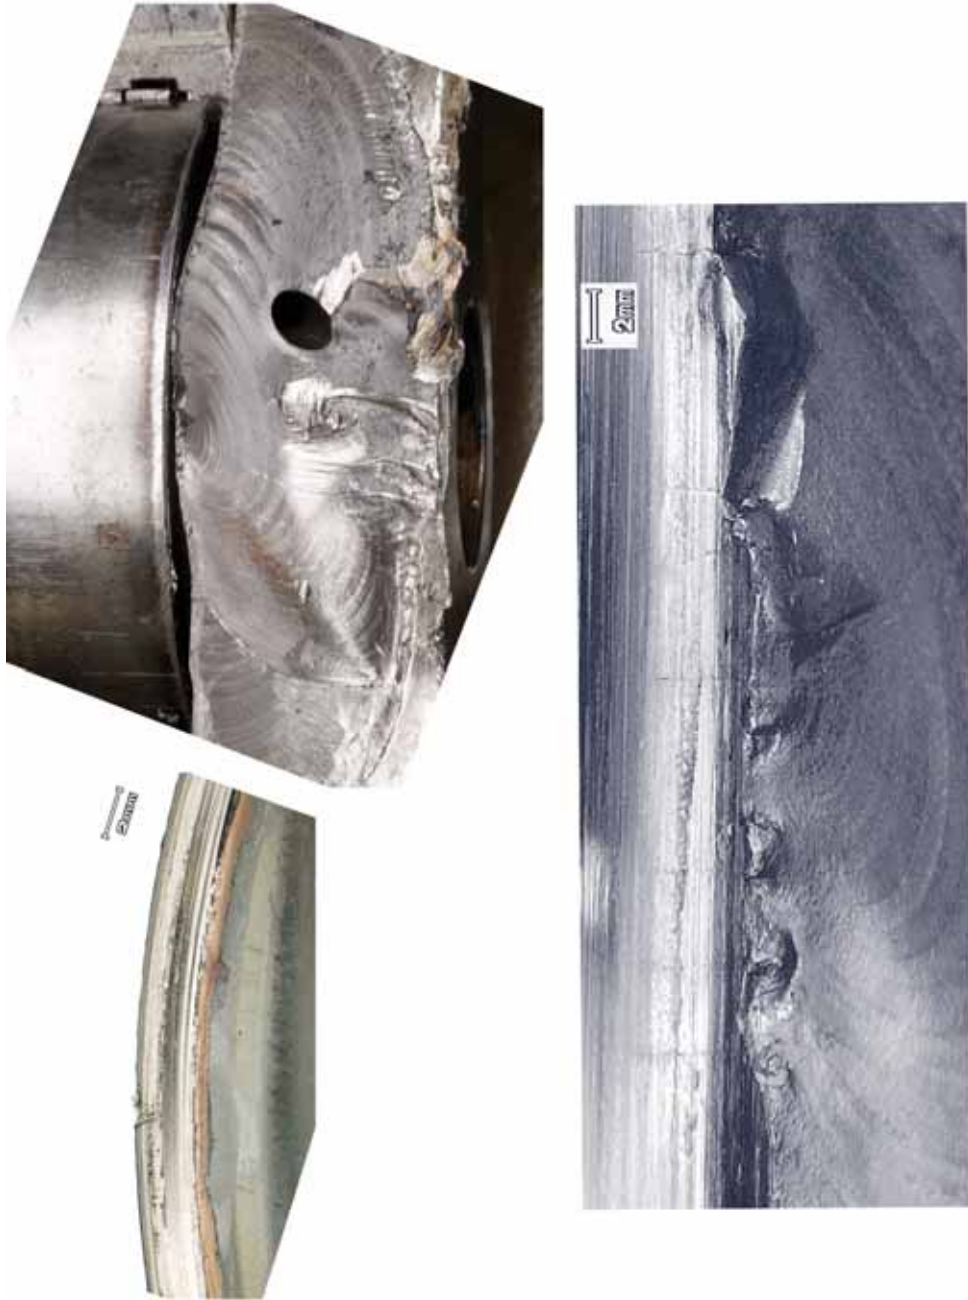
**Figure 5: The relationship between the No.4 main bearing insert and the journal fillet damage**

The position of the main bearing insert at crankcase disassembly (top left), the edge of the main bearing insert showing the effects of sliding contact with the journal fillet (bottom left), and the main bearing fillet showing the effects of sliding contact with the bearing insert (right)

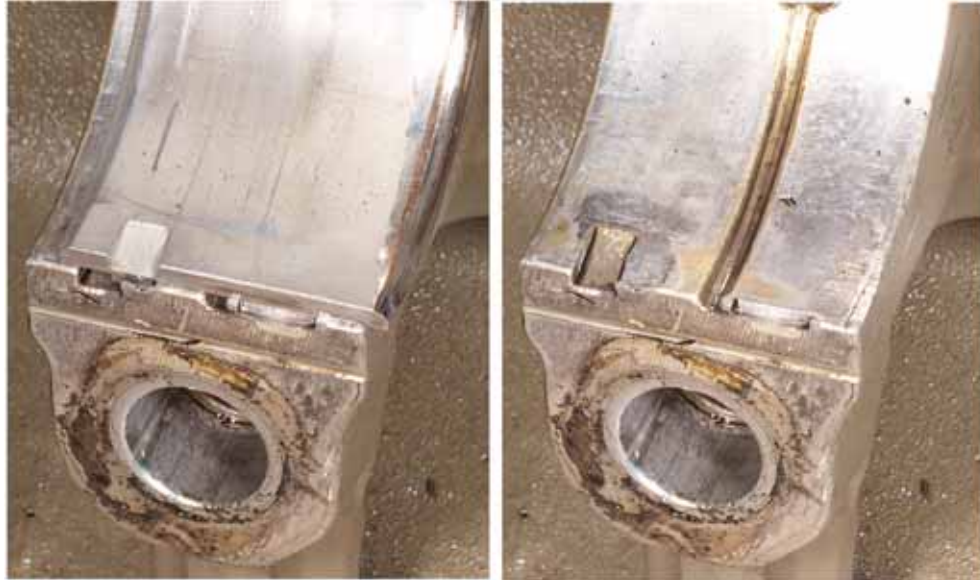
An examination of the No.4 main bearing housing revealed that the bearing insert had moved forward under the influence of loading created during engine operation. The wear created by the movement of the bearing insert, in the region of the insert tangs, delineates the extent of axial movement, see figure 6. The bearing insert did not rotate in its housing.

**Figure 6: The extent of No.4 main bearing insert displacement**

Position of bearing insert at crankcase disassembly (left). The nature and extent of wear created by the bearing insert tangs as the insert has moved in its housing

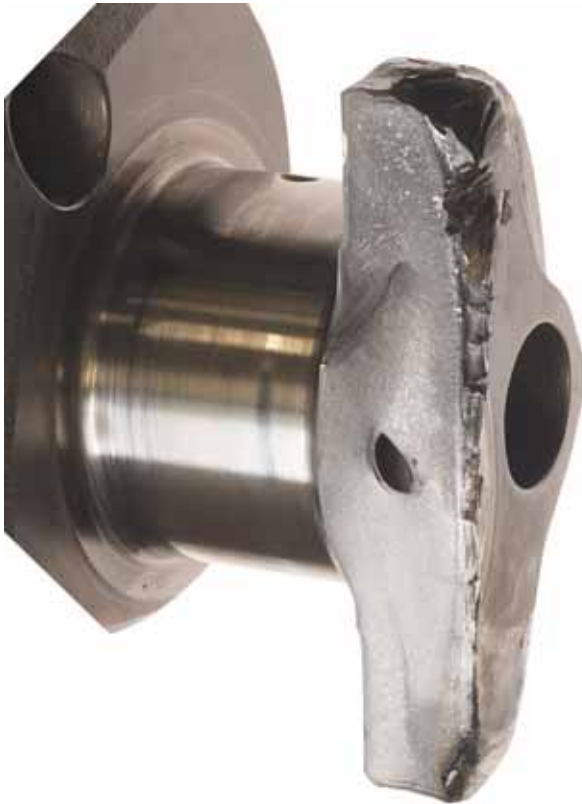
The fracture of the crankshaft web, No. 3 main/No. 3 connecting rod journals, also occurred as a result of fatigue crack initiation and growth. However, in this case the fracture surface features indicated that fatigue cracking had occurred over a short operational time period. The nature and site of crack initiation indicated that high bending loads were responsible for crack initiation and growth, see figure 7. Fatigue cracking initiated at the surface of the fillet at the transition between the fillet radius and the web, see figure 7. No abnormal features, such as, damage created through contact with other components, or material discontinuities, contributed to fatigue crack initiation.

It is evident that fatigue crack initiation and propagation in the web between the No.3 main and No.3 connecting rod journals occurred under a condition of repeated high bending loads, created by abnormal crankshaft flexure, following the fracture of the web between the No.4 main and No.4 connecting rod journals. The absence of progression mark fracture surface features, typical of those formed by the engine start/stop cycle, indicated that crack growth occurred over a short period of time during the last flight.

**Figure 7: Crankshaft web fracture, No.3 main bearing journal/No.3 connecting rod journal**

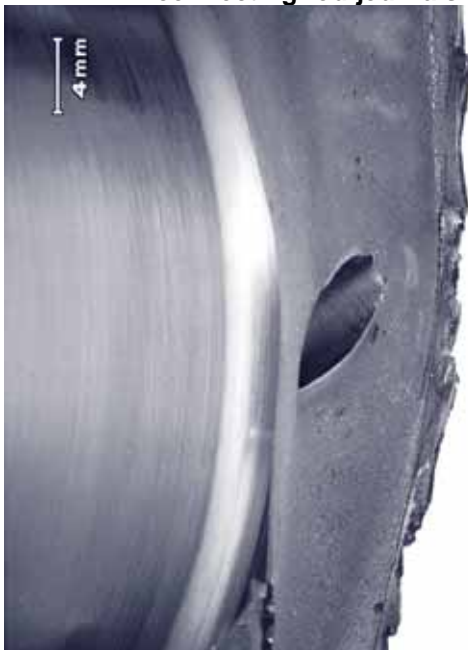
**Figure 8: Detailed view of the No.3 main bearing journal fillet at the site of fatigue crack initiation in the web between the No.3 main and No.3 connecting rod journals**

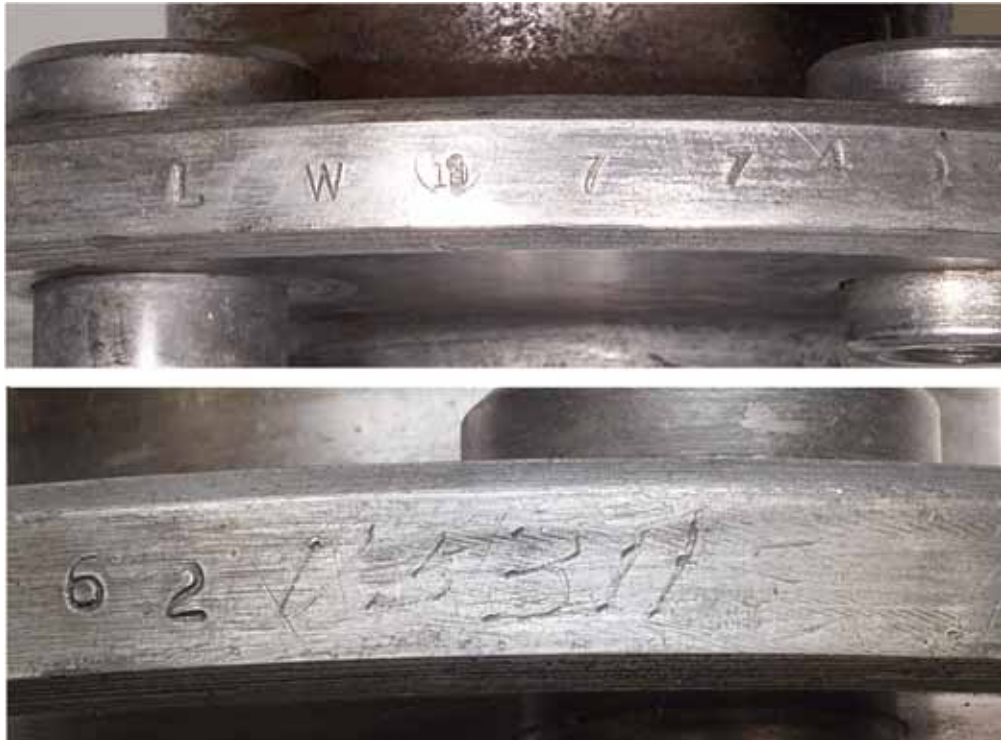
The crankshaft was identified by a series of hand etched, stamped, and as-forged numbers. The part number of the crankshaft was LW 17740 (letter stamped into propeller flange), the crankshaft serial number was V5311 (hand etched on the propeller flange), see figure 9. Two, as-forged, numbers (17707 and V60) were present on the edges of two crankshaft webs.

**Figure 9: Crankshaft part and serial number markings on the propeller flange**

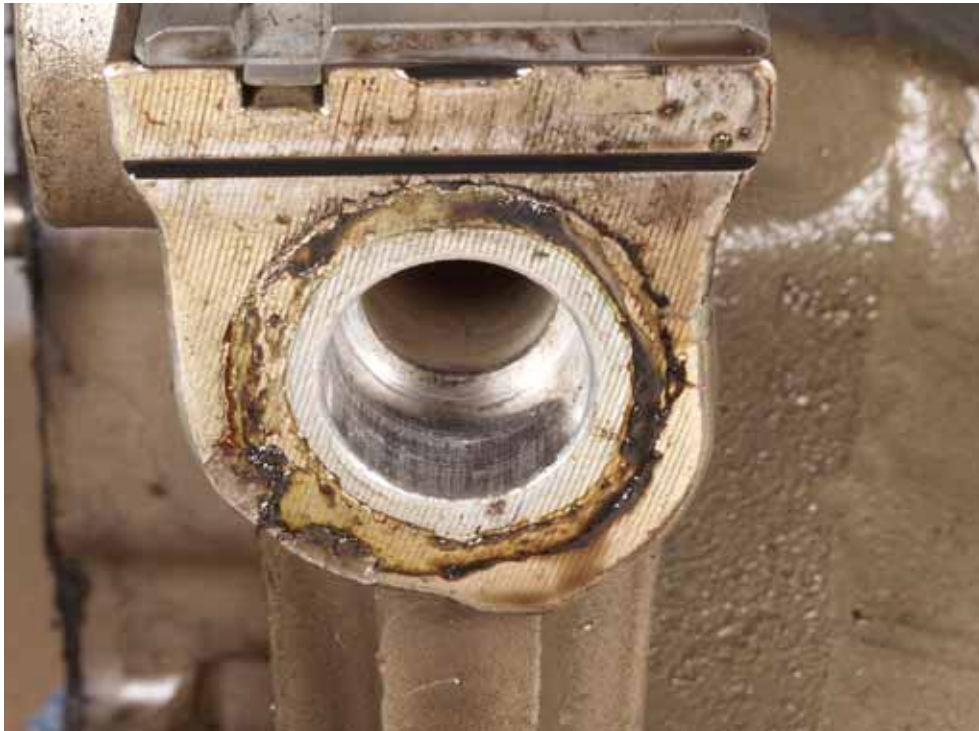
Examination of the main bearing housings revealed that a jointing compound had been placed on the parting faces of each main bearing housing, see figure 10. The inclusion of any material between the parting faces of the main bearing housings will have the effect of reducing the difference in the circumference of the housing and the outer circumference of the bearing inserts, and will reduce the magnitude of the insert retention force.

**Figure 10: An example of the nature of material placed between the parting faces of each main bearing housing**

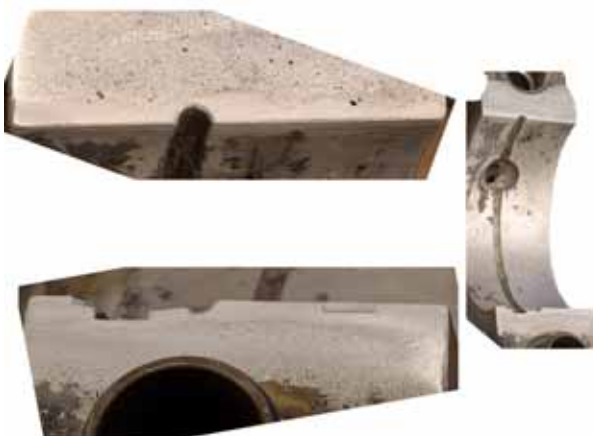
Examination of the main bearing housings also revealed that the surfaces had been restored by welding, see figures 11 and 12. Weld restorations of this nature are based on depositing weld metal (a lower strength material compared to the crankcase material) and re-boring the housing.

The need for main-bearing housing weld restoration indicates that insert movement has occurred in the past. However, the magnitude of the factors that contribute to insert movement and their synergy have not resulted in insert movement to the extent that crankshaft fillet damage has occurred in this engine

**Figure 11: One half of the No.4 main bearing housing, etched to reveal the extent of weld repair**

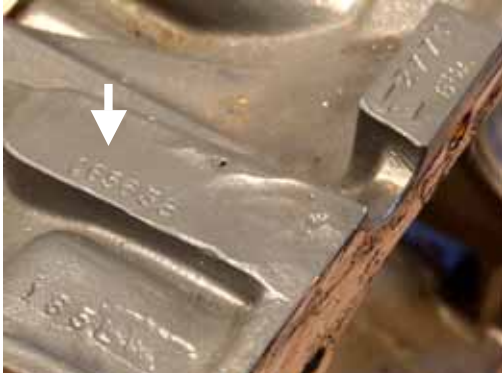
**Figure 12: Weld repair crankcase marking, CG5638**
