**ATSB TRANSPORT SAFETY INVESTIGATION REPORT**

Aviation Occurrence Investigation – 200504188

**In-Flight Engine Malfunction  
6km SSE Sydney Airport, NSW  
25 August 2005  
VH-TJX  
Boeing 737-476**

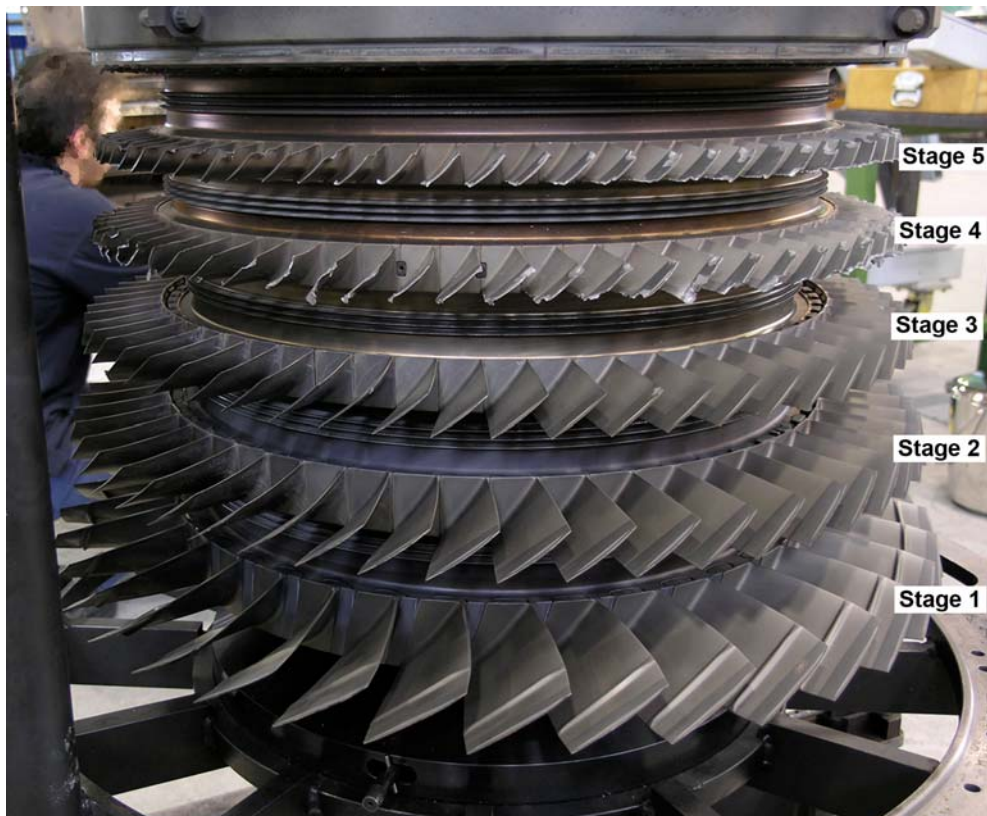
When the engine's core high pressure compressor (HPC) front stator assembly was split open and the HPC rotor removed, significant damage to the stator vanes and rotor blades was found, (Figure 2).

**Figure 2: Photograph of the HPC rotor showing damage to the stage-four and -five rotor blades. See also Figure 3.**

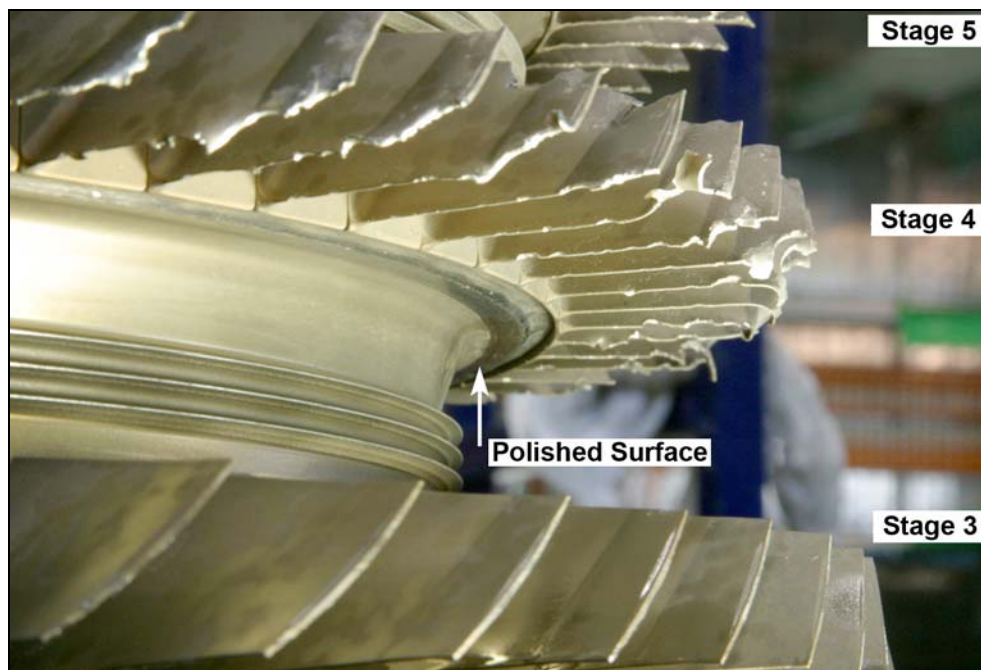
Examination of the HPC rotor revealed concentrated damage to the airfoil sections of the stage-four and -five blades. Some minor denting of the -six to -nine rotor blades was also observed. It was noted that the forward shoulder surfaces of the stage-four dovetail slot on the -four to -nine spool had been polished from hard rotational contact with another engine element, (Figure 3).

The lack of damage to the earlier stages indicated that the blade impact and mechanical battering came from an object or component liberated from stage-three of the HPC that then travelled downstream with the air flow to impact the latter HPC stages.

**Figure 3:** Close-up image of impact damage to stage-four and -five rotor blades. The forward shoulder of the dovetail slot (arrowed) shows polishing damage to the surfaces.

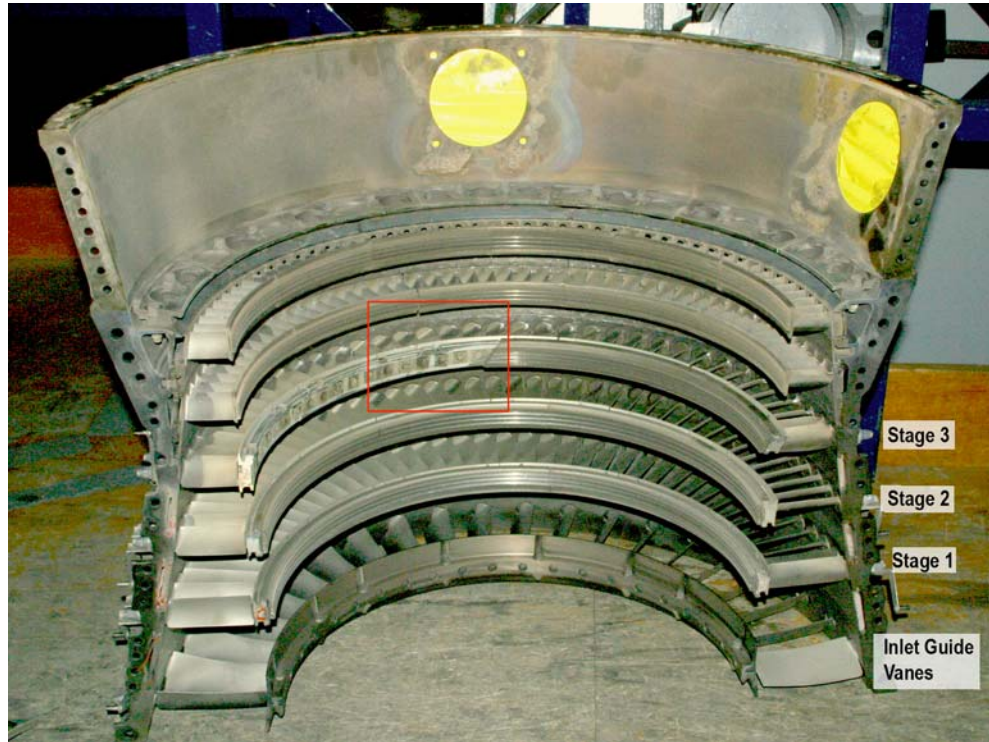
Examination of the stage-three shroud segments and interstage honeycomb seals revealed that a single D-head dowel pin was missing from its prescribed assembly position, (Figure 4 and 5). It was also observed that the stage-three air seals could be easily moved around their station. Normally, honeycomb seal rotation was limited by the presence of two anti-rotation stop pins, but in this case the pin protrusion was such that advanced rotation could occur.

The preliminary on-site assessment indicated that the stage-three honeycomb air seal sections had been allowed to circumferentially shift and bunch together, resulting in the liberation of a single stage-three variable guide vane D-head pin from its assembled position. Once loose, the dowel pin became ingested by the latter stages of the HPC causing considerable impact damage to the rotating components.

**Figure 4: General view of one half of the HPC front stator case. The location of the missing stage-three shroud D-head dowel pin is highlighted. Refer also to Figure 5.**

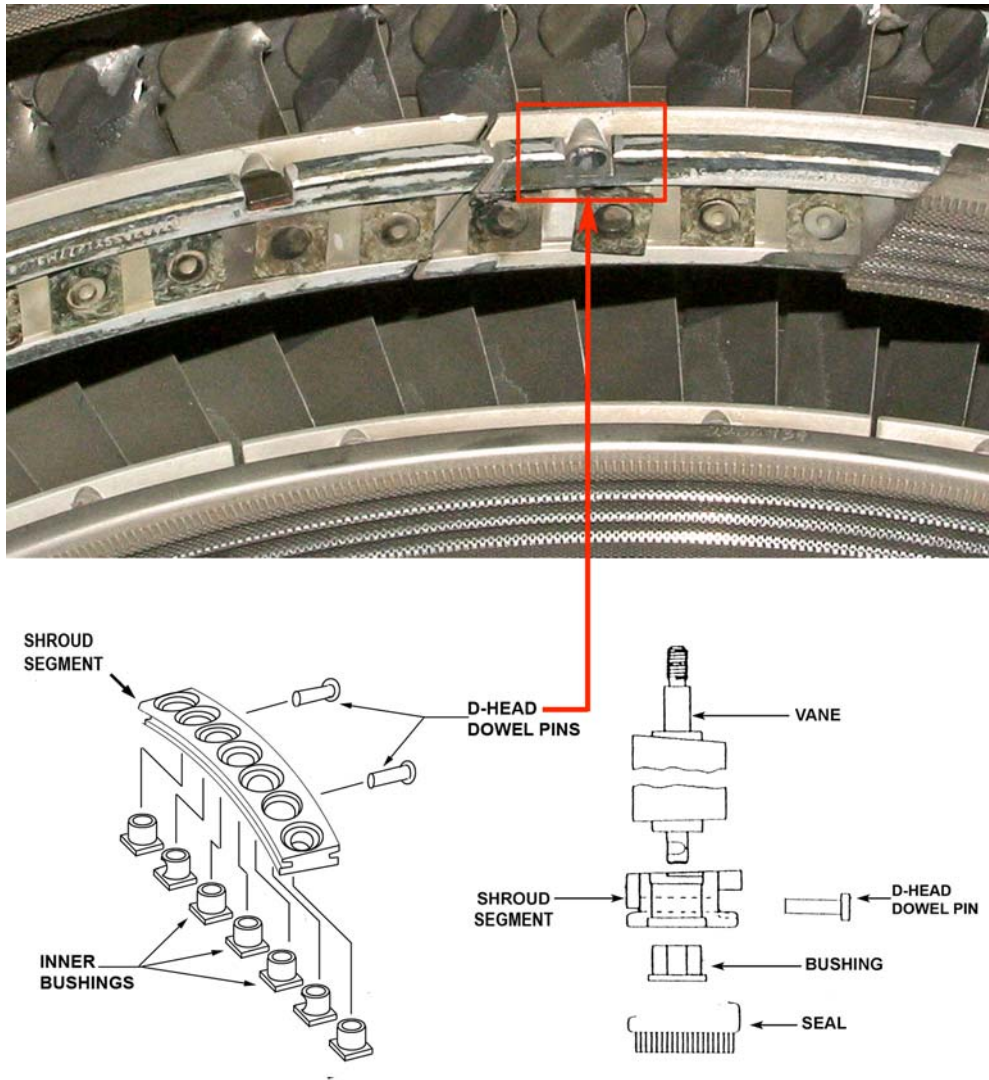
Figure 5: Close view of the stage-three stator showing the missing shroud D-head dowel pin. An assembly illustration shows how the pins were retained.

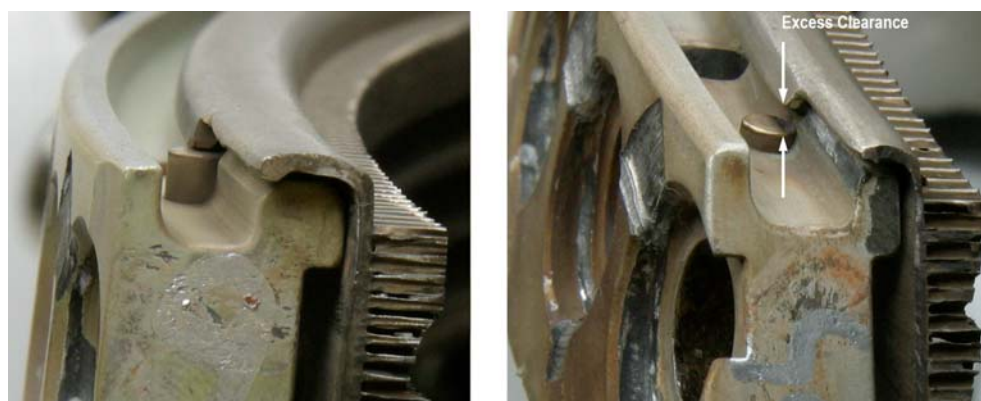
When the stage-three components were assembled together, it was evident that the honeycomb seals could slide entirely unrestricted around the rails of each stator shroud. The anti-rotation pins that had been inserted within the rails of the stage-three shroud did not restrict rotational movement.

In contrast, sliding movement of the honeycomb seals around the stage-two shroud rails was stopped by interference provided by the anti-rotation shroud pins, (Figure 6).

**Figure 6: End view of the stage-two (left) and stage-three (right) stator shrouds when fitted with honeycomb air seals.**

Note the excessive clearance between the stage-three (right image) anti-rotation pin and inner rail of the honeycomb air seal allowing the seals to rotate, compared with zero clearance from the stage-two components (left image).

The unrestricted seal shifting could be explained by the slight difference between the protruded lengths of the stage-three anti-rotation pins when compared with those from stage-two. The manufacturer's specifications indicated that in order to prevent seal segment rotation, the allowable distance between the forward rail axial face and the anti-rotation pin head should measure between 0.76 - 1.02 mm.

Measurements indicated that the stage-three pins were recessed beyond these limits specified by the manufacturer. See Table 2 for these results.

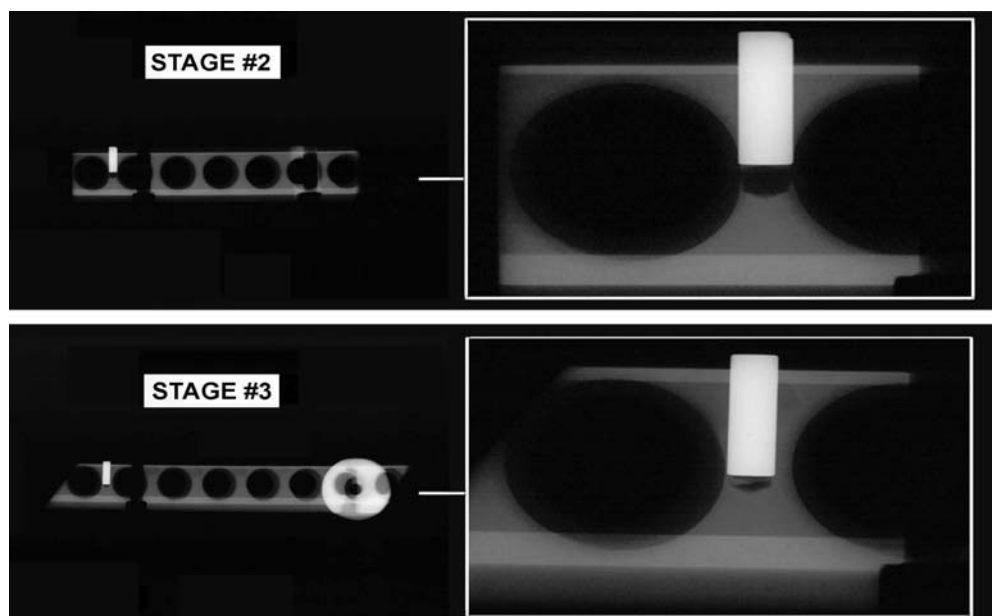
To confirm the dimensional aspects of each anti-rotation pin, the stator shrouds were non-destructively inspected using x-ray radiography. Examination and comparison of the radiographs confirmed that the stage-three pins had been pushed slightly deeper into their socket than the pins from stage-two, (Figure 7).

Measurements indicated that the pins were the correct length and had been manufactured in accordance with the manufacturer's specifications.

**Figure 7: Radiographic detail of the anti-rotation pins showing that the stage-three pins had been inserted slightly deeper into their station than the stage-two pins.**

With no requirement from the engine manufacturer to dimensionally inspect the stator shroud anti-rotation pins, it was possible that the anti-rotation pins had been pressed too deep into their shroud sockets from new. Alternatively, each of the anti-rotation pins may have been forced downward into their socket through contact with the honeycomb seals during engine operation. The investigation was not able to differentiate between either of these two possibilities.

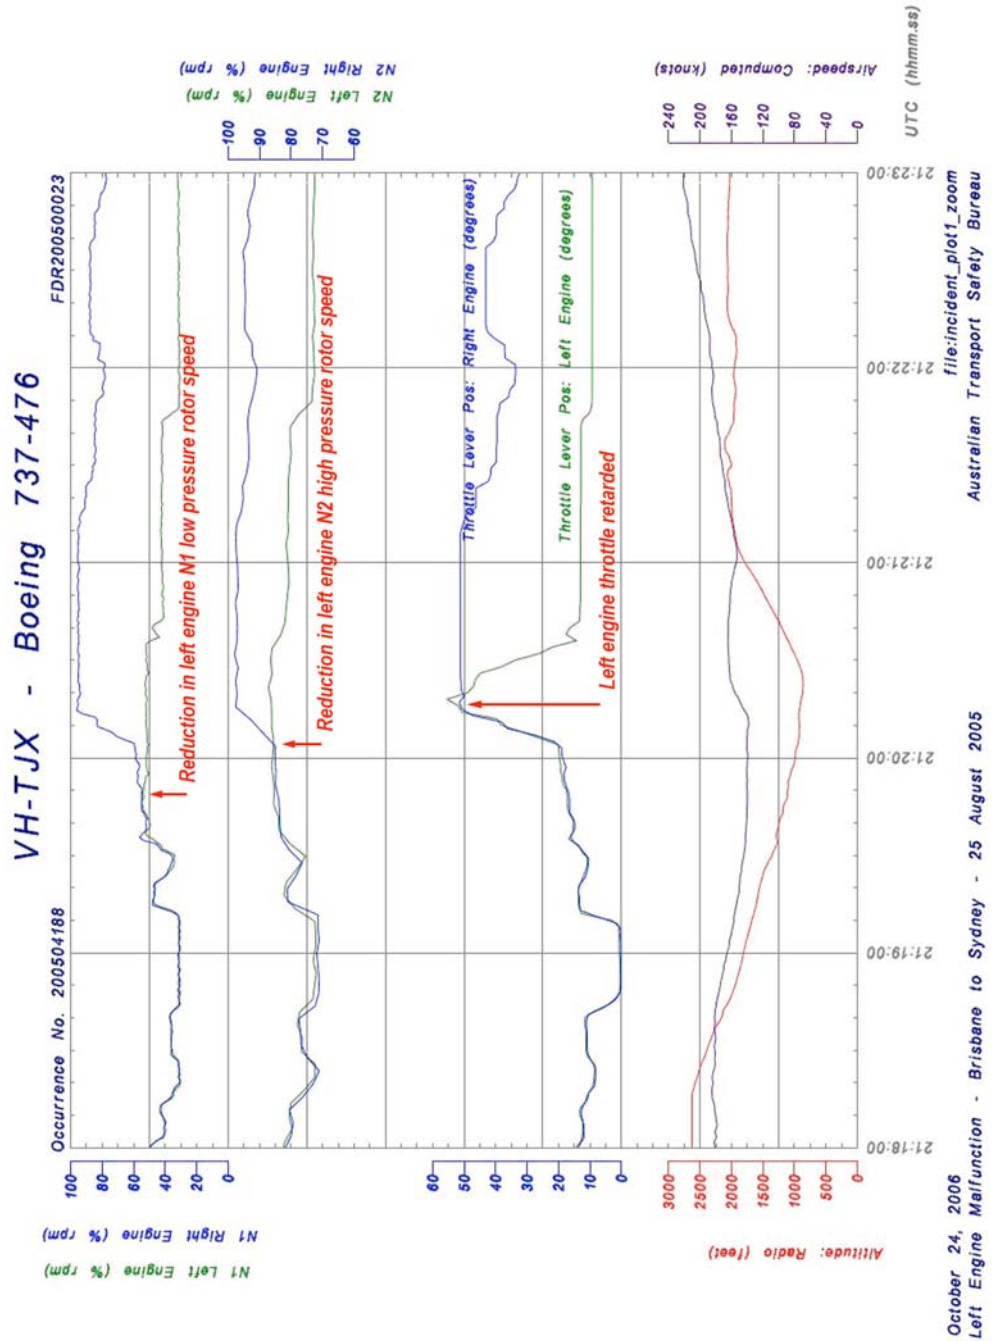
Analysis of the engine's recorded flight data indicated that the damage produced by the liberated dowel pin affected the airflow within the HPC, with reduced efficiency to both the N1 and N2 high and low pressure systems. This reduction was reflected when the pilot-in-command advanced the power levers to both engines. Only the right engine responded to the crew's input. The 'popping' noise heard by the crew was consistent with a compressor stall or surge due to the damaged HPC.

Plot of the flight data recorder data showing a five minute period during which time the engine malfunctioned. Plotted are values of engine rotor speeds (high and low pressure), radio altitude, computed airspeed and the power lever positions.
