ATSB TRANSPORT SAFETY INVESTIGATION REPORT

Aviation Occurrence Report – 200504338

Breakdown of Separation
Brisbane Airport, Qld – 31 August 2005
VH-VQD
Boeing Company 717–200
VH-UUA
Fairchild Industries Inc SA227–DC

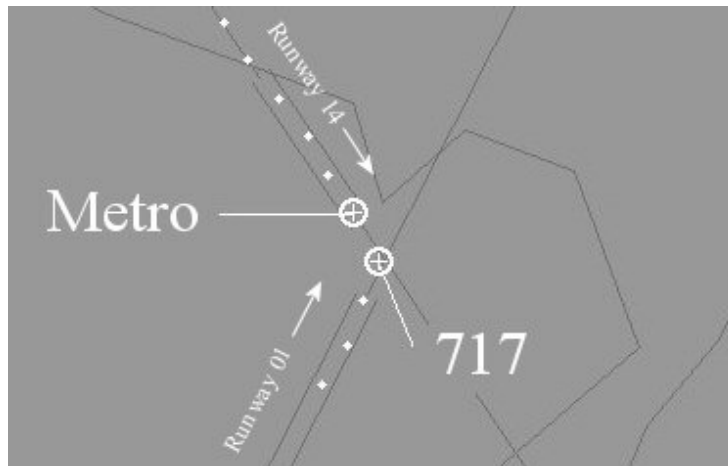
Figure 1: Extract from Airservices Australia radar replay at 1902:03

At 1902:03, the 717 crossed the flight path of the Metro, 625 m in front of, and 580 ft above the Metro. While the vertical distance between the two aircraft continued to increase, the minimum lateral distance reduced to about 343 m.

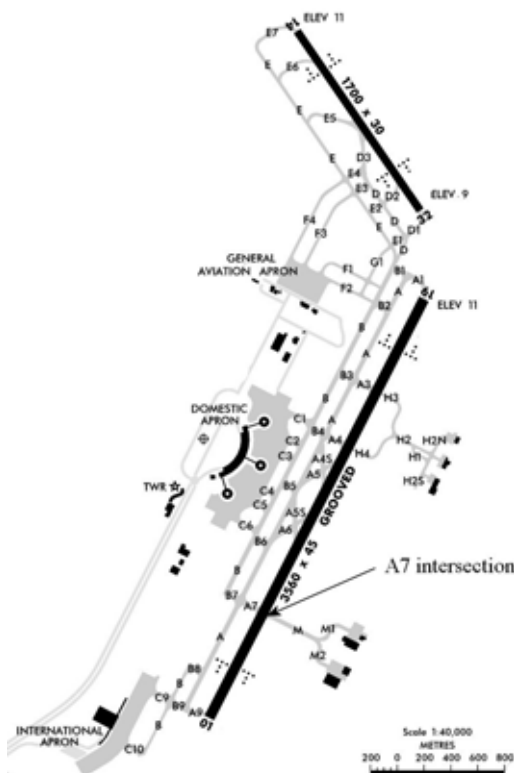
Figure 2: Extract from Brisbane Aerodrome Chart

Brisbane Airport had two runways, 01/19 and 14/32. Runway 01 was 3,560 m long, bearing 016 degrees magnetic and runway 14 was 1,700 m long, bearing 135 degrees magnetic. The runways did not physically cross, but were in the shape of an open ‘V’, with 666 m between the thresholds of runways 19 and 32. The extended centrelines of the runways intersected 387.5 m north of the threshold of runway 19, a distance from the control tower of about 2,700 m.

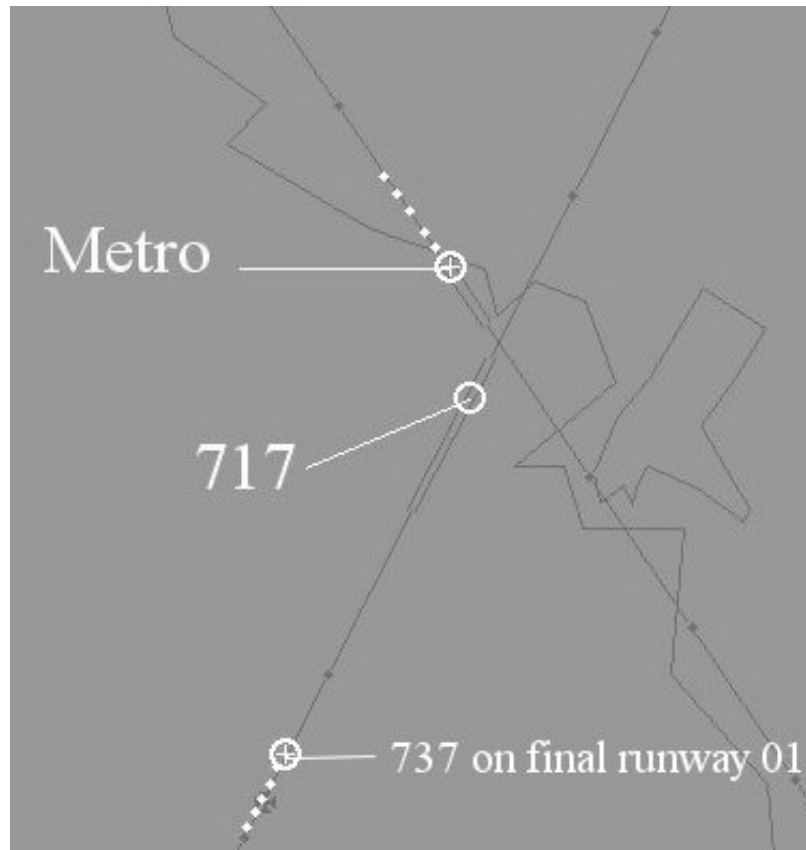
At 1901:49, the Metro crossed the threshold of runway 14 at about 500 ft and with a groundspeed of 190 kts. At about this time, the 717 was becoming airborne from runway 01 and the 737 was about 70 seconds from landing (figure 3). At that time, the aerodrome controller attempted to contact the crew of the Metro and they responded that they would not be able to complete the approach and landing, and that they were going around.

Figure 3: Extract from Airservices Australia radar replay at 1901:49

The approach controller did not instruct the crew of the Metro to transfer to the tower frequency until the aircraft was about 3.5 NM from the aerodrome. The approach controller did not advise the tower controller that the Metro would be transferring at other than the normal transfer point of 5 NM. The aerodrome controller did not contact the crew of the Metro until that aircraft was approaching the threshold of runway 14 (figure 3).

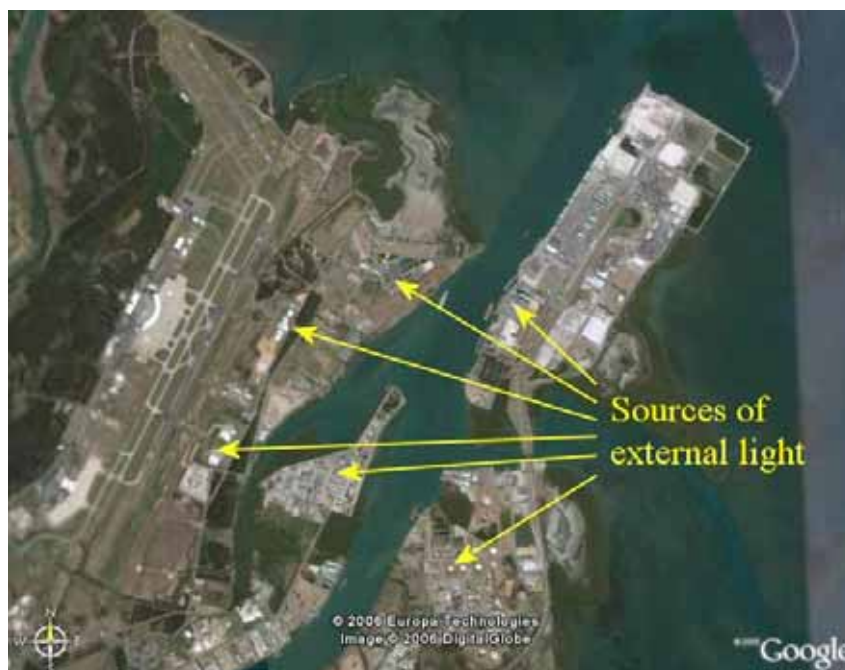
It was a dark, moonless night, with the end of civil twilight³ at 1757. For a landing on runway 14, the environmental background lighting included the runway lighting for runway 01/19, aerodrome aircraft maintenance facility lights, lights from Port of Brisbane facilities, and lighting and gas flares from fuel refinery facilities located adjacent to the Brisbane River (figure 4).

Figure 4: Sources of external lighting SE of Brisbane Airport

Without prior knowledge of the 717, the crew of the Metro found it difficult to identify the correct aircraft. The 717 was below their level and masked by a significant amount of background lighting to the south-east of the aerodrome. While the aircraft on approach would have been easily seen against the dark sky, the 717 would not have become clearly visible until it was on climb above the background lights and buildings.
