ATSB TRANSPORT SAFETY INVESTIGATION REPORT

Aviation Occurrence Report – 200504768

Fuel exhaustion – 18 km SW Bundaberg Airport, Qld

Fairchild Metro III

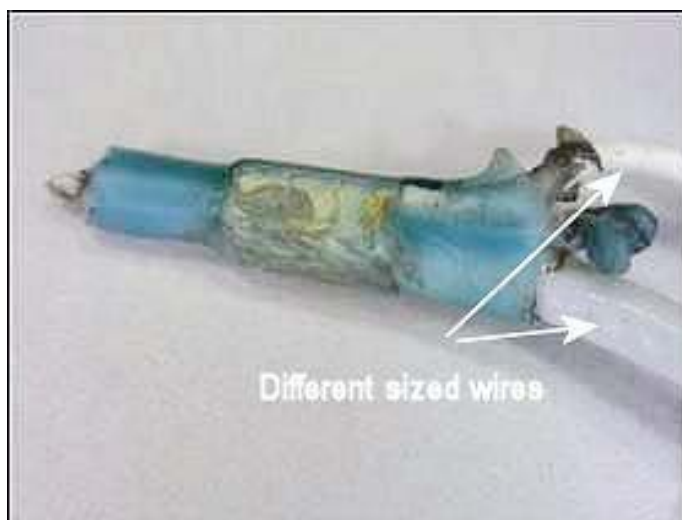
- different sized wires had been spliced (e.g. 2 mm spliced to 1 mm) (Figure 10)
- shielding of the wiring had not been properly grounded in several sections of the harness (Figure 11)
- wire insulation was chafed in some areas and had broken down in others
- the wiring loom was contaminated with glue and chemicals
- several plug connector pins had poor electrical continuity.

Figure 10: Splicing of different sized wires

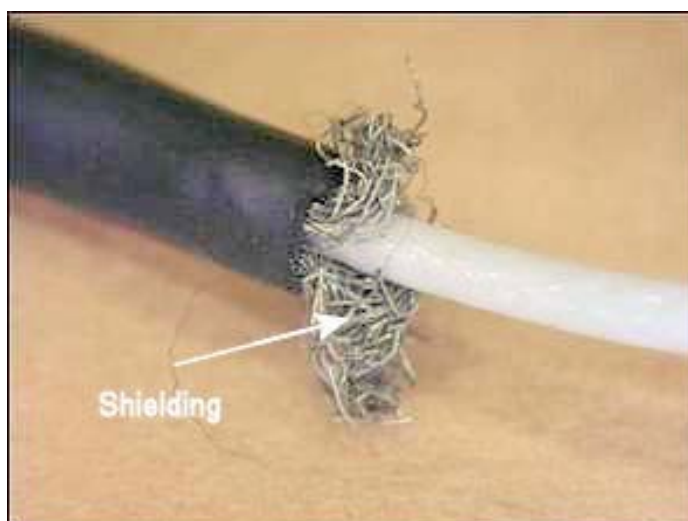
Figure 11: Wire shielding (or braiding) not grounded

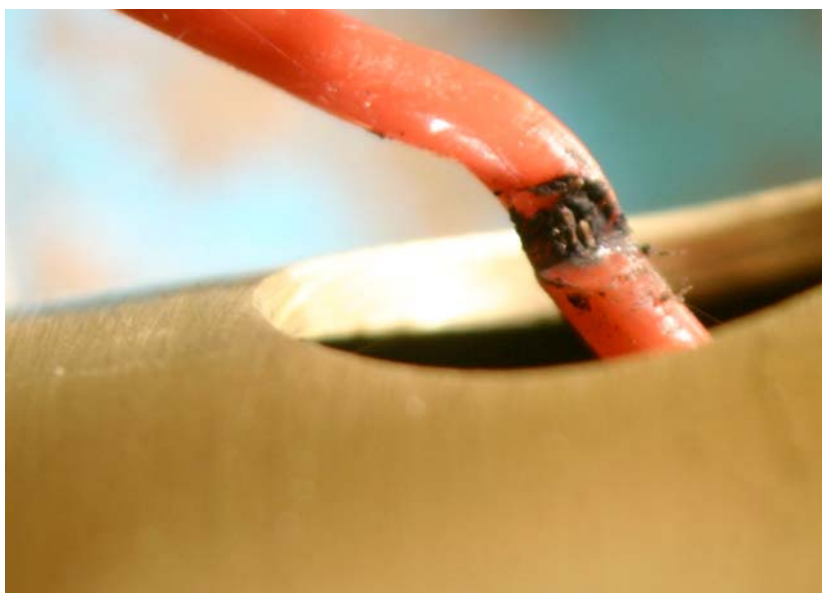
Chafing was observed on the high impedance wire of probe number 2 in the right wing fuel tank. The capacitive element of that probe had chafed into the wire insulation but had not penetrated to the conductor. Chafing was also present on probe number 3 in the left wing fuel tank. The insulation on the high impedance wire of that probe had been chafed through the insulation and into several strands of the conductor (Figure 12). The aluminium tube, which contained the inner components of the probe, displayed signs of arcing of the conductor to the tube near a pass through hole (Figure 13).

Figure 12: Chafing of right number 2 probe high impedance wire

Because the damage to the fuel probe high impedance wire insulation was symptomatic of in-service deterioration over time, it is possible that its influence on system capacitance altered over time as the condition of the probe(s) changed. The extent of that effect, and its rate of progression, could not be determined. The changes to capacitance values that resulted from movement of system wiring looms that were evident during system examination after the occurrence could also have occurred during normal aircraft operation. Either or both of those conditions could have contributed to the large and apparently random fluctuations in fuel quantity indications that occurred between flights 1 and 69 (see Figure 16).

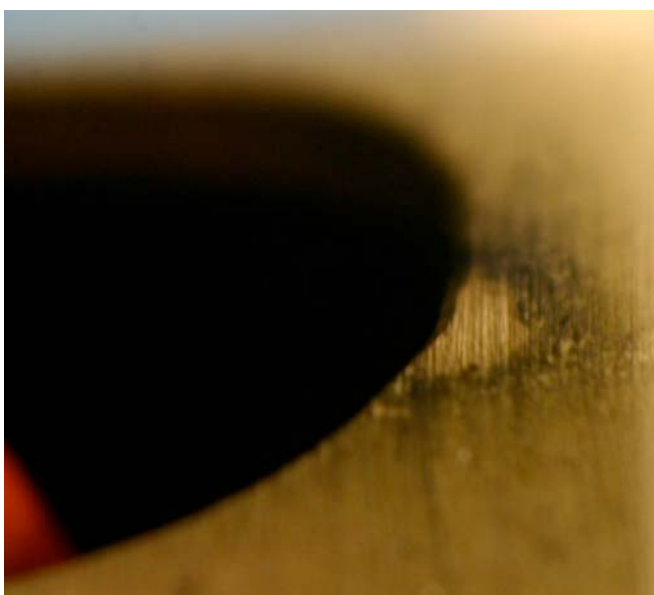
Figure 13: Evidence of arcing at edge of pass-through hole

On 24 May 2006, the ATSB was advised that chafing had been found on the high impedance wire in a fuel tank probe from another Metro 23 aircraft. That aircraft had a total time in service of 13,471.7 hours. ATSB examination of the probe revealed damage to the high impedance wire similar to that evident in Figure 13.

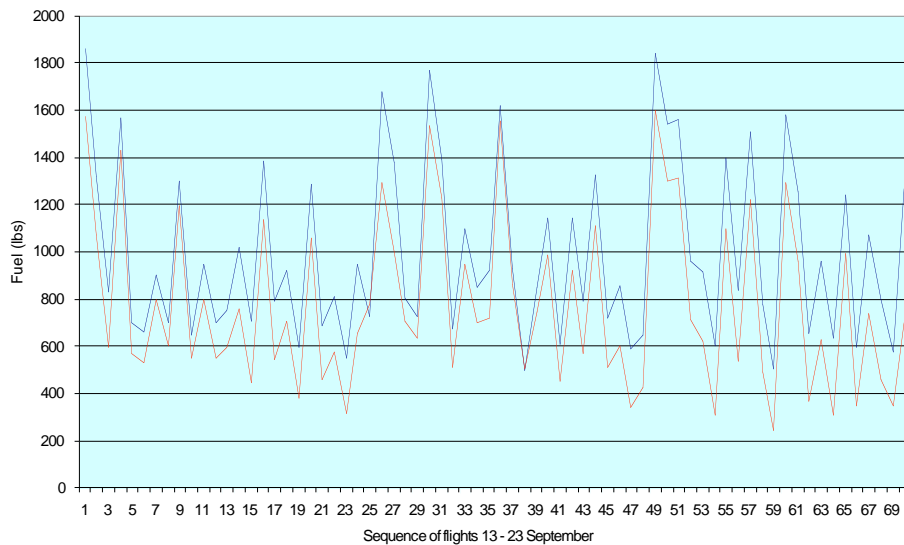
The data indicated that the derived START fuel was less than the logged START fuel for all 71 flights.

Figure 14: Logged (blue) vs derived (red) START fuel for 71 flights, 13 to 23 September 2005

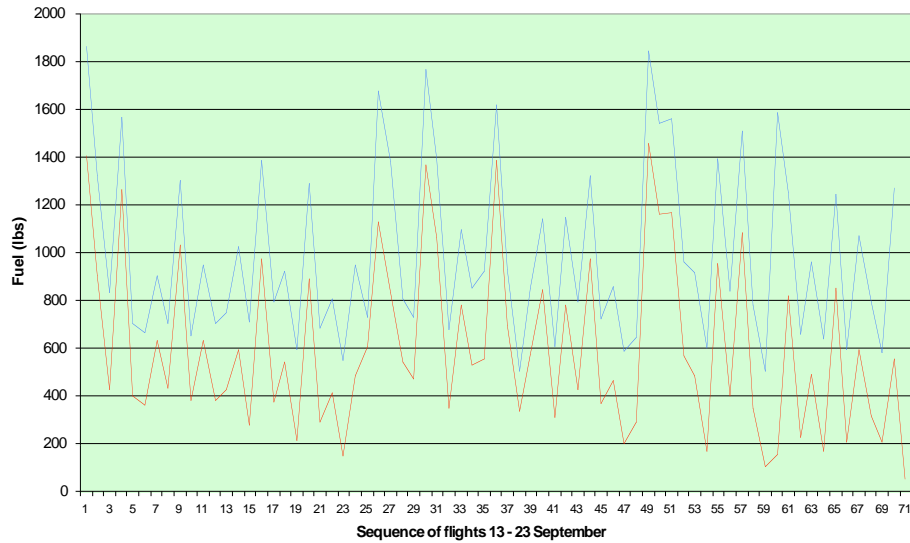
The data indicated that the fuel quantity at shut down was less than 200 lbs on four occasions before the occurrence flight and less than 250 lbs on nine other occasions.

Figure 15: Logged (blue) vs derived (red) fuel on board (FOB) for 71 flights, 13 to 23 September 2005

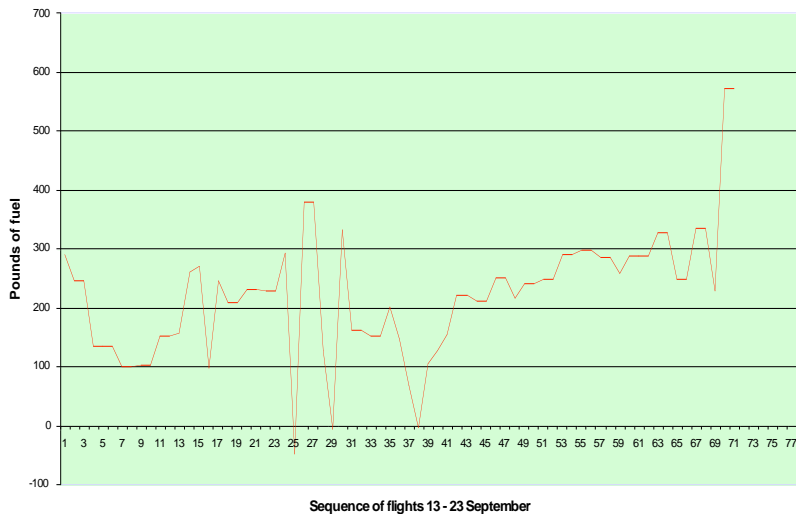
Figure 16 displays the amount by which the logged START fuel exceeded the derived START fuel for the 71 flights. The chart shows that the quantity varied significantly and apparently randomly. A sudden and significant increase in the exceedance is apparent for flights 70 and 71 (Brisbane to Thangool and Thangool to Bundaberg on 23 September), after the fuel quantity indicator had been changed.

Figure 16: Amount that logged START fuel (red line) exceeded derived START fuel for 71 flights, 13 to 23 September 2005
