ATSB TRANSPORT SAFETY INVESTIGATION REPORT

Aviation Occurrence Report – 200505236

Aircraft loss of control - Ballidu, WA

Air Tractor Inc AT-602

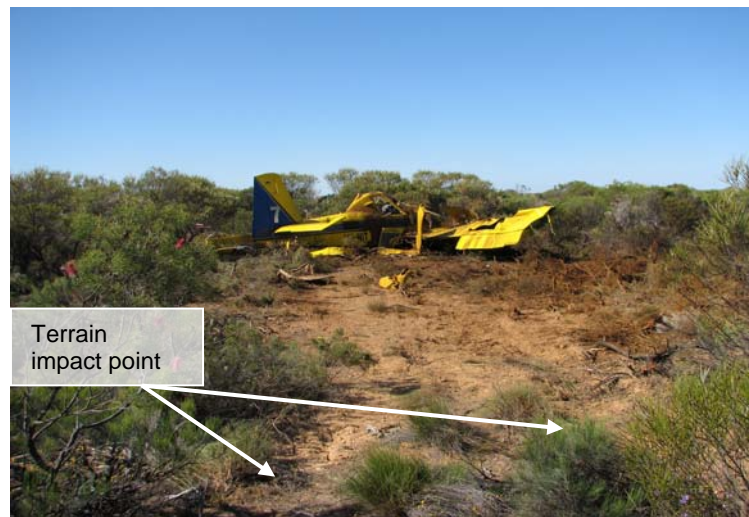
Figure 6: Terrain impact point and aircraft wreckage

The accident site was located on generally flat, scrub-type terrain. Bushes and small trees, approximately 3 to 5 m high, covered the immediate area. Damage to the vegetation in the vicinity of the initial point of impact with the terrain indicated a steep final flight path towards the ground. The main wreckage came to rest about 23 m south of that impact point (Figure 6).

Examination of the wreckage and an analysis of the impact loads through the structure of the aircraft indicated a slightly right wing-low, almost nose-level (zero) pitch attitude on impact. The characteristics of the impact were consistent with a high rate of vertical descent and low forward speed.

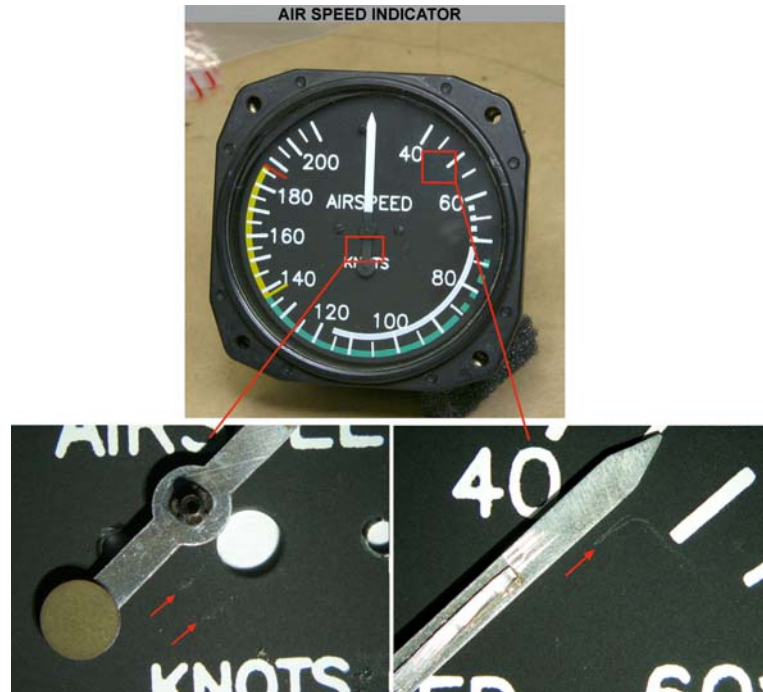
Figure 7: Witness mark on face of airspeed indicator

Laboratory examination of the instrument face of the airspeed indicator showed witness marks from the indicator needle. Those marks indicated that, at the time the indicator needle contacted the face of the instrument, the needle was indicating between 45 and 55 knots (Figure 7).

The witness marks on the face of the airspeed indicator were most probably as a result of the peak forces experienced by the aircraft early during the impact sequence. The upper range of those witness marks (55 kts) approximated the investigation-calculated, flap down aerodynamic stalling speed of about 56 kts. That, and the pattern of damage to the aircraft were consistent with the loss of aircraft control being the consequence of an aerodynamic stall.

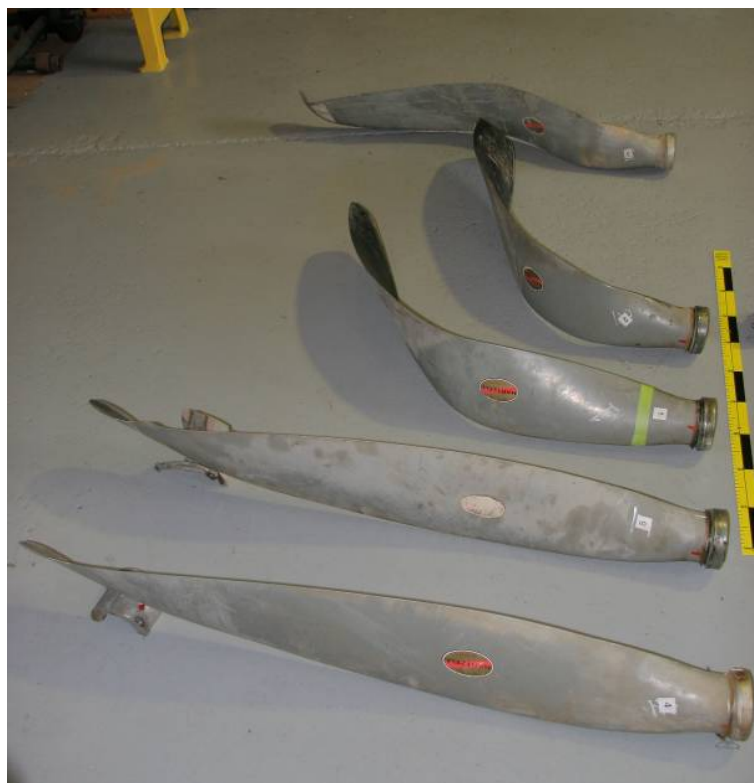
Figure 8: Propeller blade bending, reconstructed as a set

When reconstructed as a set, each of the propeller blades showed a progressive and marked increase in axial twist and rearward, out-of-plane bending around the sequence of rotation (Figure 8). That damage was consistent with a steep angle of impact with terrain (ie low horizontal speed, high vertical speed) and a rapid cessation of propeller rotation.

The pitch change mechanism for the propeller blades was damaged as a consequence of the accident, and each of the blades showed evidence of moving independently during the impact sequence. Marks on the hub of the propeller blades indicated blade rotation beyond the assembly limit of -11 degrees.

There was no evidence to indicate that the propeller was operating in the Beta or reverse blade angle range at the time of impact.
