ATSB TRANSPORT SAFETY INVESTIGATION REPORT

Aviation Occurrence Report – 200506298

**Warning device event – 46 km west of Mackay, Qld
2 December 2005
VH-VBC
Boeing 737-7Q8**

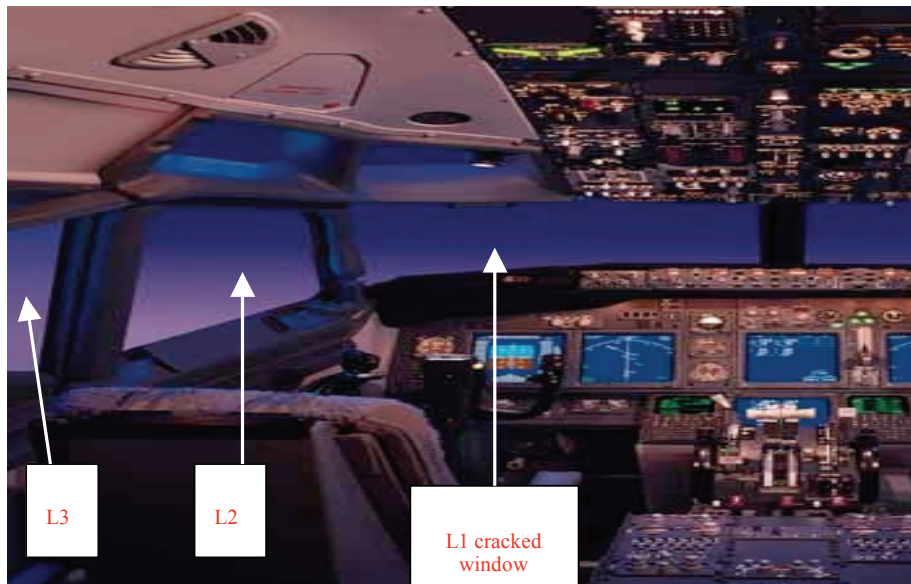
Figure 1: Window Layout

The action required of the crew in the event of window damage was set out in the NNC Window Damage, contained in the QRH. After it was determined that the window had been shattered, the PIC read this checklist, but the crew mis-identified the damaged window. A window layout diagram was not included in the window damage checklist or elsewhere in the QRH. The manufacturer considered that it was more appropriate to include a window layout diagram in the systems manual. The NNC did not require the crew to descend the aircraft as a result of the shattering of an outer layer of glass on any window.

The crew mis-identified the damaged window and as a result of implementing the Window damage non-normal checklist (NNC), a landing altitude of 13,000 ft was set instead of 10,000 ft. The damaged window was identified with haste. Had the flight crew taken more time to communicate with one another or refer to the appropriate systems information for guidance, it is likely that the damaged window would have been correctly identified.

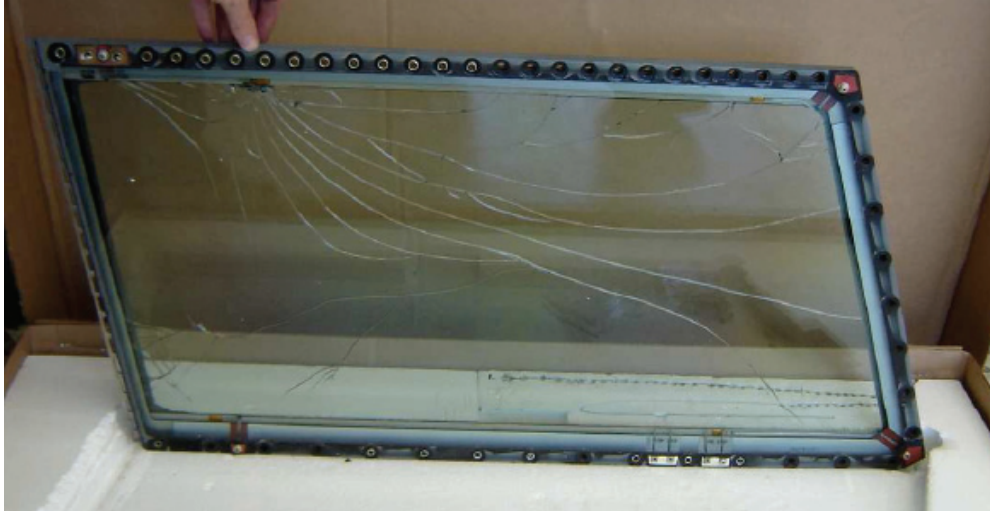
Figure 2: L1 window damage

An examination of the damaged window by the operator confirmed that the outer layer of the left side L1 window was shattered (figure 2).

The L1 window was composed of three main laminated layers:

- one non-structural glass outer pane including a conductive coating (for anti-ice)
- one structural vinyl interlayer
- one structural glass inner pane without conductive coating.

The window was designed such that a failure of one layer of glass would not result in a loss of cabin pressure. The vinyl interlayer alone is used to carry pressurization loads if the structural glass inner pane fractures and is also used for bird impact resistance. For window anti-ice, voltage is applied by the Window Heat Control Unit (WHCU) through the conductive coating on the non-structural glass outer pane. Temperature sensors embedded in the window are continually monitored by the WHCU and voltage is applied as needed to maintain an internal temperature of approximately 43.3 deg C. A window overheat amber caution light would illuminate following the detection of a window overheat condition or if electrical power to the windows was interrupted.

At the time of this report, the underlying reason for the window damage events was still being investigated by both the aircraft manufacturer and the operator.

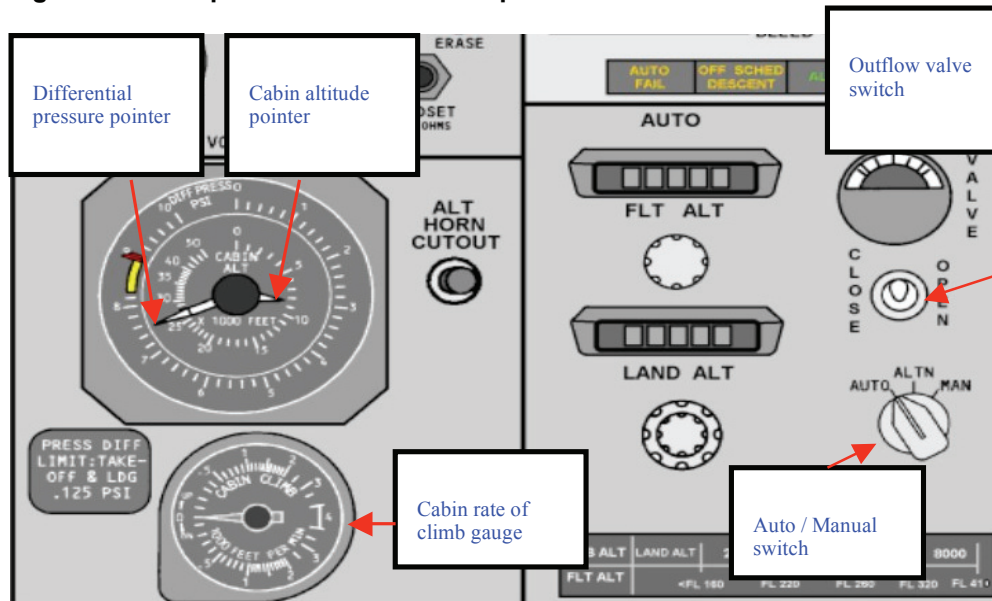
Figure 3: Cabin pressurisation control panel

Cabin pressure was set and controlled using the cabin pressurisation control panel (figure 3). The flight crew could set a flight altitude (FLT ALT) of between negative (-) 1,000 ft and positive (+) 42,000 ft. The flight crew could set a landing altitude (LAND ALT) of between -1,000 ft and +14,000 ft. The system was usually operated in the automatic mode, where it would regulate the airflow ratio to achieve the flight altitude and landing altitude targets. The system could be switched from the automatic mode to a manual mode using a three position rotary switch. In the

The gauge that indicated aircraft cabin altitude and differential pressure was a dual reading gauge (figure 3). The small pointer showed cabin altitude on the inner scale and the larger pointer showed differential pressure on the outer scale. The inner scale was not marked or calibrated to show negative cabin altitude values, although they could be be set by the crew. As cabin altitude decreases, the cabin altitude pointer will move anticlockwise, past the zero position, into an unmarked section of the gauge. Further anti-clockwise movement will result in the pointer moving into the section of the gauge where high positive cabin altitude values are marked. The manufacturer reported that misreading of the cabin altitude gauge by flight crew was not common. The manufacturer stated that the pressure state of the aircraft should be determined by referring to the three indicators of pressure available: cabin altitude, differential pressure and cabin rate of climb.

The manufacturer investigated the feasibility of modifying the cabin altitude gauge by fitting a stop peg to prevent counter clockwise movement of the pointer beyond the -1,000 ft position (the minimum selectable). The gauge supplier however advised that restriction of the pointer movement by fitting a stop peg could cause

damage to the gauge's diaphragm mechanism or the pointer itself, such that the gauge accuracy could be affected.
