**ATSB TRANSPORT SAFETY INVESTIGATION REPORT**

Aviation Occurrence Report –200506443

**Collision – 2 km east of Coldstream (ALA)  
10 December 2005**

**Piper Aircraft Corp PA-28, Warrior, VH-BZA**

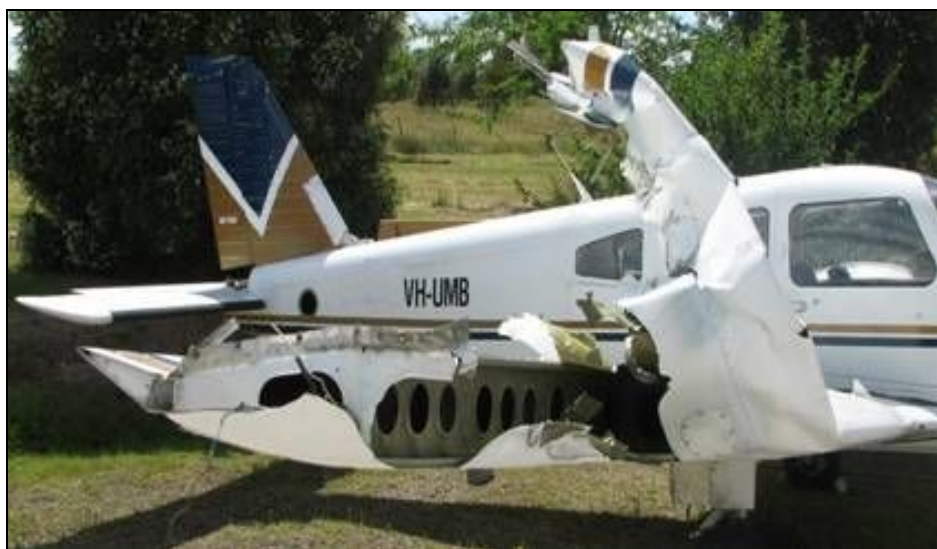
After the collision, the instructor on board UMB took over control of the aircraft from the student and after some difficulty the aircraft began to respond to his flight control inputs. He reported that he had initially considered an off-airport landing; however, after some degree of control was regained, he felt confident enough to proceed with a landing at Coldstream Aerodrome. The landing was conducted without extending flap. The right wing leading edge and the vertical stabiliser of UMB sustained substantial damage in the collision (Figure 2).

**Figure 2: VH-UMB showing significant damage to right wing leading edge**
