**ATSB TRANSPORT SAFETY INVESTIGATION REPORT**

Aviation Occurrence Report – 200600256

**Aircraft loss of control  
4 km E McArthur River Mine Aerodrome, NT  
19 January 2006  
VH-MNI  
Beech Aircraft Corp 58**

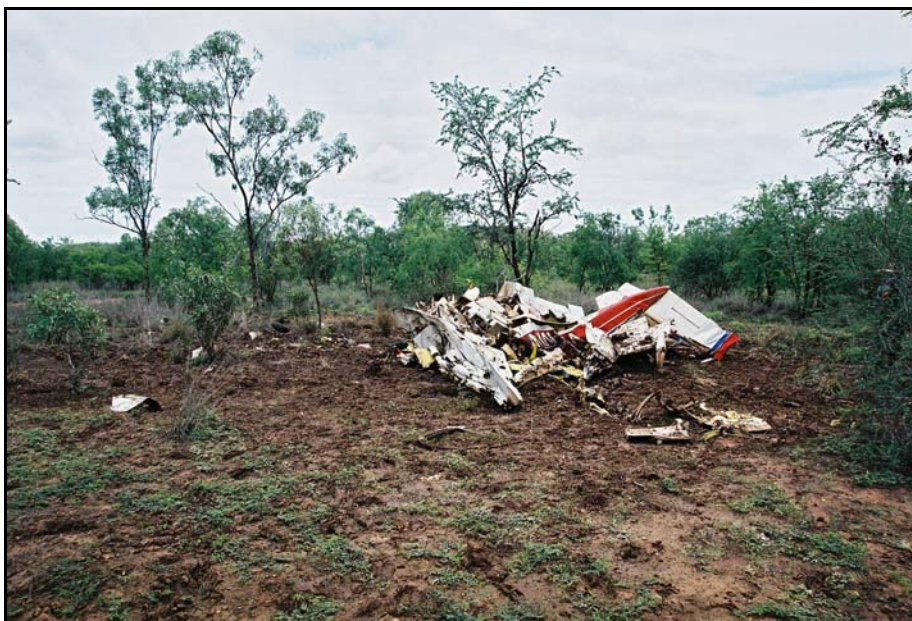
**Figure 2: Accident site**

At 1003, the aircraft operator advised AusSAR that the Baron had not landed at McArthur River Mine and that it could not contact the pilot. AusSAR reactivated the uncertainty phase, and shortly thereafter, at 1006, declared a distress phase. The pilot of the Navajo was tasked by AusSAR to look for the missing aircraft. Shortly after, observers on board the Navajo sighted the wreckage of the Baron (Figure 2).

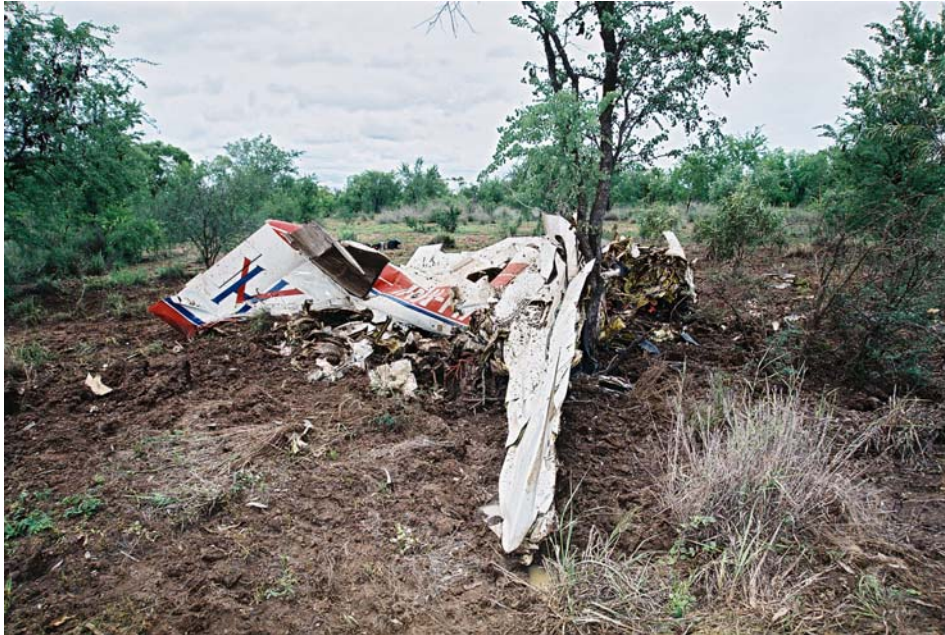
**Figure 3: Aircraft wreckage**

An examination of the wreckage indicated that the aircraft impacted the ground inverted in a steep nose-down attitude (Figure 3). The wreckage was contained in the immediate area of the impact crater, suggesting a predominantly vertical component to the direction of flight at impact. The wreckage had been disturbed by rescue personnel prior to examination by Australian Transport Safety Bureau (ATSB) investigators.

- The cockpit and aircraft cabin, to just rear of the main cabin utility door, were destroyed by extreme vertical impact forces, experienced during the accident sequence. The rear fuselage and tail section also showed evidence of impact damage with the ground. The pattern of damage to the aircraft was consistent with impacting terrain at a high speed.

- Both engines, nacelles and propellers had detached from the airframe and were located in the impact crater.
- Both wings were intact, but separated from the fuselage. The forward structures of both wings were crushed back to their rear spars and the wing fuel tanks were breached during the impact sequence, preventing the retrieval of fuel for sampling. Each of the wing fuel tank bays showed evidence of skin attachment failure on the rivet lines. First response personnel at the accident site reported a strong smell of aviation gasoline.

- The ailerons, rudder and elevator flight control surfaces, with their associated trim tabs, were located within the main wreckage area. The pilot's control column and yoke were destroyed, and the rudder pedals had separated from the vertical posts. Due to the level of damage, it was not possible to trace all of the control systems. The nature of the damage showed that the aileron controls were intact prior to impact. The rudder and elevator control cables were severed during the post-accident recovery activities. However, the cable turnbarrels were observed intact and lockwired. In summary, a detailed examination of the wreckage did not identify any manual control system anomalies that would have prevented controlled flight of the aircraft prior to impact. However, due to the severe impact damage and post-accident recovery activities, it was not possible to confirm the integrity of some parts of the elevator or rudder control systems.

- The landing gear was extended.
- The wing flaps were extended in the approach (15 degrees) position.
- The fuel selector for each engine was in the ON position.
- Due to the extent of impact damage, no reliable evidence of control settings in the cockpit could be obtained.
- The emergency locator transmitter was found in the wreckage, however it was destroyed by impact forces and would have been incapable of transmitting any signal.

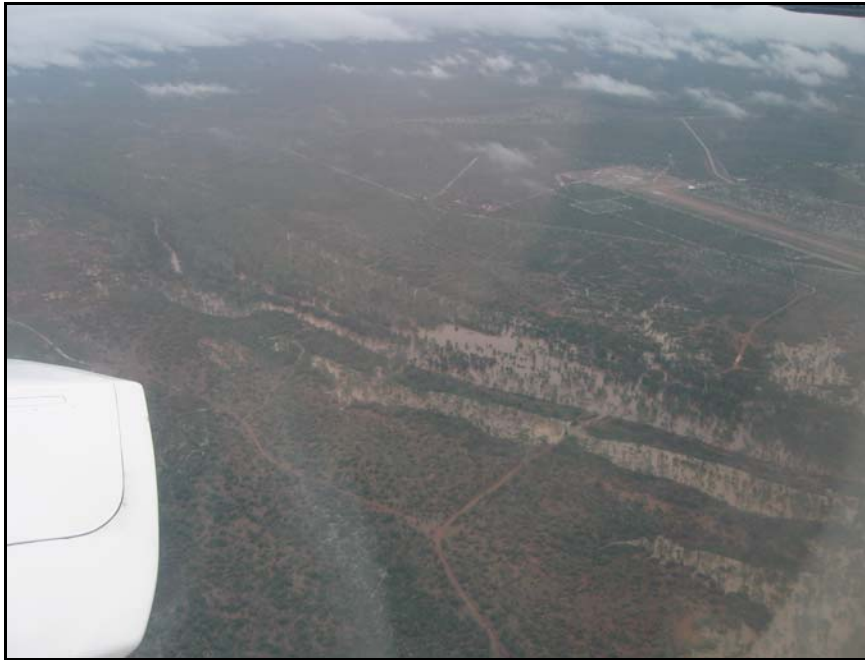
**Figure 4: Photograph taken shortly before the Baron overflowed McArthur River Mine**

Figures 4 and 5 were photographs taken from on board the Navajo when that aircraft was in the circuit area. Figure 4 was taken when the aircraft was located to the south of the runway, above the circuit height (1,000 ft). The photograph shows scattered cloud below the aircraft looking to the west. Figure 5 was taken a few minutes later when the aircraft was in the downwind leg of a right circuit to land on runway 06. The photograph shows the terrain and sky looking towards the north, the direction from which the Baron approached the aerodrome. In both photographs, the aircraft was travelling to the left.
