ATSB TRANSPORT SAFETY INVESTIGATION REPORT

Aviation Occurrence Report – 200600523

Wirestrike
15 km east of Parkes Aerodrome, NSW
2 February 2006
VH-MFI
Bell Helicopter Co 206B (III)

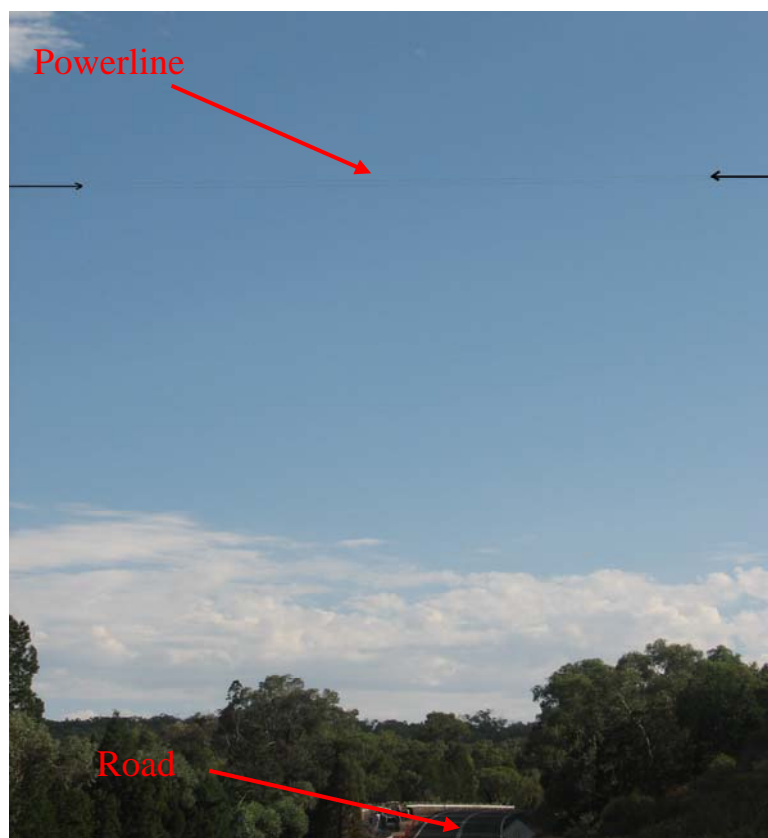
Figure 2: View of powerline overhead the road, looking about 044 degrees true

The helicopter was observed by the driver to strike the powerline that crossed the road (Figure 2), abruptly changing attitude before rotating as it fell to the left of its original direction of travel, and striking the ground adjacent to the road.

The three occupants of the helicopter were fatally injured and the helicopter was destroyed by impact forces and a post-impact, fuel-fed fire. There was no damage to the powerline or its associated facilities and structures.

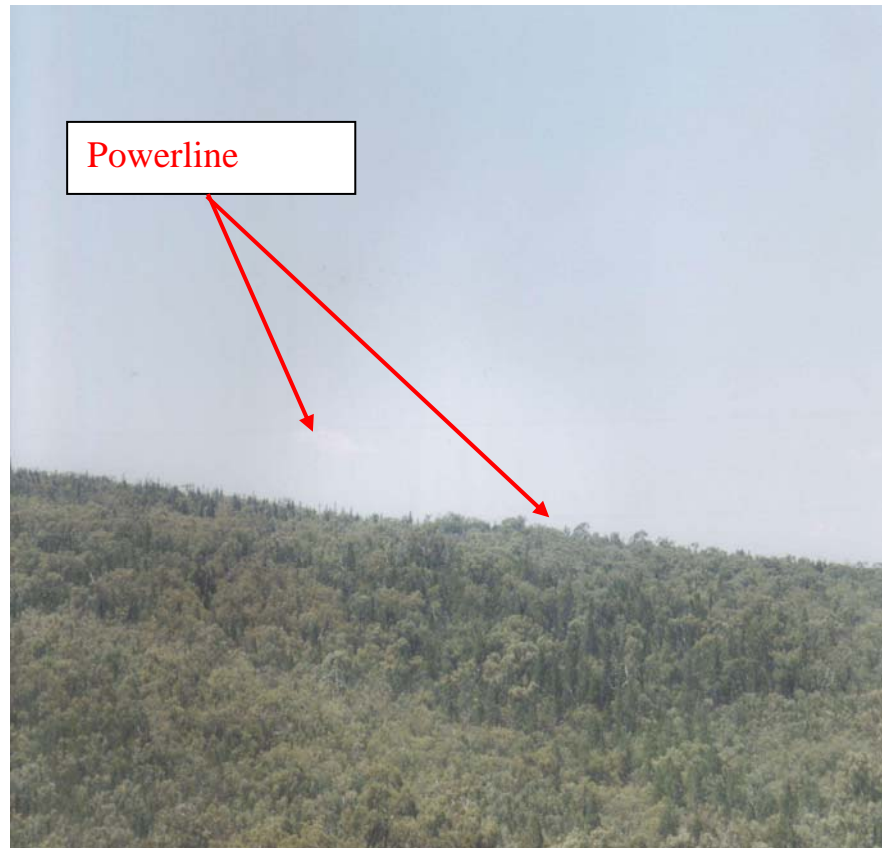
Figure 3: Pilot's view of the powerline from slightly below eye height⁷

high tension. The maximum electrical power carried by the powerline was reported to be 22 kVA.

There was no spike or surge of electricity recorded by the power supply company on the day of the accident. However, the company stated that that would only occur if the cables had broken and made contact with each other. The company inspected the power poles and cable joins after the accident and found no damage as a result of the wirestrike.

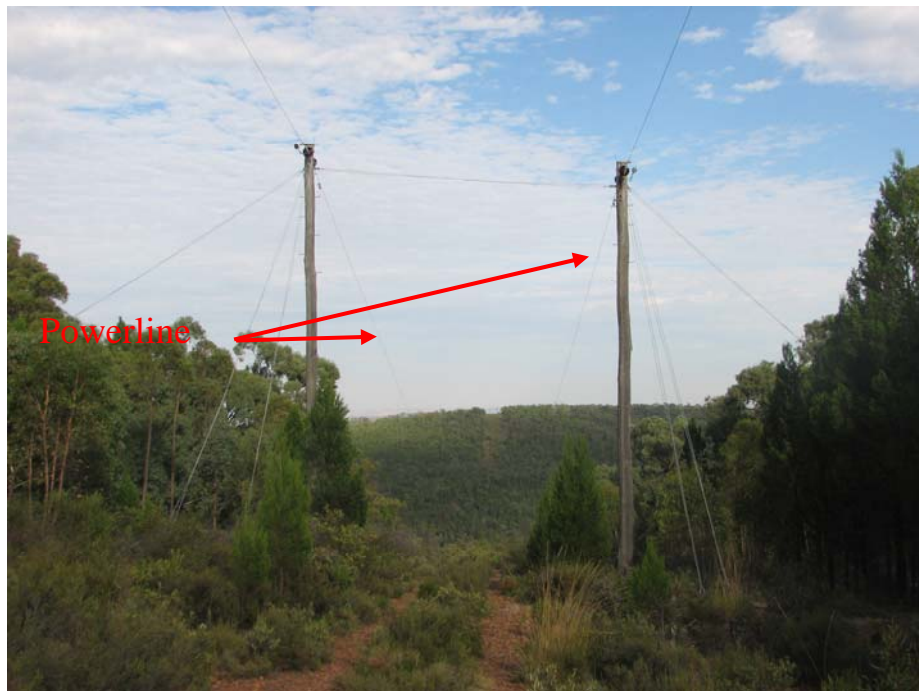
Figure 4: View of the eastern power poles, looking west

When surveyed after the accident, the pole structures at each end of the 1,260.1 m span were found to be 7.5 m apart (Figure 4). The surveyor determined that, at the then ambient temperature of 39°C:

- the sag of the two cables that constituted the powerline were at differing heights by about 2.5 m (8 ft)
- overhead the road, the cables were:
 - 7.9 m apart laterally
 - about 38.7 and 36.2 m (127 and 119 ft) AGL respectively.

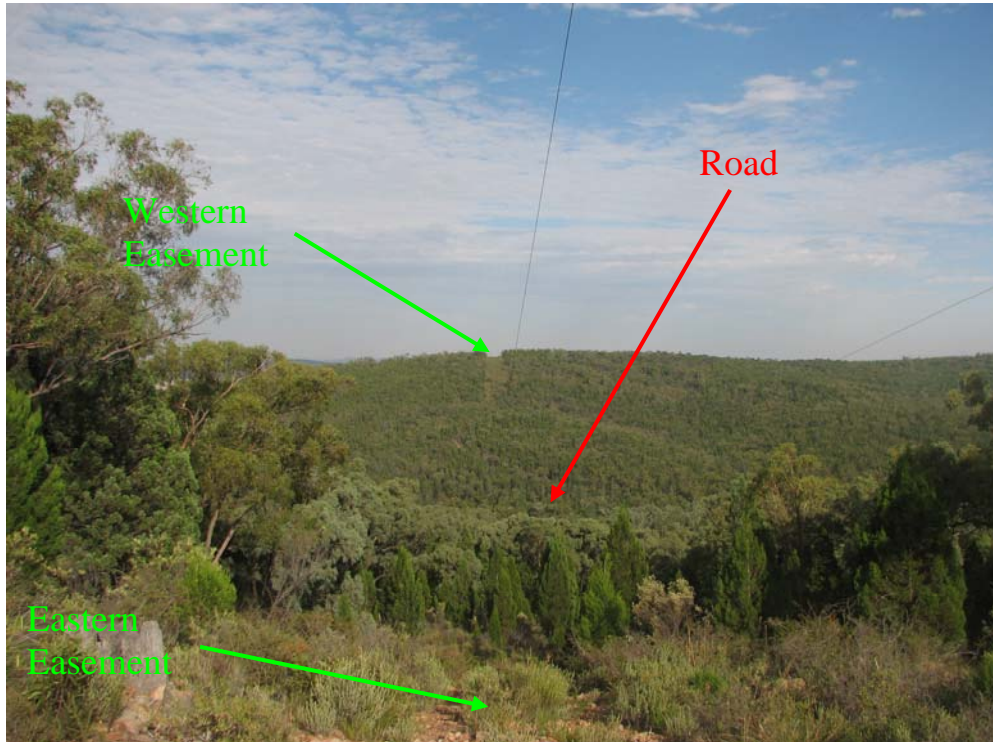
Figure 5: East to west view of the power line

The accident site was in a shallow valley that broadly ran at right angles to the powerline. The nature of the terrain was such that the access track (or easement) normally associated with the progress of a powerline through woodland ceased on the eastern and western ridgelines that formed the valley, and on which the powerline support pole structures were located (Figure 5).

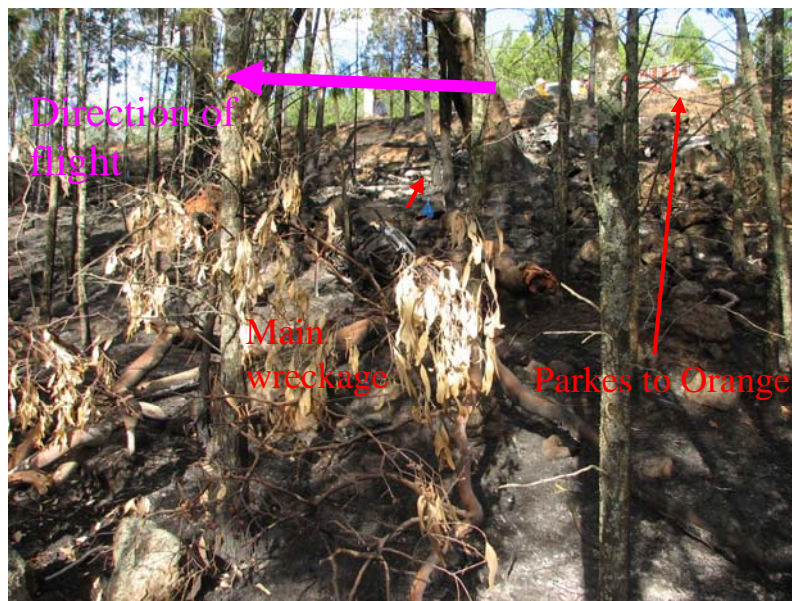
Figure 6: Terrain and surrounds at the accident site

The accident site spanned the Parkes to Orange road about 15 km east of Parkes Aerodrome. The terrain at the site broadly sloped from right to left to the direction of flight, at about 20 to 30 degrees down to the horizon. Numerous rocks and large trees surrounded the site (Figure 6).

The main body of the wreckage was found inverted, about 5 m down a steep embankment from the road (Figure 6). The engine assembly had separated from its fuselage mounting points and came to rest a further 5 m down the embankment from the main wreckage. A severe post-impact fire consumed the majority of the helicopter’s fuselage.

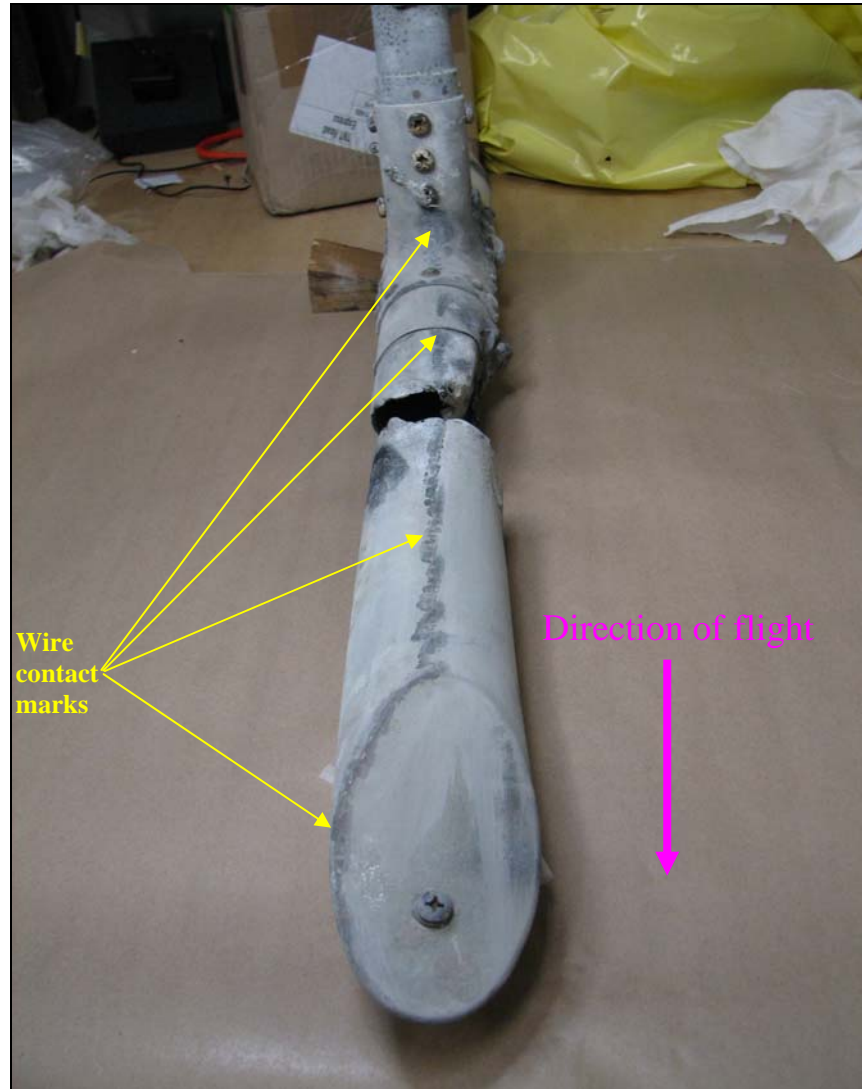
Figure 7: Wire contact markings on the left landing gear skid and crosstube

Witness reports and impact markings on the forward upper surface of the helicopter's left landing gear skid and the junction of that skid with the left forward skid landing gear crosstube (Figure 7), were consistent with the helicopter striking

the powerline that crossed the direction of flight about 88 m back along the direction of flight. No similar marking was identified on the helicopter's right skid landing gear, or elsewhere on the remaining wreckage.

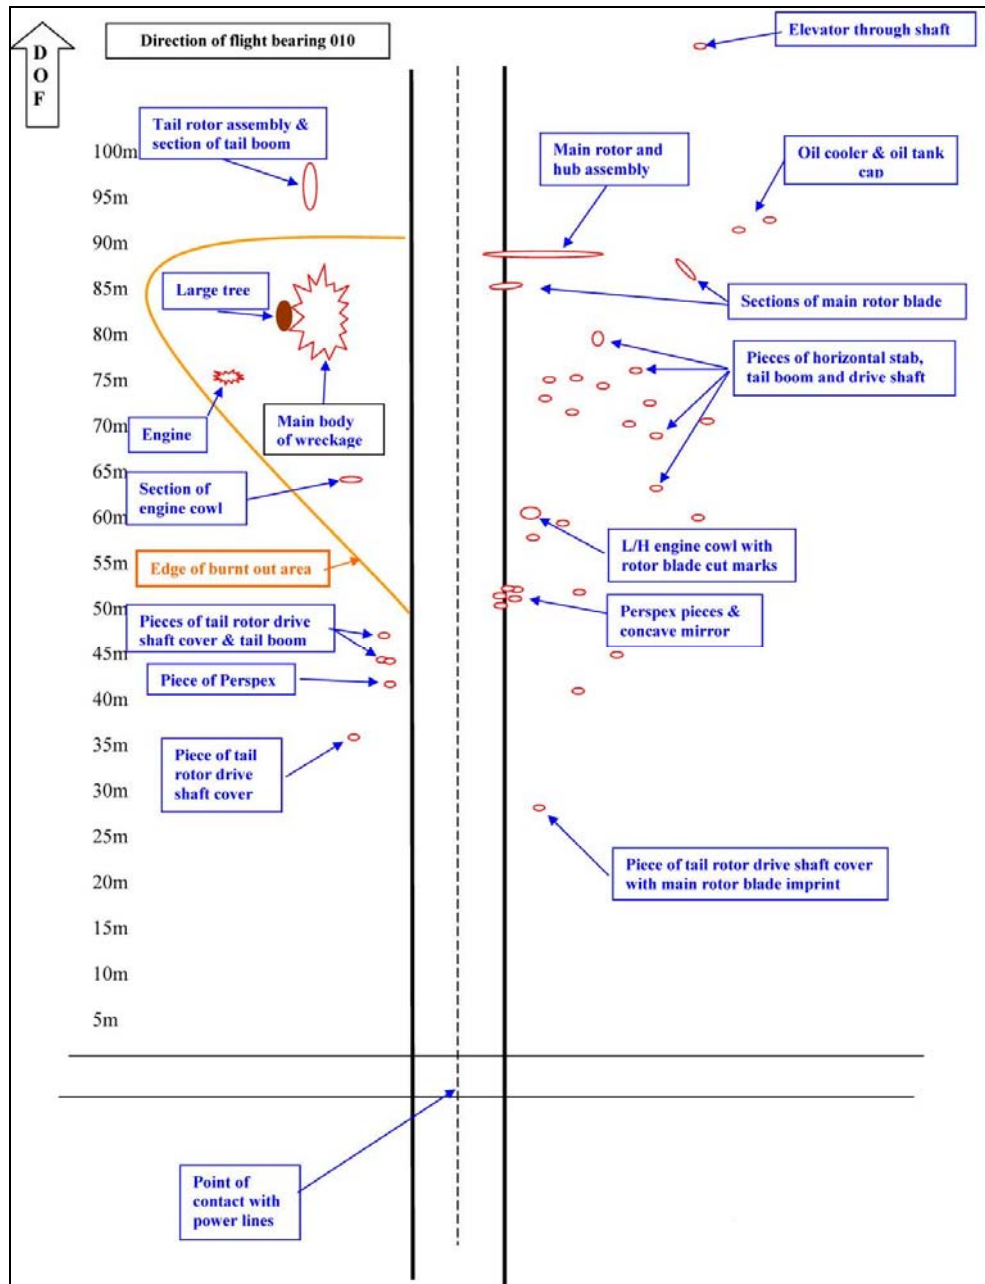
Figure 8: Diagram of the accident site

The wreckage of the helicopter was spread over about 120 m in the direction of flight (Figure 8). The main rotor and hub assembly, and a number of smaller items were located to the east of the Parkes to Orange road, and the remainder of the helicopter was located to the west of the road.

Trajectory analysis that was conducted by the investigation after the accident indicated that, when the helicopter struck the powerline, it was travelling at an estimated 61 kts.

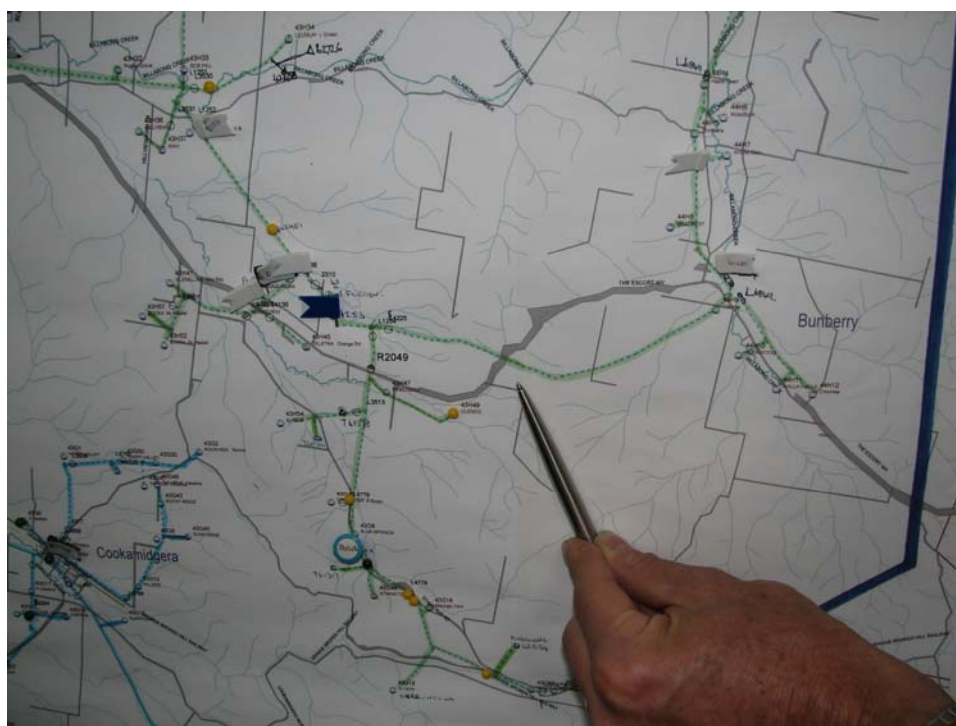
Figure 9: Power supply schematic¹³ (indicating the approximate position of the powerline)

The powerline that was struck by the helicopter was not marked on any aviation or other map or chart that might be expected to be normally accessed by a pilot. The Parkes office of the power supply company retained a schematic representation of its known infrastructure (Figure 9). That representation did not include a scale, or either an indication of the latitude and longitude or of a grid reference system for application when using the schematic.

Prior to being used by the pilot, it would have been necessary for the pilot to have transposed the 381 known powerlines in the survey area from the power supply company's schematic chart onto a suitable topographic chart.
