**ATSB TRANSPORT SAFETY INVESTIGATION REPORT**

Aviation Occurrence Investigation – 200600837

**Aircraft loss of control  
56 km S of Lombadina, WA  
15 February 2006**

**VH-OTV  
Viking Air Ltd  
DHC-3-T ‘Turbo-Otter’**

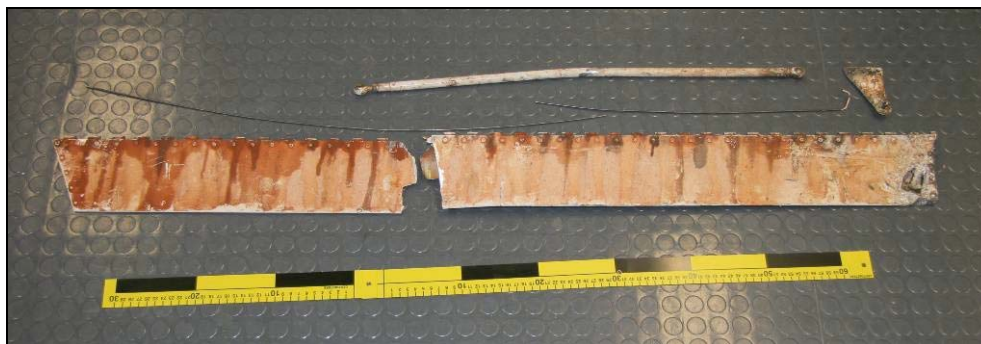
The damaged servo tab, hinge, control horn and actuator rod (Figure 2) were retained by the ATSB for laboratory examination to ascertain the reasons for the damage sustained.

**Figure 2. Servo tab removed from the VH-OTV right elevator after the event**

Two of the three rivets securing the control horn to the servo tab had failed through the central cylindrical section, in a manner consistent with mechanical overload (Figure 3). The third (forward-most) rivet had failed by pulling through the control-horn hole, with remnants of the rivet head remaining around the periphery. The corresponding rivet holes in the control horn all presented prominent elongation and wear damage, consistent with looseness and repeated oscillatory movement in service. Wear and material loss from the inside surface of the control horn was also consistent with repeated movement, as was the accumulation of fine grey wear debris over the joint interfacial surfaces.

The temporary loss of control of the DHC-3 aircraft reported by the pilot was a direct consequence of the onset of aerodynamic flutter and subsequent structural failure of the servo tab located at the trailing edge of the aircraft's right elevator. The flutter event was precipitated by the separation of the control horn from the outboard end of the tab, allowing the unbalanced tab to immediately and violently oscillate (flutter) within the airflow across the elevator surface. The strong nose-down pitching tendency of the aircraft reported by the pilot was likely to have been a consequence of the loss of longitudinal trim resulting from the disconnection of the servo tab, and the subsequent damage to the tab and elevator trailing edge from the flutter behaviour.

Evidence of localised wear and movement between the servo tab control horn, rivets and mounting surfaces suggested the horn had been progressively loosening over an indefinite period. That behaviour was consistent with exposure to the elevated aerodynamic stresses resulting from turboprop engine operation.

As immediate post-incident remedial work, the elevator assembly of VH-OTV was repaired and modified to incorporate the flutter prevention requirements promulgated by CASA AD/DHC-3/40.

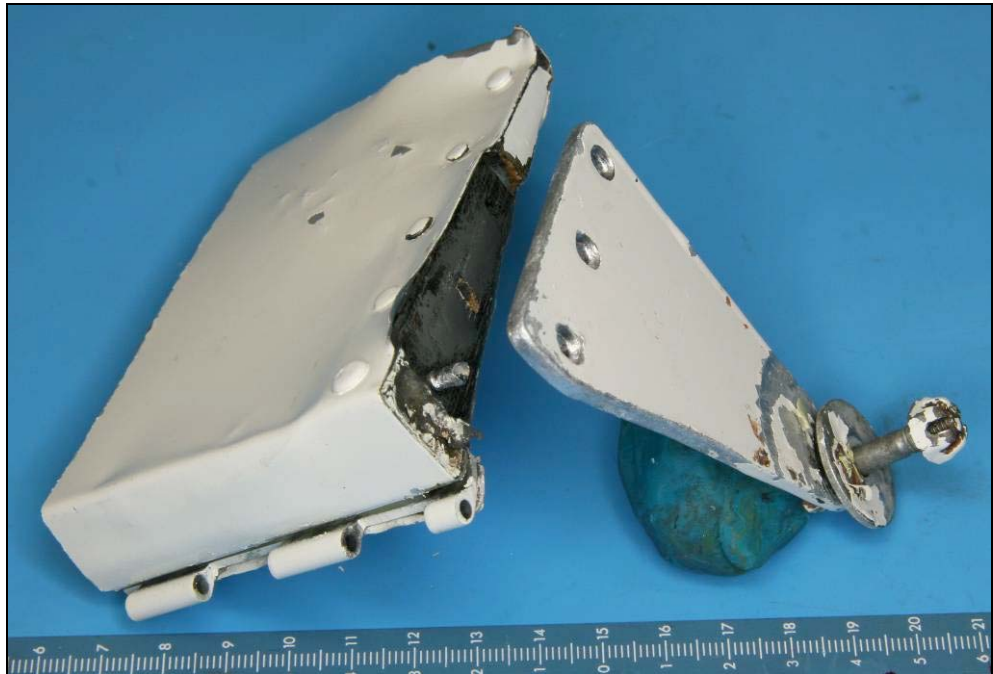
**Figure 3. Detail of the control horn separation from the servo tab outer end**

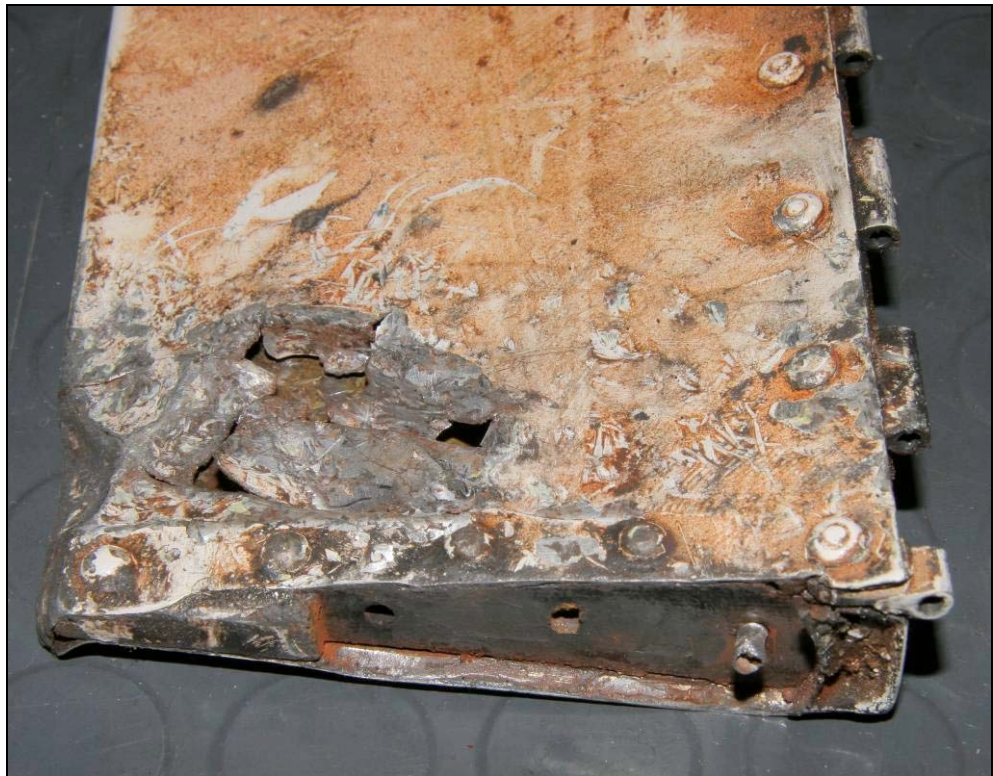
Adjacent to the control horn connection, the servo tab upper surface skin presented severe mechanical indentation and puncture marks, consistent with repeated impacting against the edges and corners of the control horn after it had separated from the tab (Figure 4). The horn remained connected to the control rod, which had slightly bent about its mid-span. Approximately 60 cm from the outboard end, the servo tab had torn and fractured in a chord-wise manner, with the irregular fractures suggesting the loss of some pieces of skin and tab structure from around the point of failure. Slight downward buckling of the tab trailing edge was also noted, approximately 5 cm outboard from the main fracture.

**Figure 4. Damage to the upper surface of the servo tab resulting from repeated impact against the separated control horn**
