ATSB TRANSPORT SAFETY INVESTIGATION REPORT

Aviation Occurrence Report – 200600979

**Collision with terrain
10 km west of Gunpowder Mine, Qld
21 February 2006
VH - HBS
Robinson Helicopter Company R44**

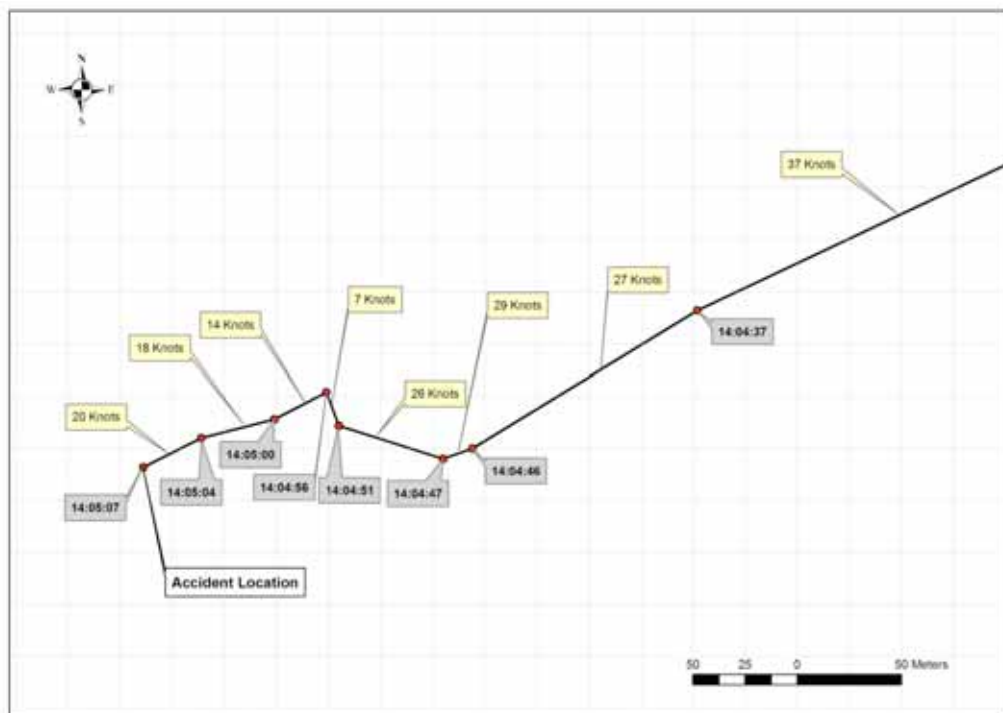
Figure 2: Recovered data showing last recorded track positions – derived groundspeeds above track and recorded times below track

The last recorded data revealed that the helicopter was tracking in a south-westerly direction at derived groundspeeds between 26 and 37 knots. Six recorded positions before the last valid data, the track changed to a westerly and then a northerly direction and the derived groundspeed decreased to 7 knots (see Figure 2). In the absence of additional data and evidence or witnesses, the investigation was unable to determine the possible reasons for this change of direction.

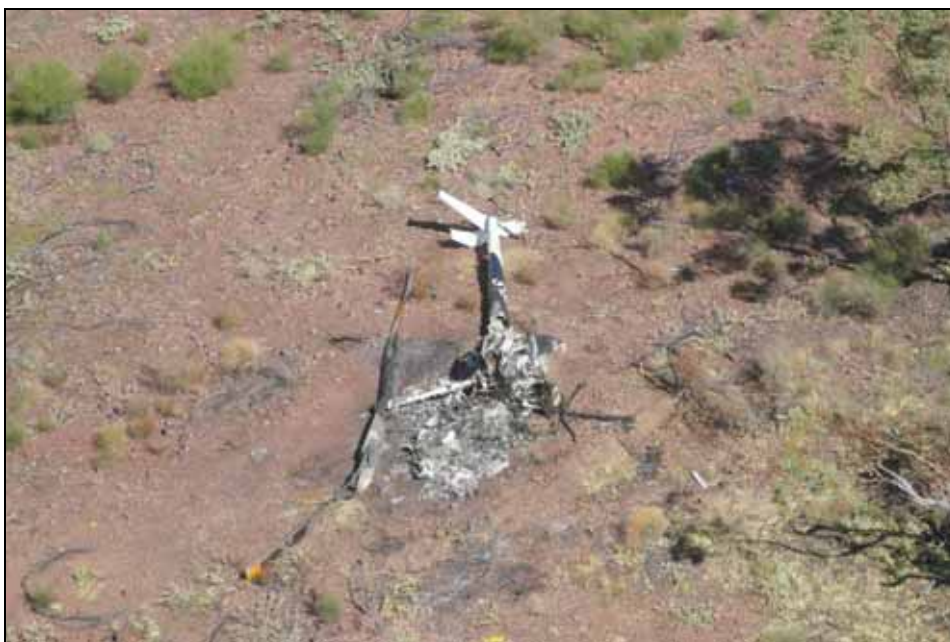
Figure 3: Helicopter wreckage

The helicopter impacted the ground with significant vertical force, sufficient to compress the stainless steel vertical engine firewall to less than half of its original height and to separate both landing skids from the helicopter. The engine air induction and oil sump systems, located at the bottom of the engine, both sustained significant crushing damage.

The main rotor blades displayed evidence of low rotational energy at the point of impact and there was significant compression wrinkling (coning) of the upper outer surface of both main rotor blades (Figure 4). One main rotor blade had contacted the ground, resulting in the rotor tip being torn from the blade. That tip was located within the wreckage area of the helicopter. The main rotor blades had not contacted the tail boom of the helicopter, and there was no indication that they had contacted the cabin area.

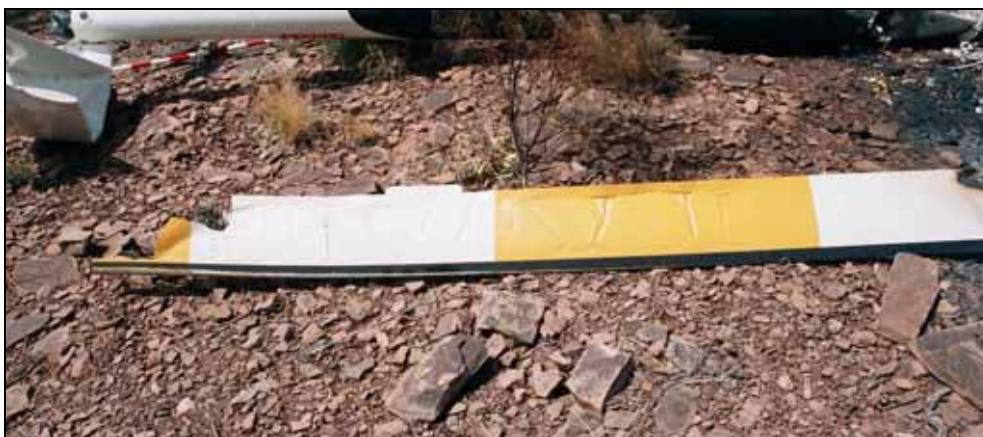
Figure 4: Compression wrinkling on main rotor blade upper surface

In the likely absence of a major engine power loss or drive train failure, main rotor drag in excess of the applied drive torque was also a possible factor. The main rotor blades were intact and showed no signs of delamination or other faults that may have decreased aerodynamic efficiency. In the absence of any identifiable flight control system defects, the investigation considered that overpitching was probably the source of the low rotor RPM.
