ATSB TRANSPORT SAFETY INVESTIGATION REPORT

Aviation Occurrence Report – 200601053

**Engine In-flight Shutdown –
40km NW Callion, WA – 27 February 2006
VH-LBA
Cessna Aircraft Company 441**

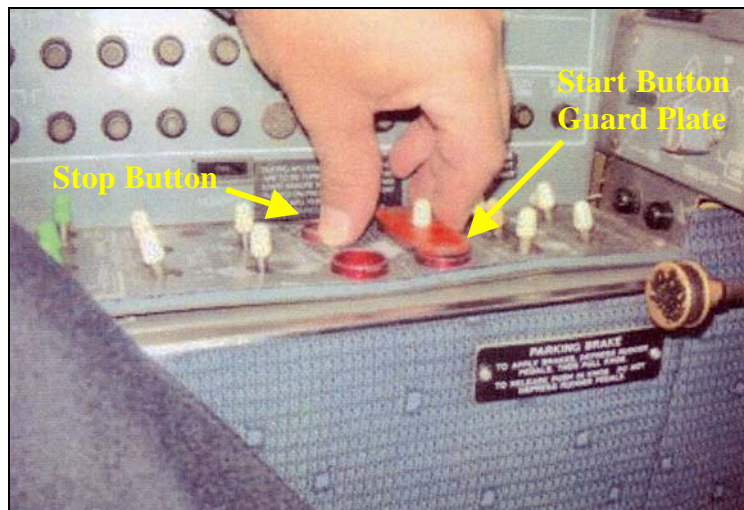
Figure 1: Start Button Guard Plate²

Following the occurrence, the flight crew reported that, prior to the engine shutdown, the pilot in command (PIC) had inadvertently depressed the left engine STOP button. Prior to the event, the flight crew were discussing the use of the Start Button Guard Plate which was in place over the engine START buttons. In the course of explaining to the second pilot the use of the Start Button Guard Plate, the PIC inadvertently depressed the left engine STOP button (Figure 1).

A review was completed to assess the potential for this type of event to occur with specific attention to the effectiveness of the Start Button Guard Plate.

The aircraft operations manual is being revised to include the correct usage and procedures related to the 'Start Button Guard Plate'.
