ATSB TRANSPORT SAFETY INVESTIGATION REPORT

Technical Analysis Occurrence Report – 200601173

Microlight Structural Analysis
Airborne Edge
Aircraft Registration: 32-4456 and 32-4388

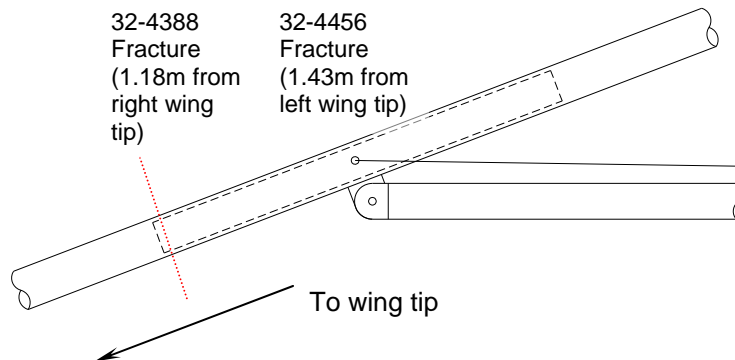
The left and right rear leading-edge wingspar (Streak 1 airframe) for 32-4456 were received and examined. The spar tube (tip) had a wall thickness of 1.2 mm and the location of fracture of the left spar was 1.43 m from the left wing tip, see figure 3. The fracture occurred transversely through the tubular section, at the insertion of the reinforcing sleeve. The fracture site showed typical characteristics of bending (i.e. the thin-walled tubular section had collapsed) with evidence of tearing of the aluminium tube, see figure 4. The concave surface of the collapsed section was located on the underside of the spar, indicating a downward bending load (normal to the plane of the wing). There was no evidence of defects or pre-existing cracks that could have contributed to the failure of this component.

Figure 3: Location of the fractures fore 32-4456 and 32-4388. Note: both occurred through the outer end of the internal reinforcing sleeve. Diagram not to scale.

- Failure of the spars occurred at the point of maximum bending stress of the section (through the internal reinforcing sleeve).
- Fractures of these wingspars were downward/rearward to the plane of the wing. This is consistent with negative G loading of the aircraft.
- There was no evidence of material deficiencies or inconsistencies that could have contributed to the failure of wingspars.

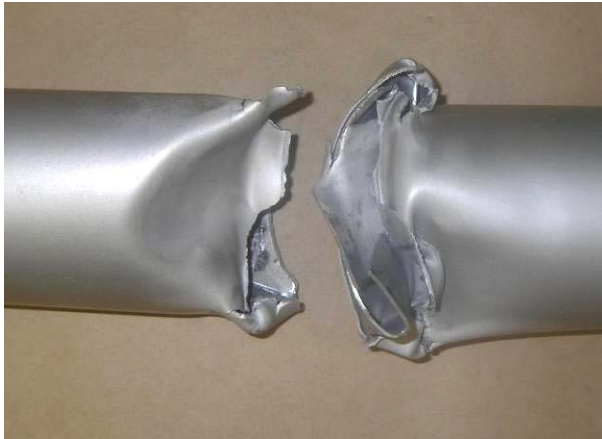
Figure 4: Fracture of the left wingspar of 32-4456.

Examination of leading-edge wingspar failures from 32-4456 and 32-4388, and expert witness statements (Hexham accident) suggested that the applied load on the wingspars was a downward bending moment. Evidence showed the tubes initially failed in compression, resulting in an unstable section collapse. This is typical for a thin-walled circular tube under a bending load. The wingspar from 32-4388 exhibited an angled fracture surface, indicating an additional rearward load during failure.

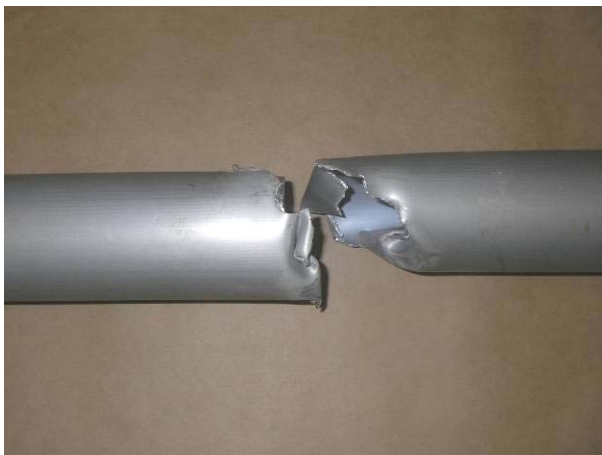
Examination of the fractured right wing spar from 32-4388 (Streak 3 airframe) showed similar fracture characteristics to 32-4456. The fracture occurred 1.18 m from the right wing tip, at the outer end of the internal reinforcing sleeve, and evidence of bending and tearing of the tubular section was observed, see figure 5. Unlike the fracture of 32-4456, the fracture surface was angled, indicating a downward bending load (normal to the plane of the wing) and rearward load (i.e. parallel to the plane of the wing). Small dents in the wingspar were observed along its length. There was no evidence of pre-existing defects or prior cracks that could have contributed to the failure of this component.

Figure 5: Fractured right wing spar of 32-4388. Note buckling and tearing features of the fracture and the 'slant' of the fracture.

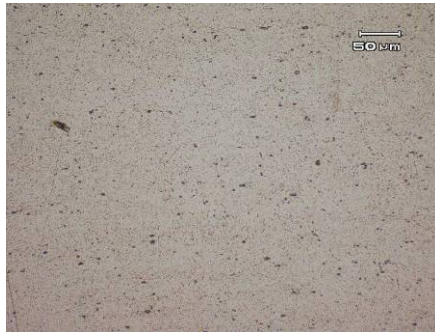
The microstructure, see figure 8, of all three samples included elongated grains, containing small, black, evenly dispersed particles suspected to be Magnesium Silicide (Mg_2Si).

Figure 8: Microstructure of sample 3. Similar characteristics were observed for samples 1 and 2.

Five Vickers hardness tests were completed for each of the three samples. Hardness ranged between 98HV₅ and 104HV₅ (average 101HV₅). This was typical for Aluminium alloy 6061-T6⁴.

The microstructure and hardness results for all three samples taken from the leading-edge wingspars of 32-4456 and 32-4388, were consistent with an Aluminium alloy 6016-T6. They were within the manufacturer's material specifications and there was no evidence of material deficiencies or abnormalities that could have contributed to the failure of the wingspars.

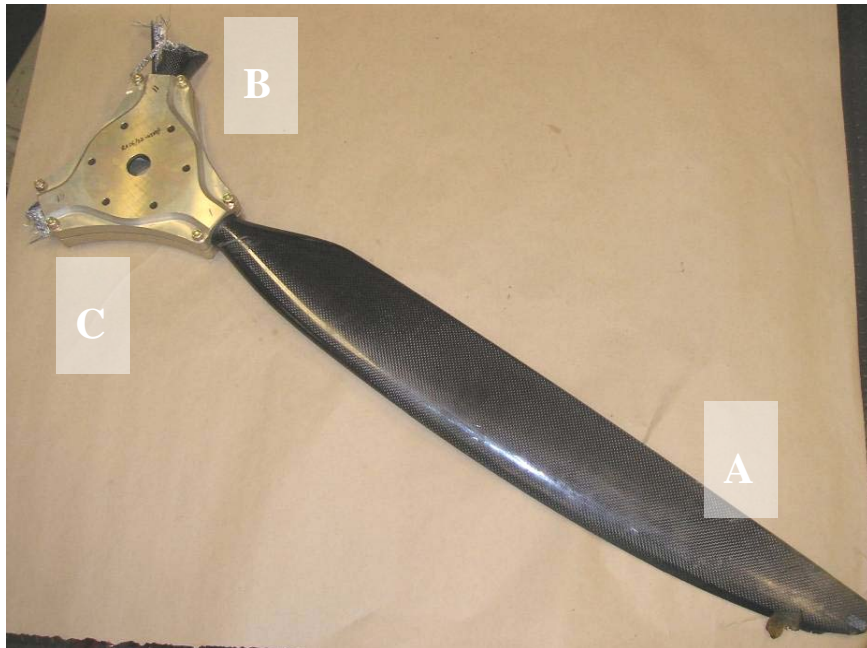
The propeller from 32-4388 is shown in figure 9 in its as-received condition. The propeller assembly was identified as a Carbon Fibre- Epoxy, three-blade construction with an aluminium alloy hub. The blades consisted of a glass fibre-epoxy and foam core, with a carbon fibre-epoxy outer surface⁵. For analysis purposes, the three blades were labelled A, B and C, see figure 9. All three blades were able to be rotated within the hub assembly.

Figure 9: Fractured propeller from 32-4388.

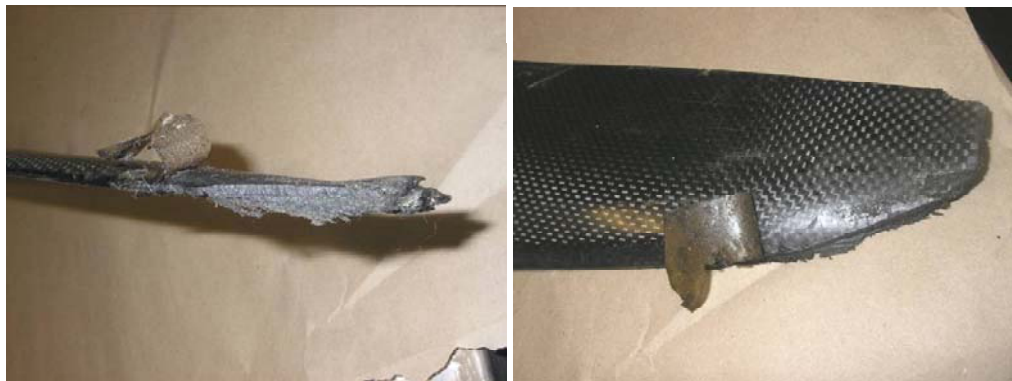
Examination of blade A, the only intact blade, revealed leading edge damage, see figure 10. The damage was predominantly at the tip of the blade and included splitting of the carbon fibre surface and de-bonding of the outer coating. There was no observed fibre pull out at this location.

Figure 10: Leading edge damage to blade A.

Damage to the tip of blade A from microlight 32-4388 was consistent with being involved in an impact event. Failure of blades B and C were consistent with bending overload failure. Both blades exhibited fibre pullout which was longer on one side of the fracture to the other, suggesting failure under directional bending load. Damage to blade B was consistent with a bending load applied in the direction of rotation, however this could not be established for blade C, as the blade had moved within the hub. It is likely that such loading occurred during an impact event. There was no evidence of mechanical or material defects that could have contributed to the premature failure of the propeller.

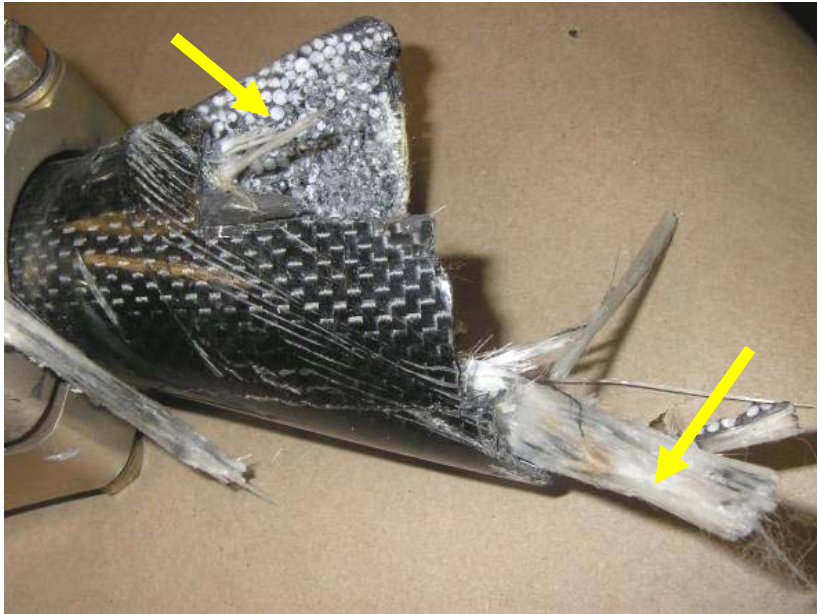
Blade B included a stepped fracture surface and glass fibre pull out was observed. The pull out was longer on one side of the fracture than the other, arrowed in figure 11. The fracture characteristics of the foam core showed two distinct fracture regions, a smooth region and a coarse region.

Figure 11: Fracture surface of blade B. Note that fibre pull out is longer on one side of the fracture (arrowed).

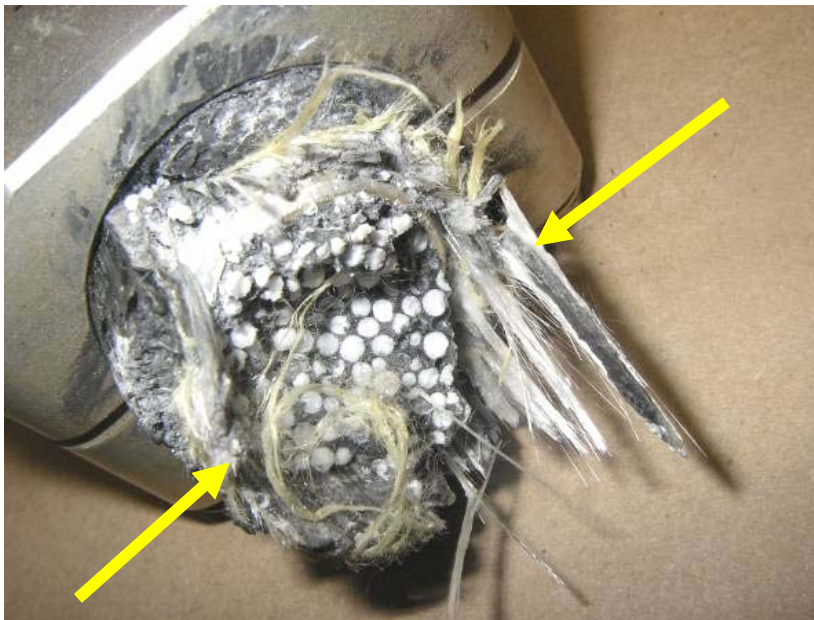
The fracture of blade C was close to the propeller hub and was relatively flat, the inner metal core was visible and glass fibre pull out was observed. Similar to blade B, fibre pull out was longer on one side of the fracture than the other, arrowed in figure 12.

Figure 12: Fracture surface of blade C. Note fibre pull out was more pronounced on one side of the fracture surface (arrowed).

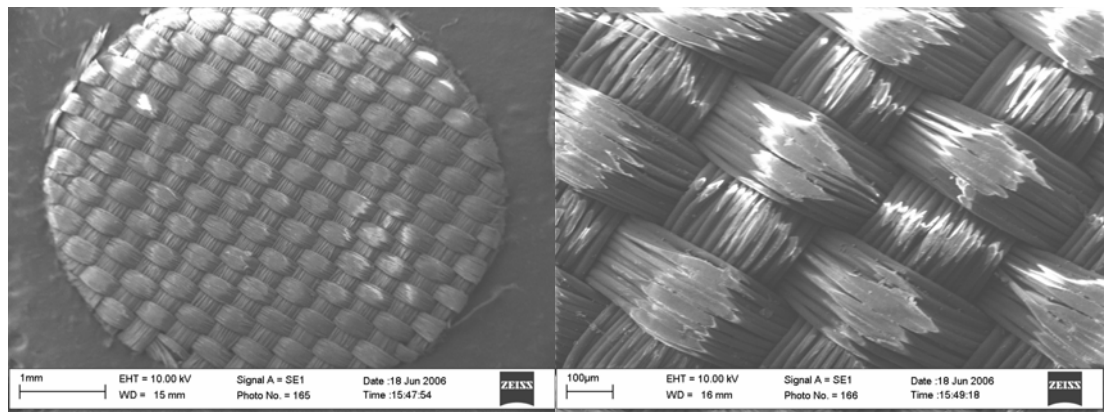
Examination of the purple fabric samples, see figure 14, revealed intact, undamaged threads, with no visual evidence of degradation. Examination of the off-white fabric samples showed irregularities in the weave and contamination of the threads, arrowed in figure 15. Those samples were viewed under the light microscope, and areas of damage coincided with stains on the fabric.

Figure 14: Thread condition characteristic of the purple fabric sample at high and low magnifications.

Visual examination of the canopy material from microlight 32-4456 showed no evidence of gross abnormalities. The samples representative of the purple fabric section of the microlight canopy were in good condition. Threads were observed to be intact and the weave was regular. The samples representative of the off-white fabric section of the canopy exhibited some irregularities in the weave and damaged threads. These corresponded to stains observed on the fabric. It is likely that these threads were damaged during impact, as dirt was encrusted onto the fabric.

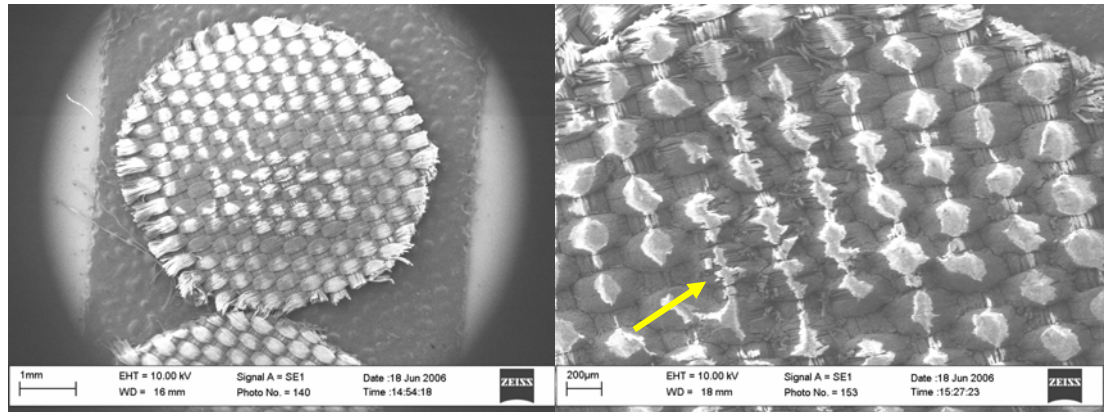
Figure 15: Thread condition characteristic of off-white fabric samples at high and low magnifications. Note the irregularity in the fabric weave.

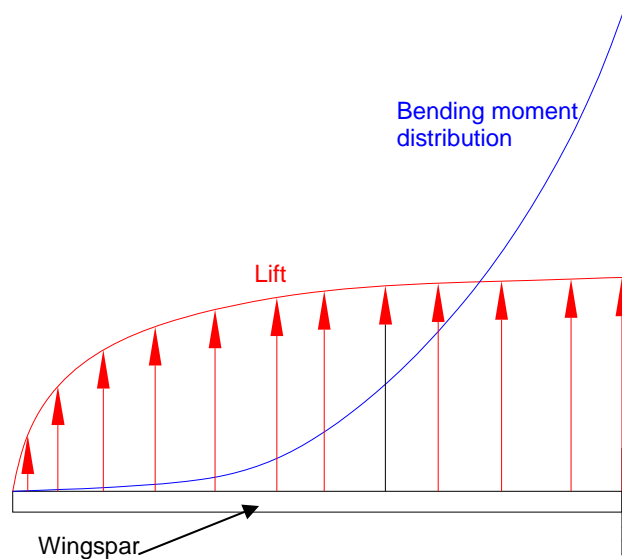
Review of the Airborne Edge microlight structure indicated that the section of leading-edge beam, outboard of the outer most bracing wire, would effectively act as a cantilever. Figure 16 presents bending moment distribution of a cantilever under this type of loading. The maximum bending moment would occur at the bracing-wire attachment, however the internal reinforcing sleeve would provide a significant amount of support to the beam and thus it is likely in overload conditions that the failure would occur in the main tube at the end of the sleeve, as observed.

Figure 16: Bending moment distribution on a cantilever representation of the wingspar
