**ATSB TRANSPORT SAFETY INVESTIGATION REPORT**

Aviation Occurrence Report – 200601367

**Analysis of failed turbocharger turbine wheel shafts  
Garrett model TH08A  
Piper PA-31-350 aircraft VH-MZM and VH-TZY**

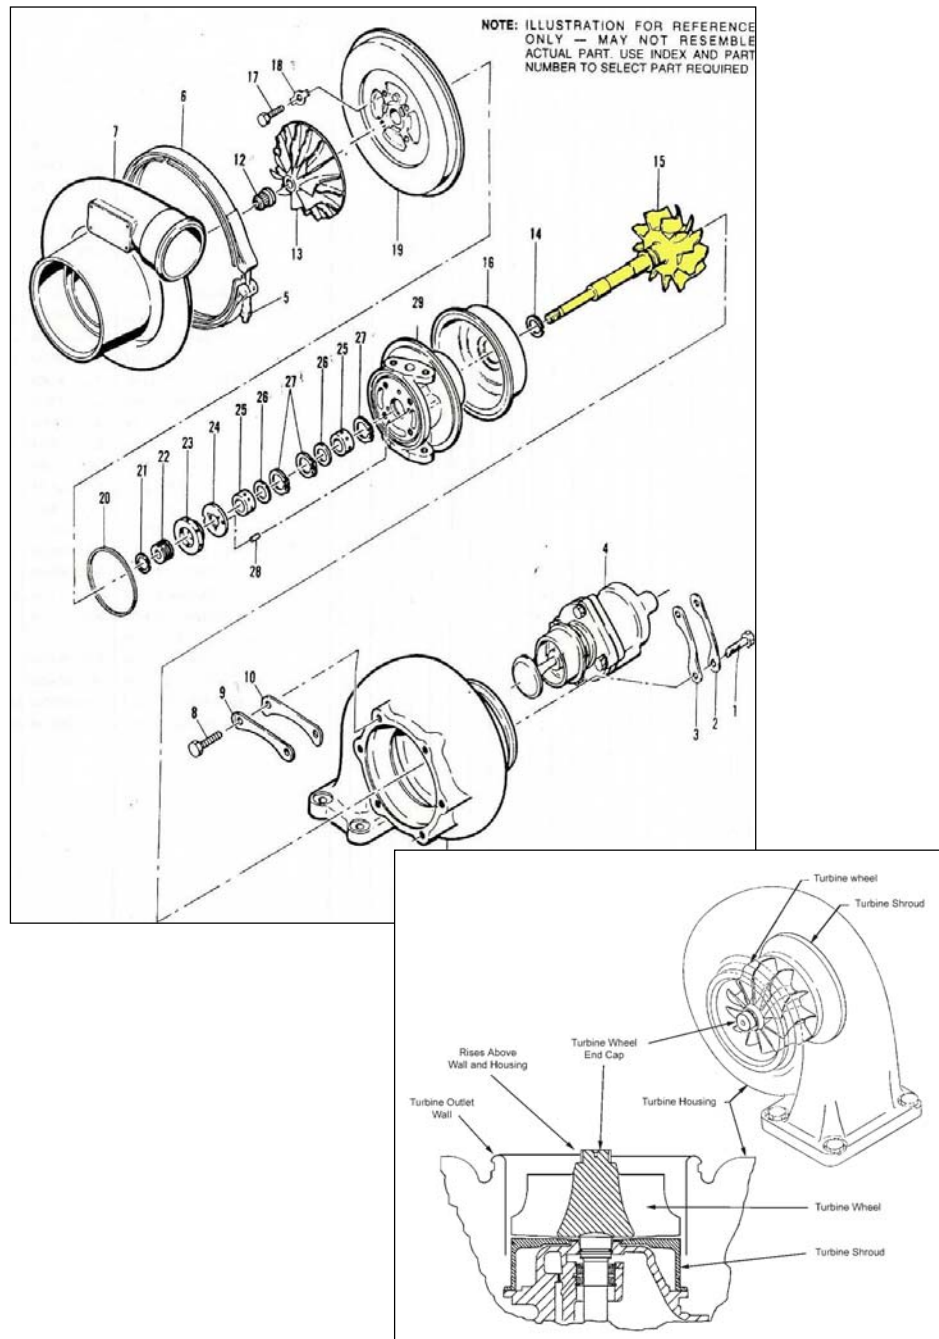
The TH08A turbine wheel assembly from VH-MZM and VH-TZY consisted of discrete shaft and wheel components, friction welded at a location approximately 0.5" from the rear face of the turbine wheel (see figure 1). The friction welding

process<sup>3</sup> incorporated a heat treatment operation to relieve residual stresses induced by the welding process. Courtesy of the TH08A turbocharger's common shaft design, the compressor and turbine wheels were supported in a cantilever fashion by a centre housing assembly. Of note in the TH08A design, the turbine wheel end cap protruded slightly from the housing inlet (see inset in figure 1).

**Figure 1: Exploded parts diagram of the turbocharger assembly, model TH08A<sup>1</sup>. The turbine wheel assembly is shaded yellow.**

On 28 November 2006, the turbocharger manufacturer (Kelly Aerospace Power Systems) released Service Information Letter (SIL) number A-117, providing general recommendations for the handling of TH08A series turbocharger assemblies. The service letter detailed the safety issue resulting from the extension of the turbine wheel end cap beyond the housing, and presented recommendations for the handling, assembly, disassembly and shipping of the turbocharger units, so as to minimise the likelihood of damage to the wheel and shaft components.

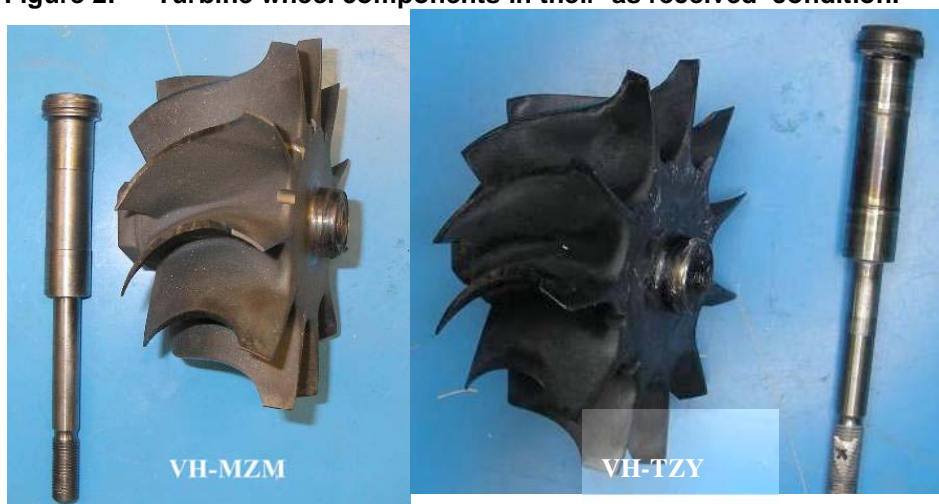
Figure 2 shows the turbine wheel assemblies as received. The wheels themselves showed minimal damage, other than some discolouration and heavy blade tip rub and abrasion. Both assemblies carried the identification '406787-0010 FAA-PMA 05-04' etched on the central shaft section.

In both instances, the turbine shaft had fractured from the hub of the turbine wheel transversely through the ring groove location (adjacent to the friction weld). As far as practicable, given the damage associated with the fractures, measurements taken for both assemblies confirmed the ring groove outer diameter and width were within specified service limits, with no surface abnormalities observed.

**Figure 2: Turbine wheel components in their 'as received' condition.**

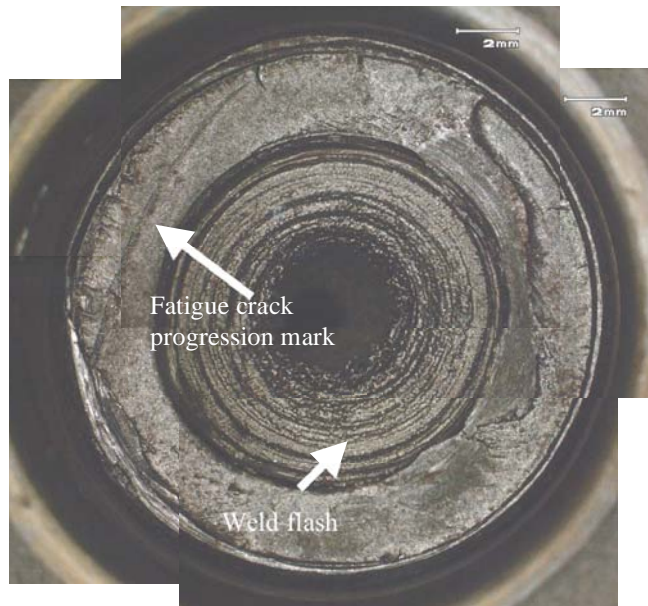
The VH-MZM assembly fracture surfaces presented several chordwise crescent shaped features that were indicative of fatigue crack initiation and growth from an external surface origin (see figure 3). Scanning Electron Microscopy (SEM) conducted on this region confirmed the presence of fatigue features. An extensive coverage of uniform indentations or 'dimples' observed across the fracture surfaces obscured much of the finer fracture detail, limiting further examination. Those features were later confirmed as the product of a shot/bead blasting procedure carried out before the components were submitted to the ATSB. A bead of extruded material, typical of welding flash, was observed on the wheel side of the fracture between the shaft bore and the limit of the welded section.

**Figure 3: Fracture surface features of the turbine wheel component (VH-MZM).**

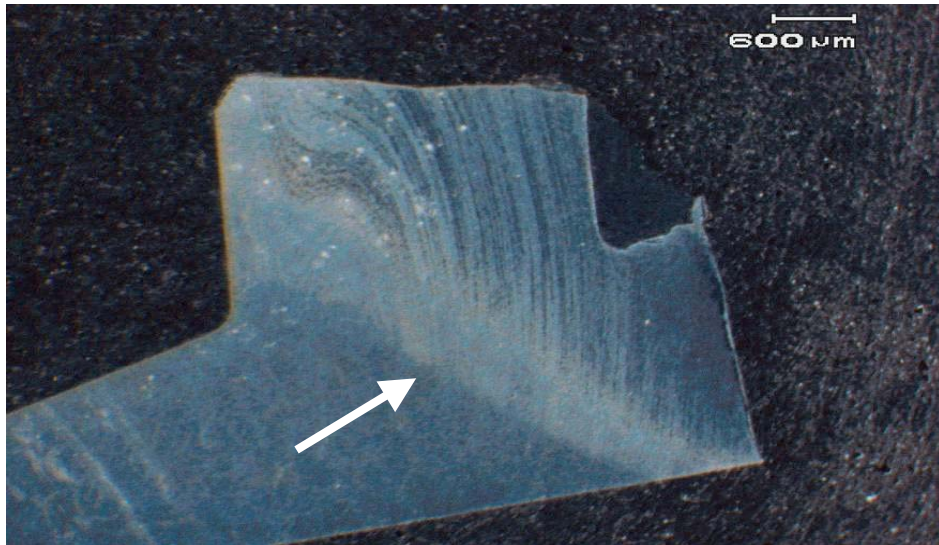
Several axially-oriented cross-sections were taken through the region of failure of the VH-MZM turbine wheel and prepared for metallographic examination. Initial study confirmed the fracture to have originated within the recessed shaft ring groove, located approximately 0.120" from the fusion boundary of the weld between shaft and turbine wheel, see figure 5. The microstructure of the alloy steel material in the vicinity of the failure presented as a fine, tempered martensite, with some evidence of thermally-induced transformation effects, consistent with the weld heat-affected zone (HAZ), or frictional heating post-failure (see figure 4). The weld fusion boundary showed no evidence of incomplete fusion or other entrained defects.

**Figure 4: Thermally affected region adjacent to shaft fracture**

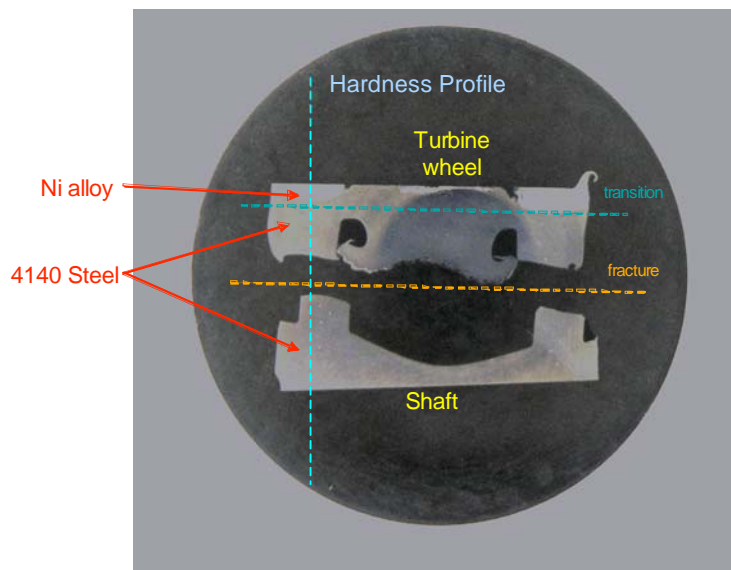
A hardness profile was taken between the hub of the turbine wheel and the shaft, across the fracture region (see figure 5). Sixteen hardness readings in total were taken, approximately 2 mm from the outer edges of the sample. Hardness measurements were compared to those taken from the alloy steel parent material (remote from the weld region), with results presented in figure 6.

**Figure 5: Micro-section with features and location of hardness profile indicated**

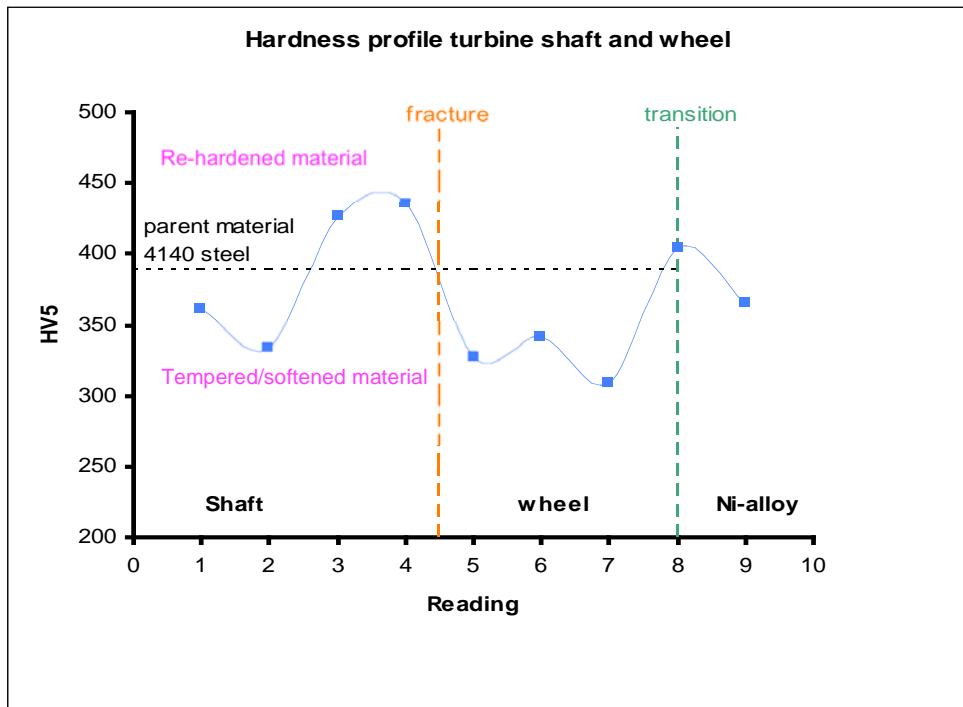
The graphical representation shows the variation in hardness across the fracture zone, with the values obtained correlating with the microstructural observations. The nominal 370 – 380 HV shaft parent metal hardness was as expected and consistent with the alloy having undergone a hardening and tempering heat-treatment.

Figure 6: Hardness measurements from profile
